## Annual Inspection

Brundall Parish Council

Meadow View Play Area

Inspection Ref: 2205981

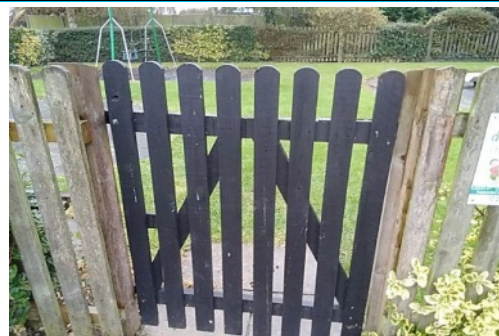
**Item:** Gate - Pedestrian  
**Manufacturer:** Unknown  
**Surface Type:** Paving Slabs  
**Item Quantity:** 1  
**Equipment Compliance:** N/A  
**Surface Area Compliance:** Yes

This item is satisfactory - no work required -

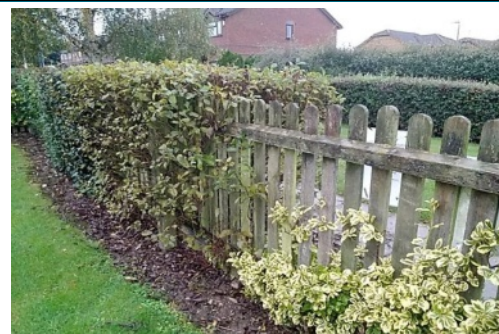
**Item:** Fencing - Timber  
**Manufacturer:** Unknown  
**Surface Type:** Soil  
**Item Quantity:** 1  
**Equipment Compliance:** N/A  
**Surface Area Compliance:** N/A

This item is satisfactory - no work required -

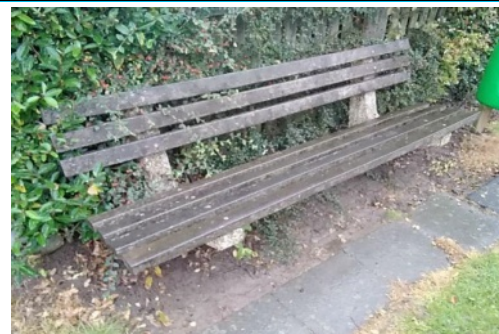
**Item:** Seat  
**Manufacturer:** Unknown  
**Surface Type:** Mixed Surface  
**Item Quantity:** 1  
**Equipment Compliance:** N/A  
**Surface Area Compliance:** Yes

This item is satisfactory - no work required -

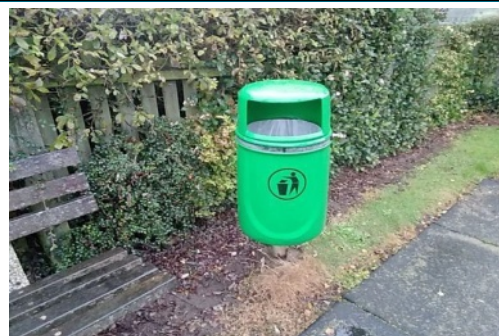
**Item:** Litter Bin  
**Manufacturer:** Unknown  
**Surface Type:** Grass  
**Item Quantity:** 1  
**Equipment Compliance:** N/A  
**Surface Area Compliance:** Yes

This item is satisfactory - no work required -

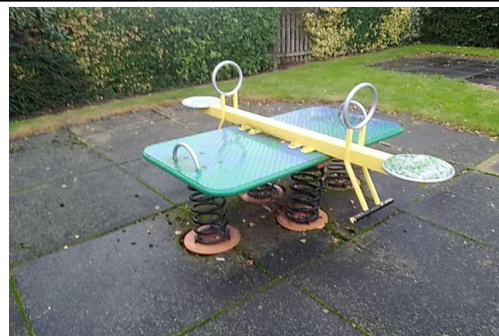
**Item:** Four Way Springer  
**Manufacturer:** Levercrest  
**Surface Type:** Rubber Tiles  
**Item Quantity:** 1  
**Equipment Compliance:** No  
**Surface Area Compliance:** Yes

The end of footrests have a cross section of less than 15cm<sup>2</sup> and fail to meet the requirements of BS EN 1176 Part 6 - Monitor - No remedial work recommended

There are gaps opening in between the tiles - Monitor for any further deterioration and repair as required

The safety surface around the area is beginning to wear - Monitor for any further deterioration and budget for surface upgrade

Surface edging is missing - Replace surface edging as part of surface upgrade

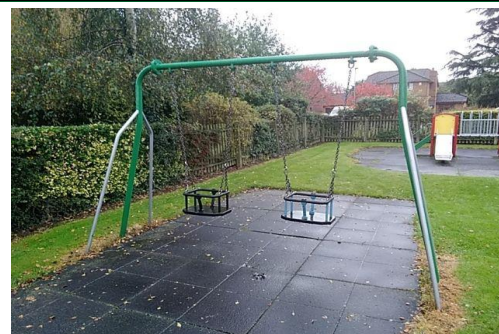
**Item:** 1 Bay 2 Seat (Cradle)  
**Manufacturer:** Levercrest  
**Surface Type:** Rubber Tiles  
**Item Part Number:** 1.98m Swing  
**Item Quantity:** 1  
**Equipment Compliance:** Yes  
**Surface Area Compliance:** Yes  
**Total Findings:** 5

Corrosion evident at the seat fixings - Monitor for deterioration and replace when required

There are gaps opening between the surfacing and the edging surround or between the joints in the surfacing - Monitor for any further deterioration and repair as required

Surface edging missing - Replace surface edging as part of surface upgrade

The bushes are showing signs of wear - Monitor for any further deterioration and replace as required (manufacturer no longer trading, replacement parts might not be available)

The safety surface around the area is beginning to wear - Monitor for any further deterioration and budget for surface upgrade

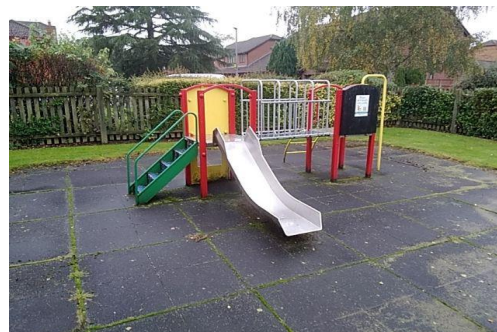
**Item:** Multi Play (Toddler)  
**Manufacturer:** Levercrest  
**Surface Type:** Rubber Tiles  
**Item Quantity:** 1  
**Equipment Compliance:** No  
**Surface Area Compliance:** Yes

The item fails to meet the requirements of BS EN 1176 Part 1 4.2.7.2 for head and neck entrapment between bridge frame & tower uprights and at arch climber top rung - Monitor - No remedial work recommended

There is a dent in the slide surface - Monitor for any further deterioration

There are gaps opening in between the tiles - Monitor for any further deterioration and repair as required

There is moss growth on the surface - Clean and treat appropriately

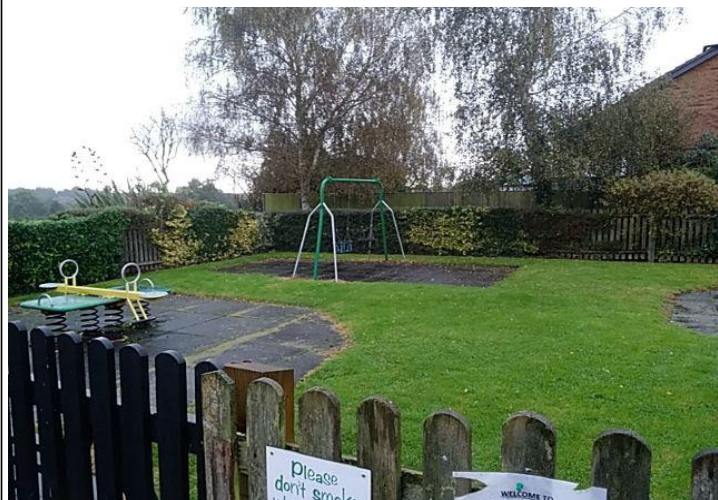
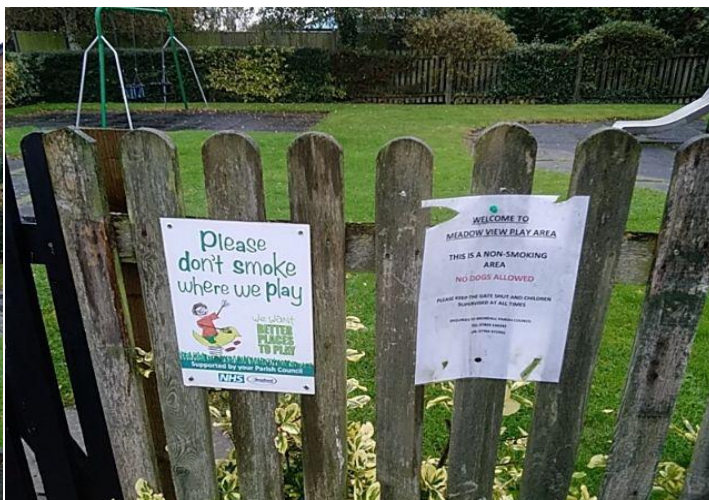
**Item:** Signs - Playground Sign  
**Manufacturer:** Not Applicable

**Finding:** It is recommended that signage, with information including the site address, contact information for maintenance issues and emergency contact details are provided for the facility

**Action:** Provide in accordance with the recommendations

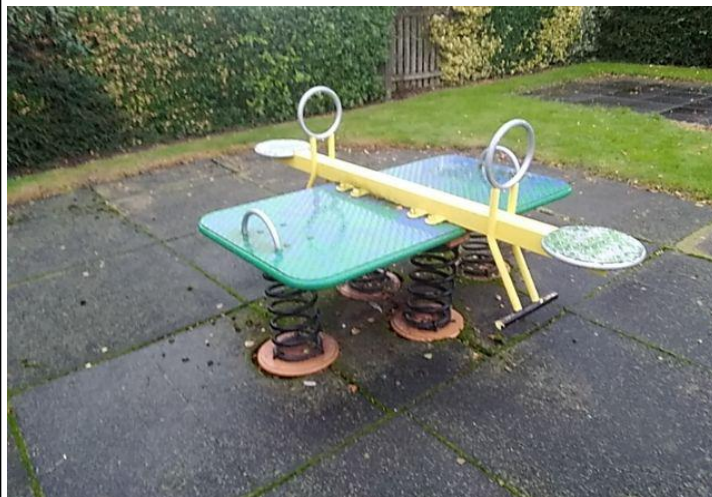
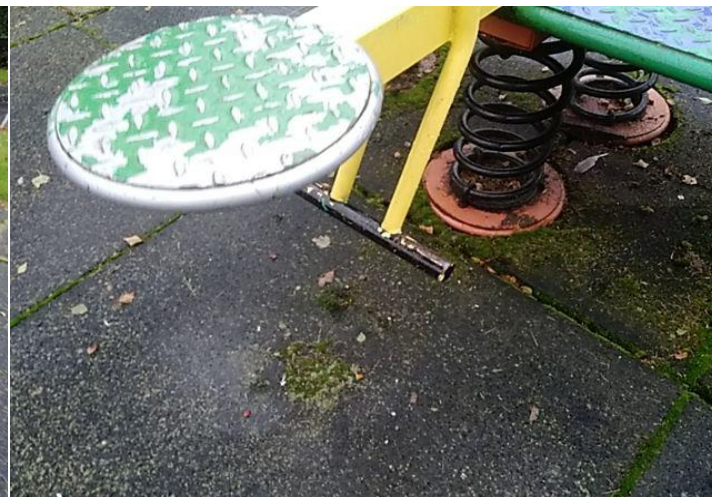
**Item:** Rocking Equipment - Four Way Springer  
**Manufacturer:** Levercrest

**Finding:** The end of footrests have a cross section of less than 15cm<sup>2</sup> and fail to meet the requirements of BS EN 1176 Part 6

**Action:** Monitor - No remedial work recommended

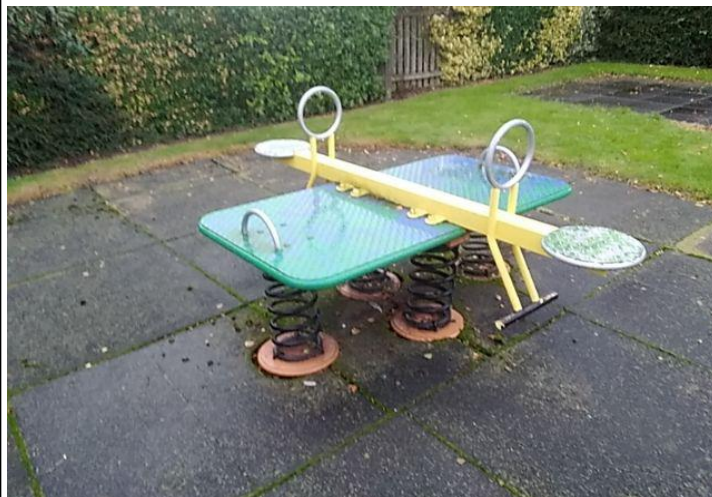
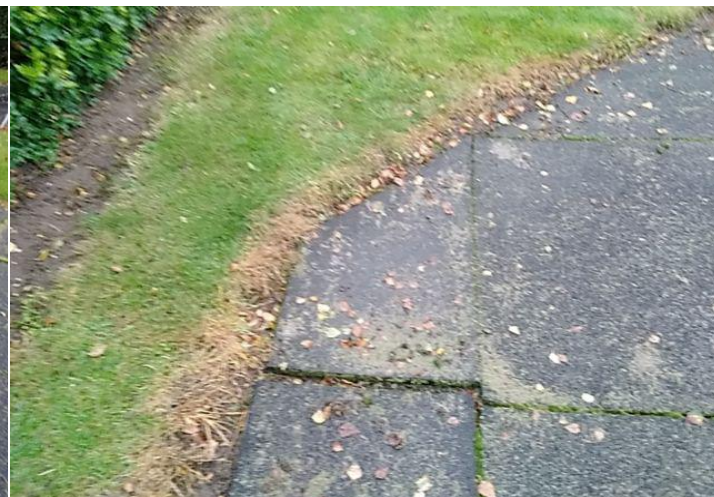
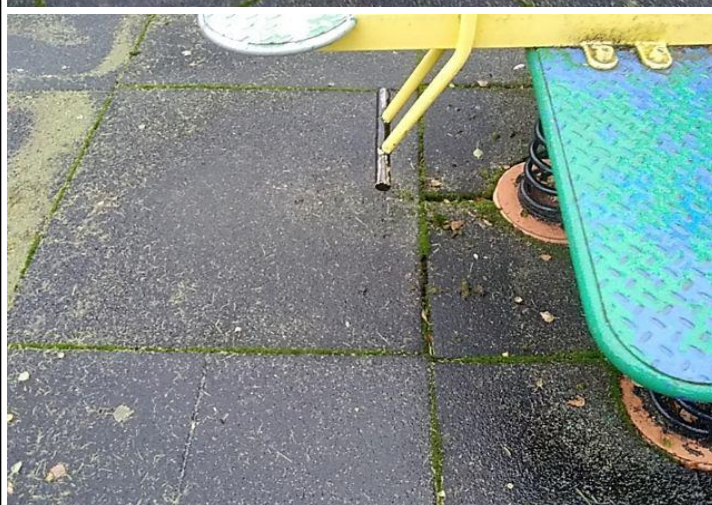
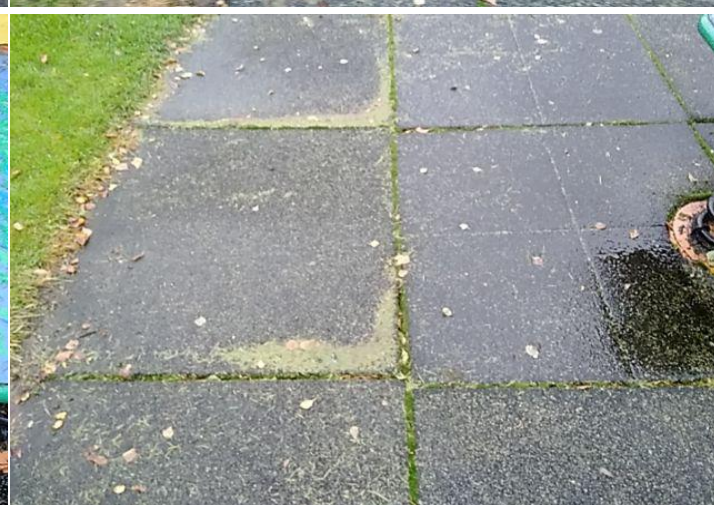
**Item:** Rocking Equipment - Four Way Springer  
**Manufacturer:** Levercrest

**Finding:** There are gaps opening in between the tiles

**Action:** Monitor for any further deterioration and repair as required

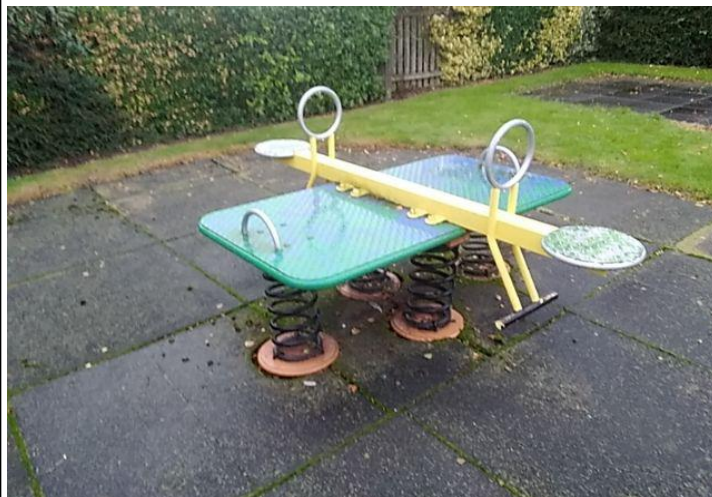
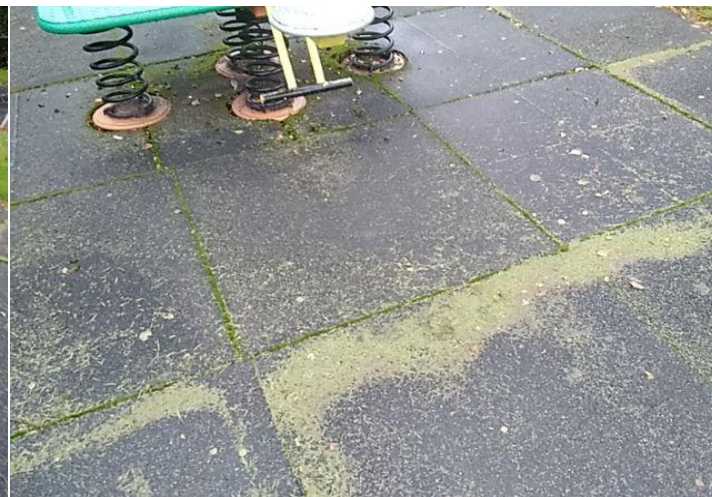
**Item:** Rocking Equipment - Four Way Springer  
**Manufacturer:** Levercrest

**Finding:** The safety surface around the area is beginning to wear  
**Action:** Monitor for any further deterioration and budget for surface upgrade

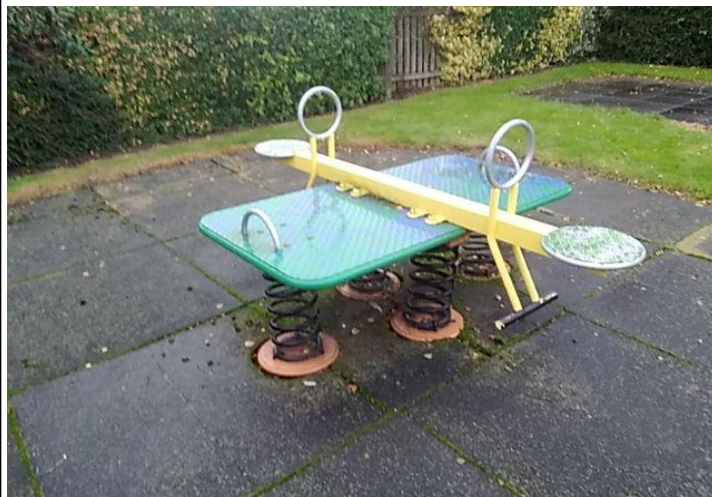
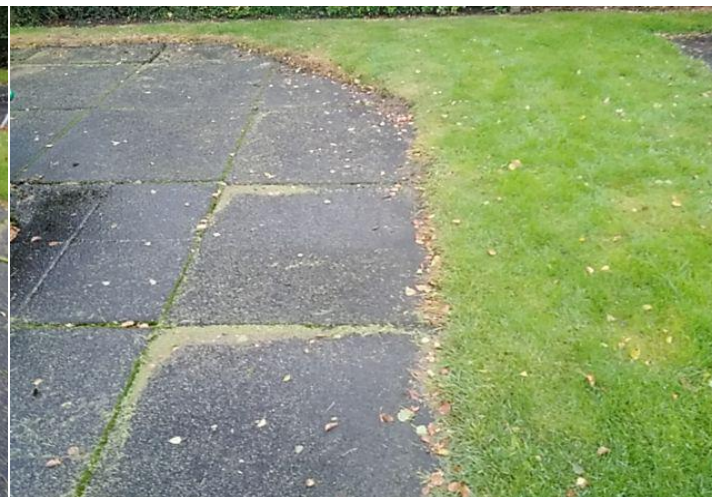
**Item:** Rocking Equipment - Four Way Springer  
**Manufacturer:** Levercrest

**Finding:** Surface edging is missing

**Action:** Replace surface edging as part of surface upgrade

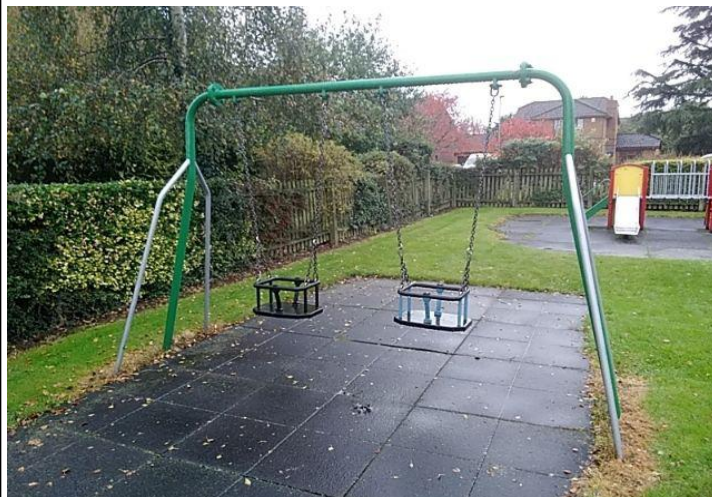
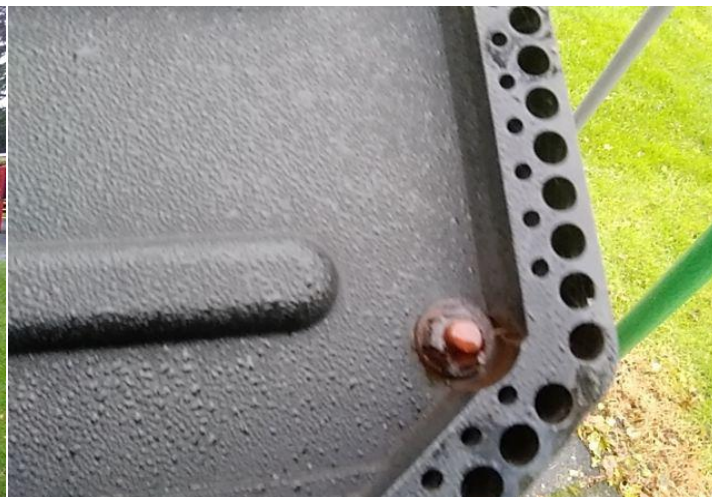
**Item:** Swings - 1 Bay 2 Seat (Cradle)  
**Manufacturer:** Levercrest

**Finding:** Corrosion evident at the seat fixings

**Action:** Monitor for deterioration and replace when required

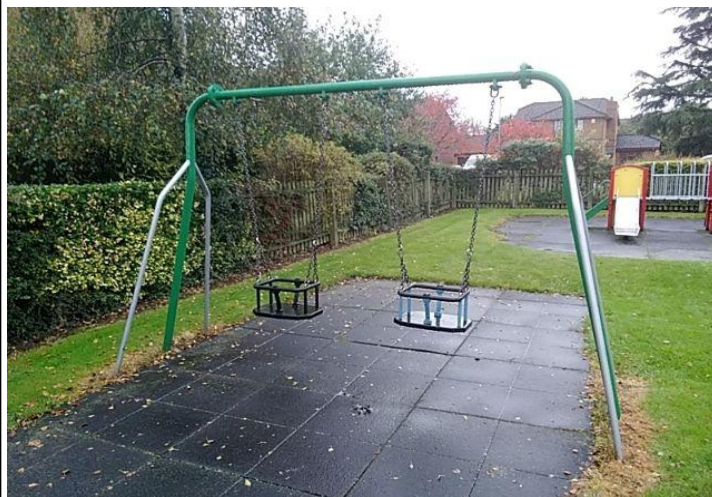
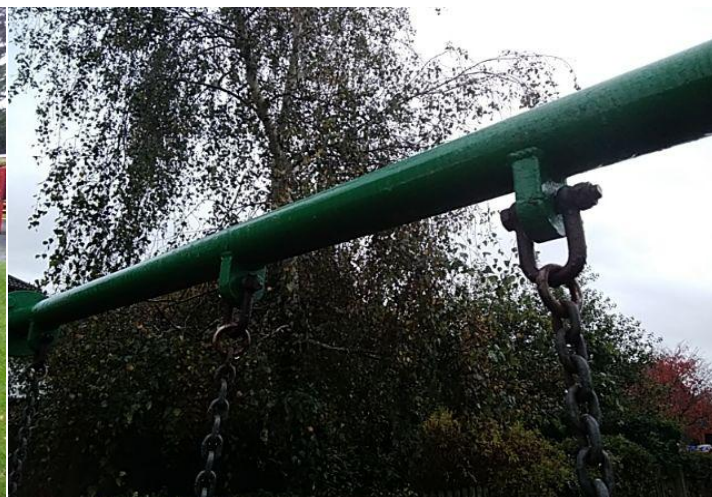
**Item:** Swings - 1 Bay 2 Seat (Cradle)  
**Manufacturer:** Levercrest

**Finding:** The bushes are showing signs of wear

**Action:** Monitor for any further deterioration and replace as required (manufacturer no longer trading, replacement parts might not be available)

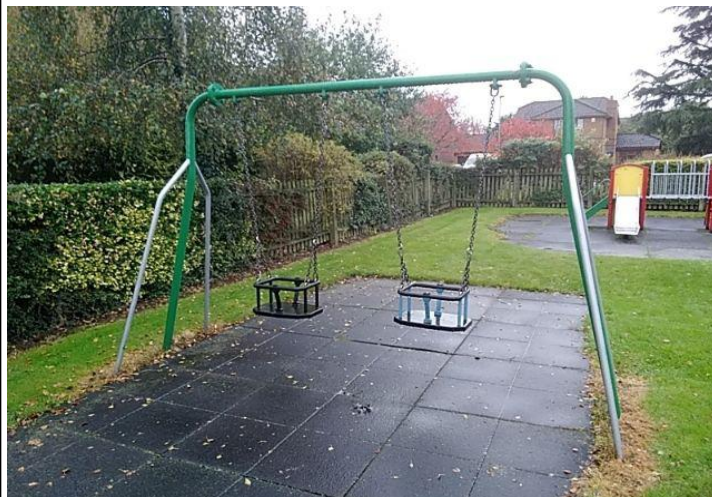
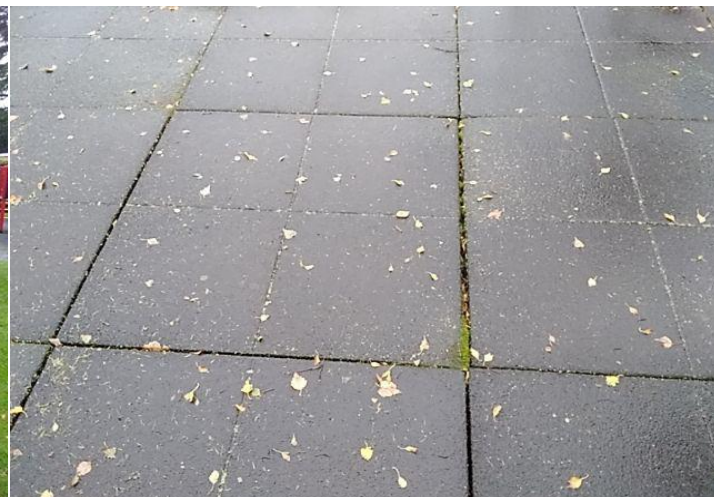
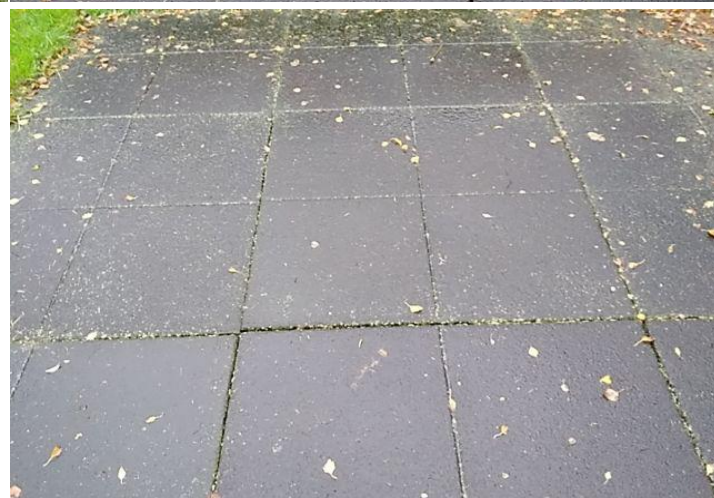
**Item:** Swings - 1 Bay 2 Seat (Cradle)  
**Manufacturer:** Levercrest

**Finding:** There are gaps opening between the surfacing and the edging surround or between the joints in the surfacing  
**Action:** Monitor for any further deterioration and repair as required

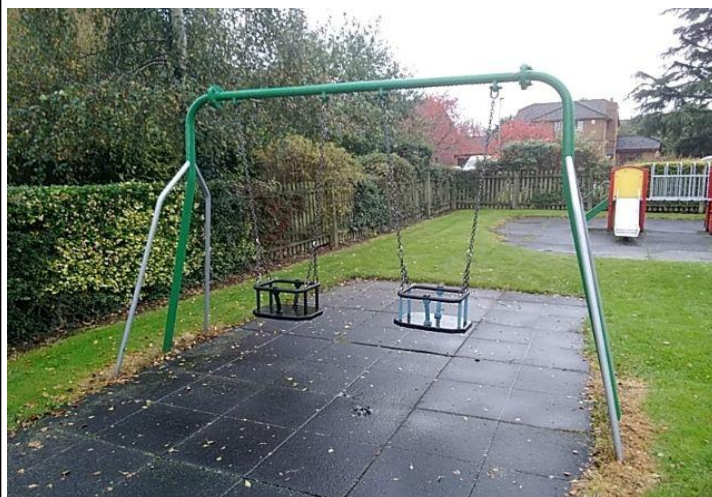
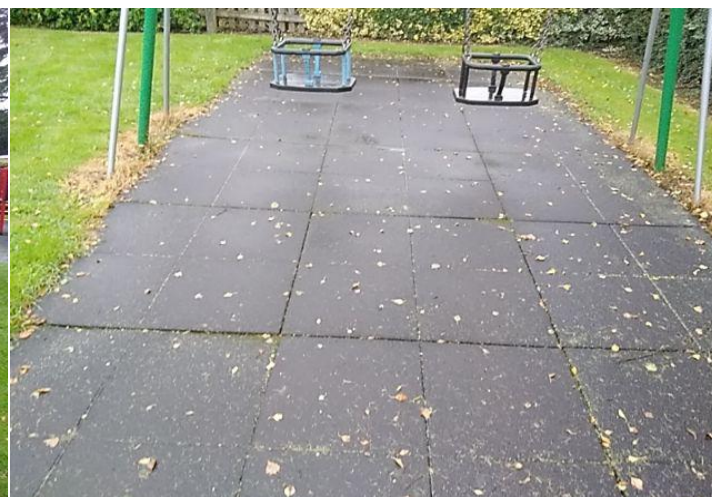
**Item:** Swings - 1 Bay 2 Seat (Cradle)  
**Manufacturer:** Levercrest

**Finding:** The safety surface around the area is beginning to wear  
**Action:** Monitor for any further deterioration and budget for surface upgrade

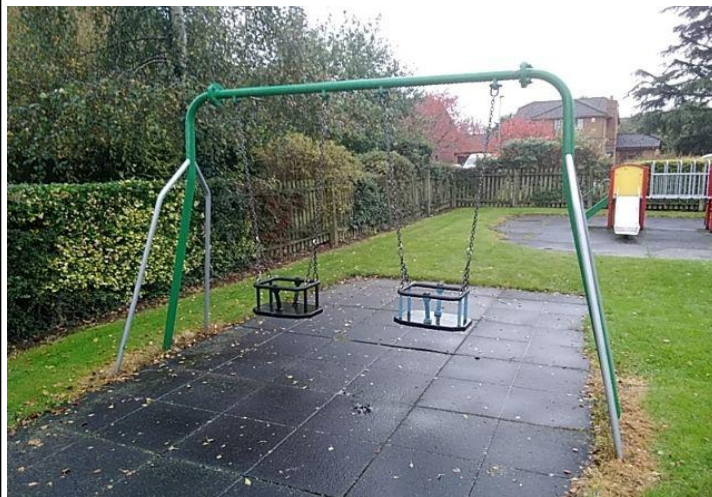
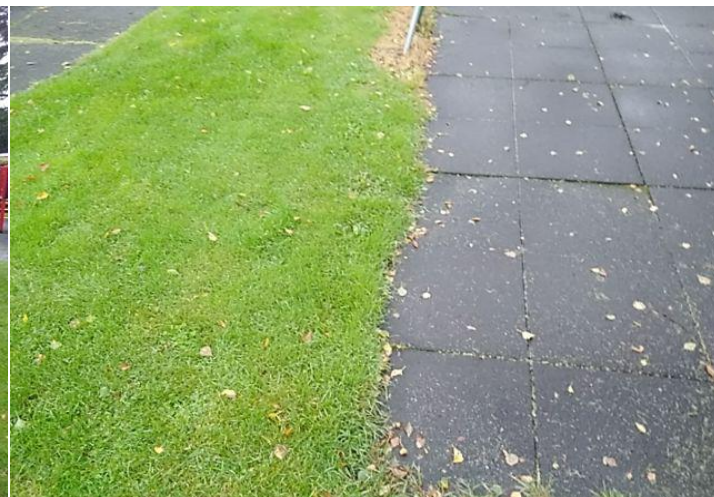
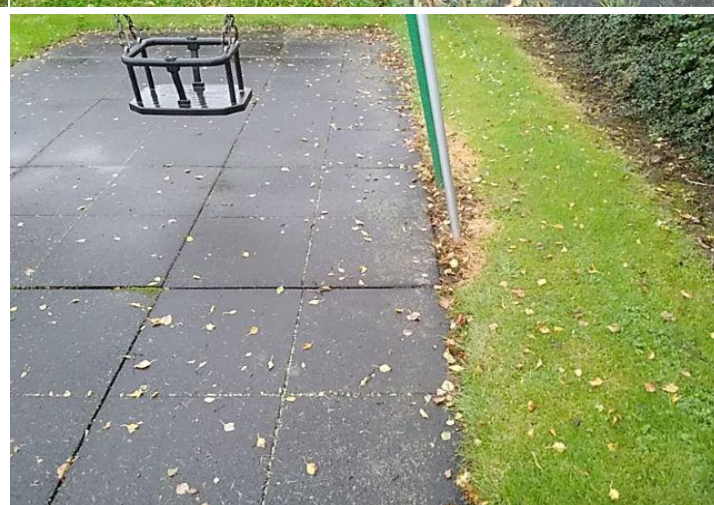
**Item:** Swings - 1 Bay 2 Seat (Cradle)  
**Manufacturer:** Levercrest

**Finding:** Surface edging missing

**Action:** Replace surface edging as part of surface upgrade

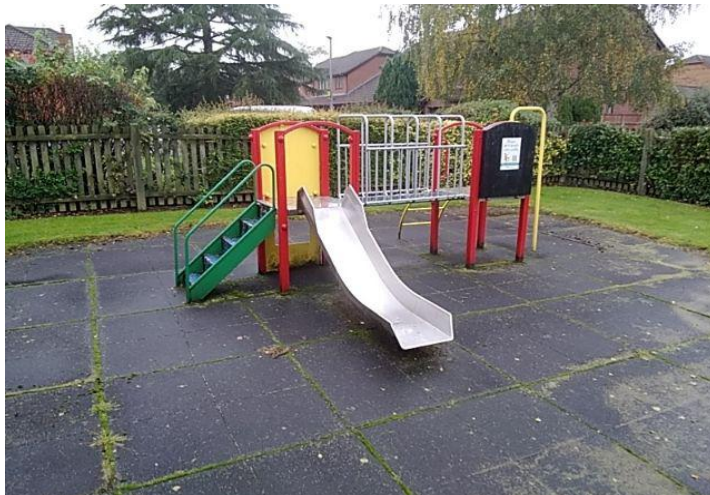
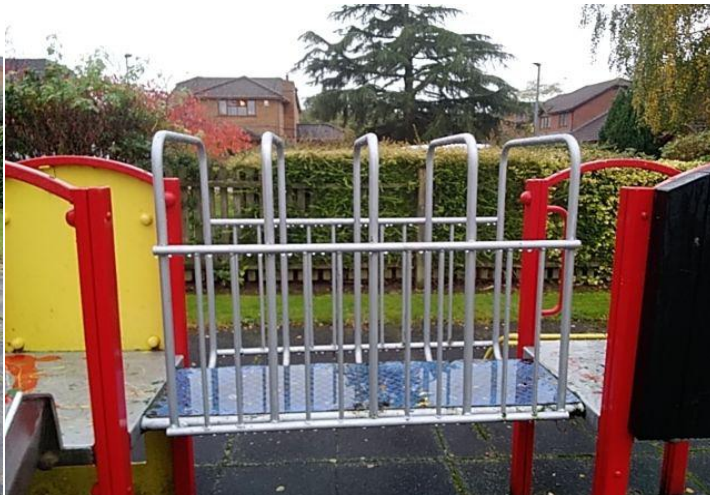
**Item:** Activity Equipment - Multi Play (Toddler)  
**Manufacturer:** Levercrest

**Finding:** The item fails to meet the requirements of BS EN 1176 Part 1 4.2.7.2 for head and neck entrapment between bridge frame & tower uprights and at arch climber top rung

**Action:** Monitor - No remedial work recommended

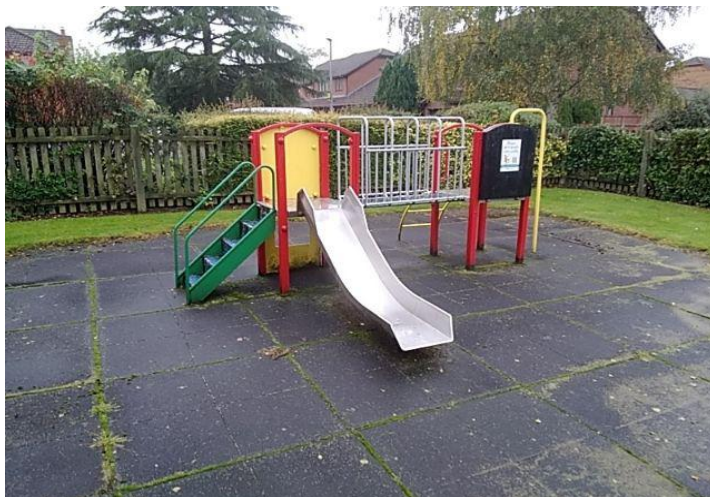
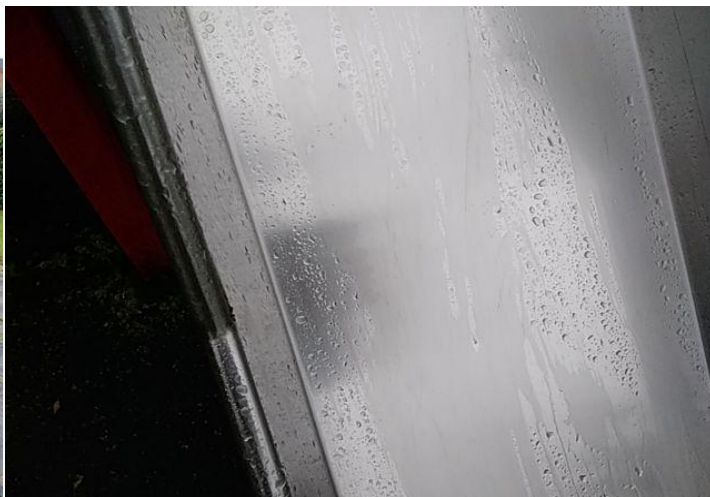
**Item:** Activity Equipment - Multi Play (Toddler)  
**Manufacturer:** Levercrest

**Finding:** There is a dent in the slide surface

**Action:** Monitor for any further deterioration

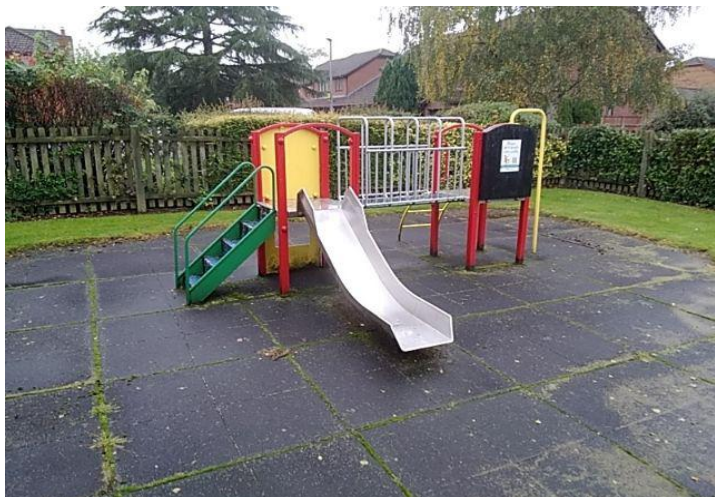
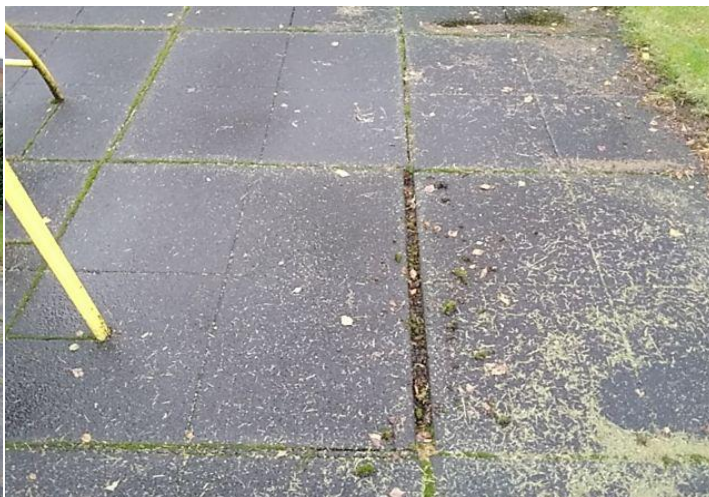
**Item:** Activity Equipment - Multi Play (Toddler)  
**Manufacturer:** Levercrest

**Finding:** There are gaps opening in between the tiles

**Action:** Monitor for any further deterioration and repair as required

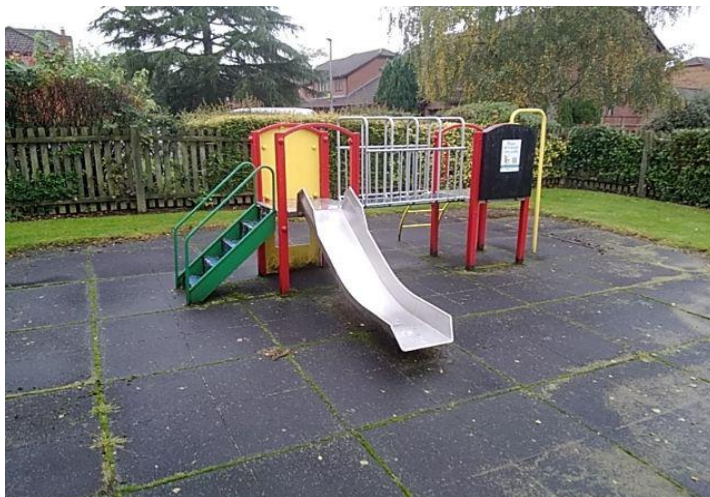
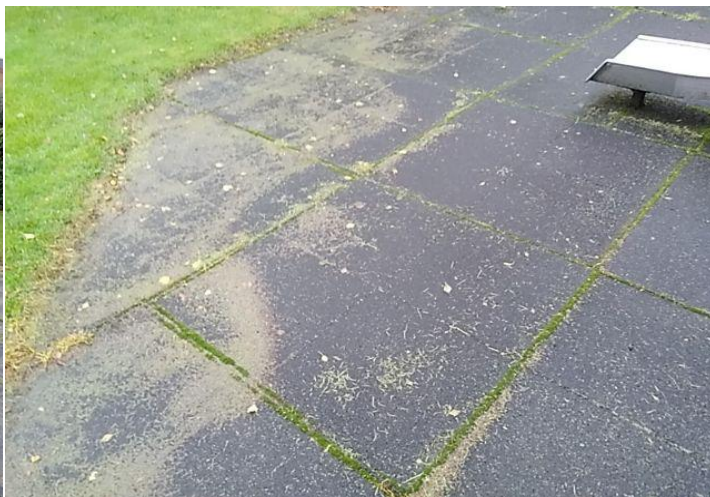
**Item:** Activity Equipment - Multi Play (Toddler)  
**Manufacturer:** Levercrest

**Finding:** There is moss growth on the surface

**Action:** Clean and treat appropriately
