## Annual Inspection

Brundall Parish Council

Memorial Hall Play Area

Links Avenue, Brundall, Norfolk, NR13 5LL

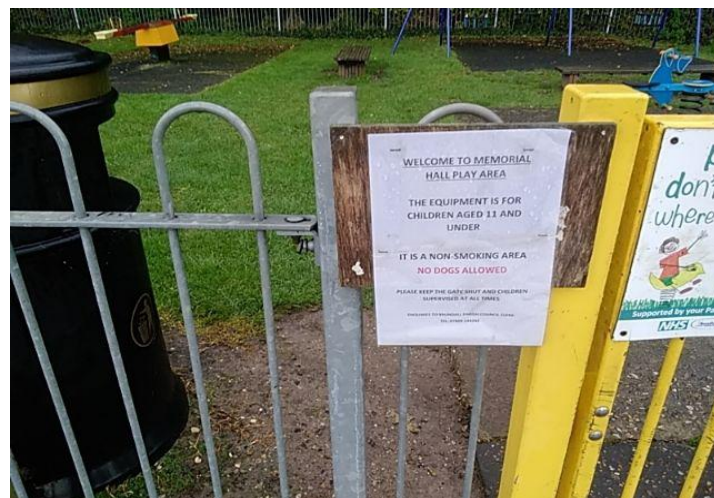
**Item:** Signs - Playground Sign  
**Manufacturer:** Not Applicable

**Finding:** It is recommended that signage, with information including the site address, contact information for maintenance issues and emergency contact details are provided for the facility

**Action:** Provide in accordance with the recommendations

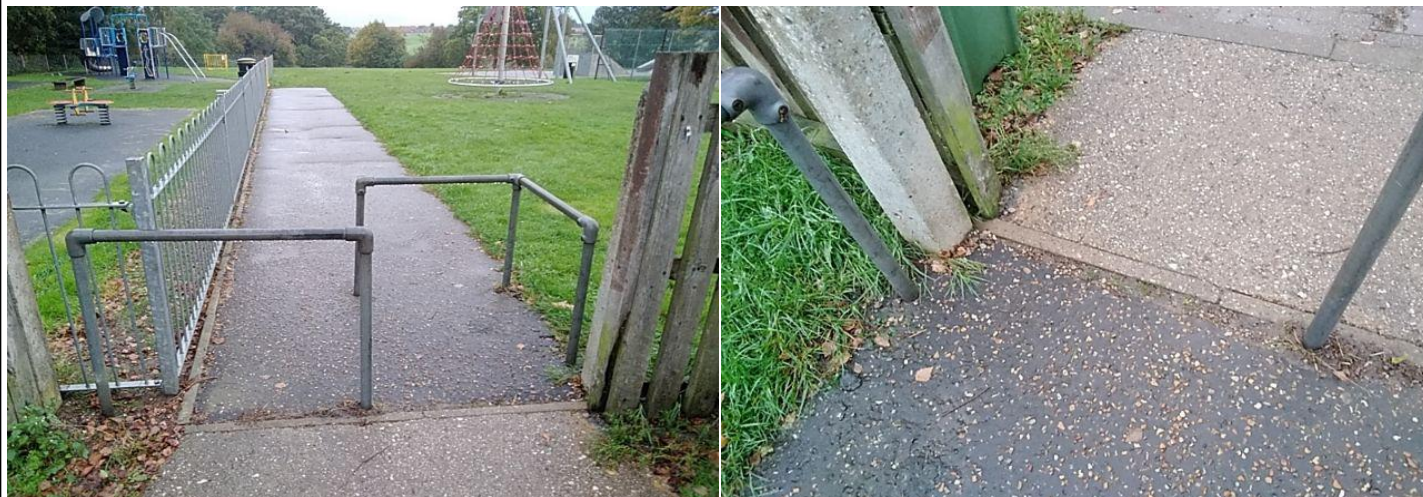
**Item:** Ancillary Items - Barrier  
**Manufacturer:** Unknown

There is a trip hazard at the edge of the surface - Monitor for deterioration, repair as required

**Finding:** There is a trip hazard at the edge of the surface

**Action:** Monitor for deterioration, repair as required

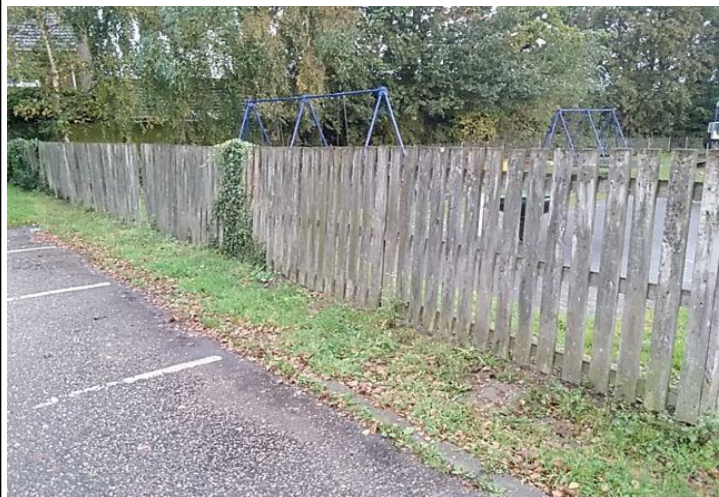
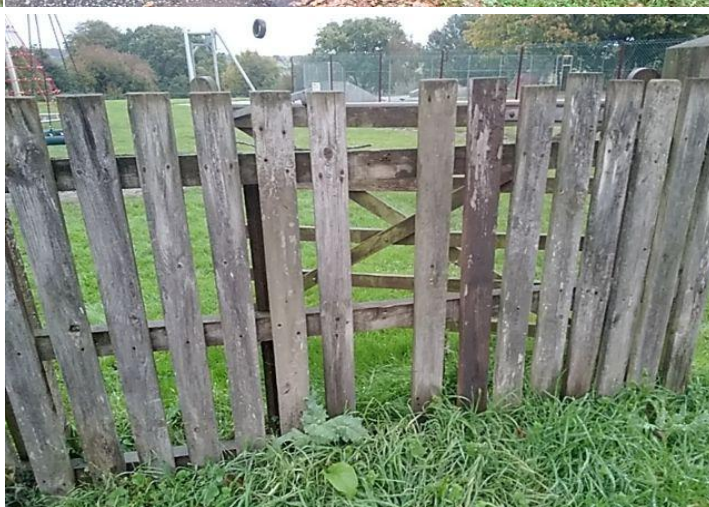
**Item:** Fences - Fencing - Timber  
**Manufacturer:** Unknown

There are a number of timber slats missing from the fence - Replace missing slats

**Finding:** There are a number of timber slats missing from the fence

**Action:** Replace missing slats

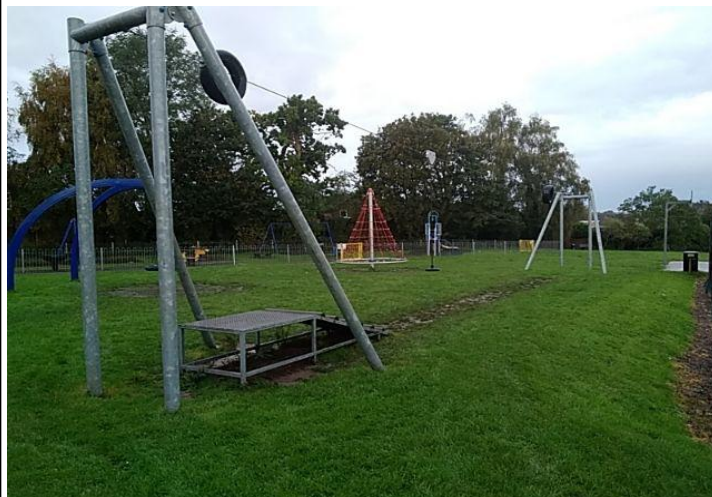
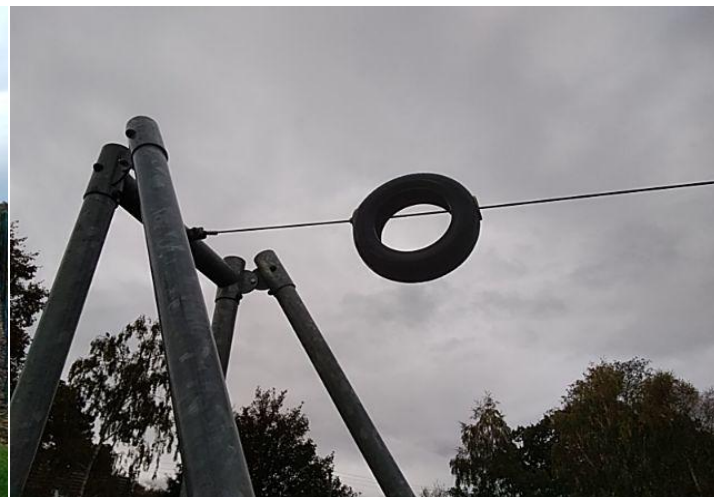
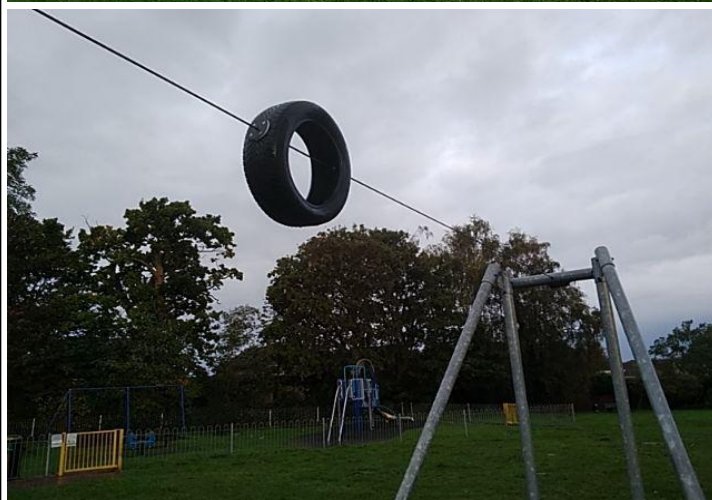
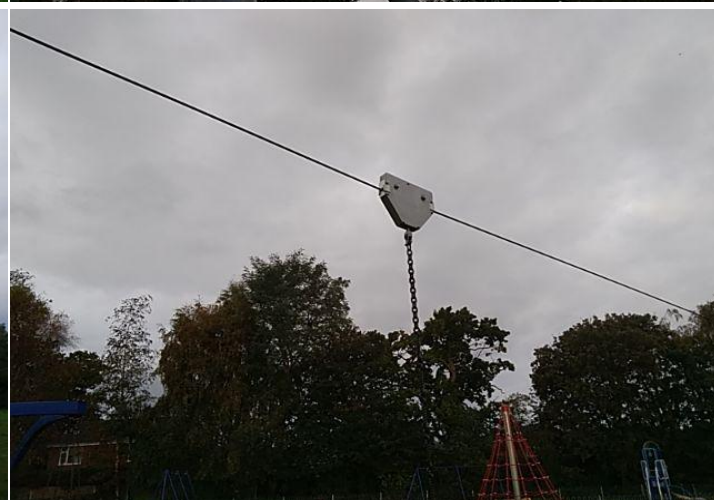
**Item:** Other - Cable Runway  
**Manufacturer:** Wicksteed Playgrounds

**Finding:** We have completed a visual inspection of the cable and fixing points from ground level, however it is not possible to fully inspect the cable and fixings without either hiring equipment to gain access or removing the cable and inspecting at ground level. We recommend that the main cable and fixing security is thoroughly inspected at least in accordance with the manufacturers recommendations to check for damage, security or internal rusting, this will help to ensure the continued safe use of the equipment

**Action:** Inspect in accordance with the manufacturers recommendations

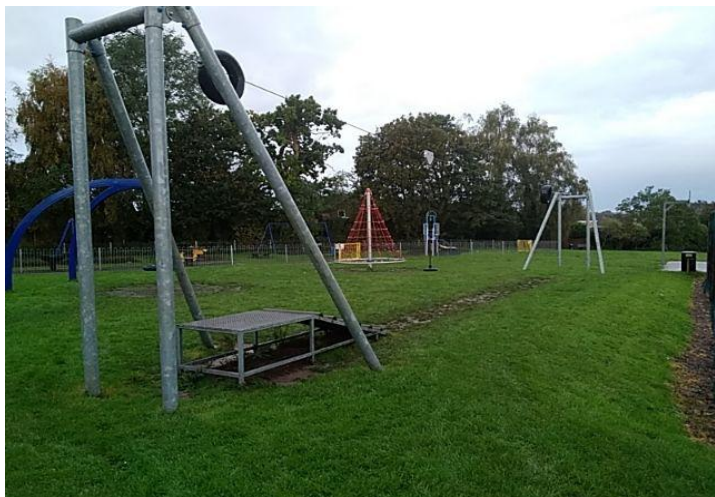
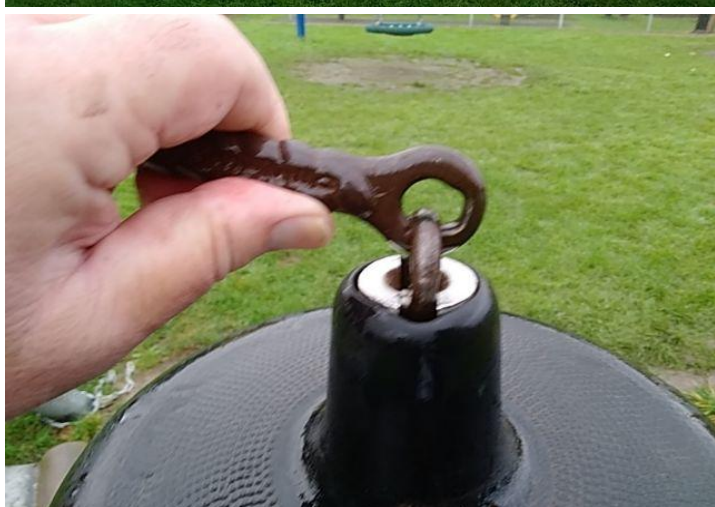
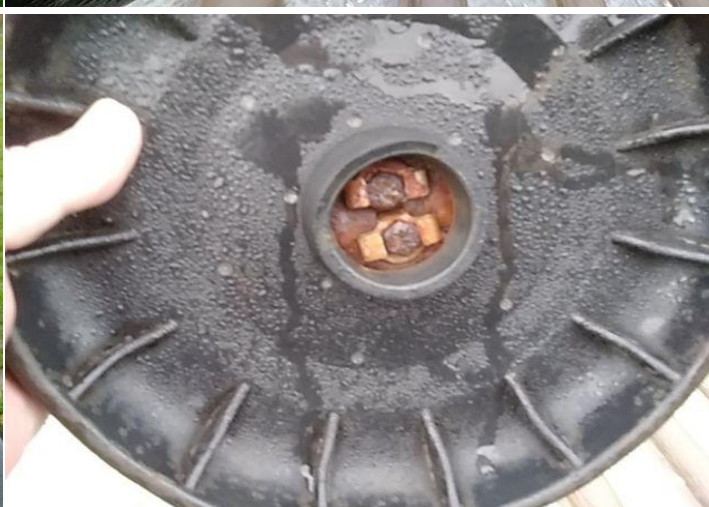
**Item:** Other - Cable Runway  
**Manufacturer:** Wicksteed Playgrounds

There is some notable evidence of chain wear - Monitor for any further deterioration and replace when 40% worn

**Finding:** There is some notable evidence of chain wear

**Action:** Monitor for any further deterioration and replace when 40% worn

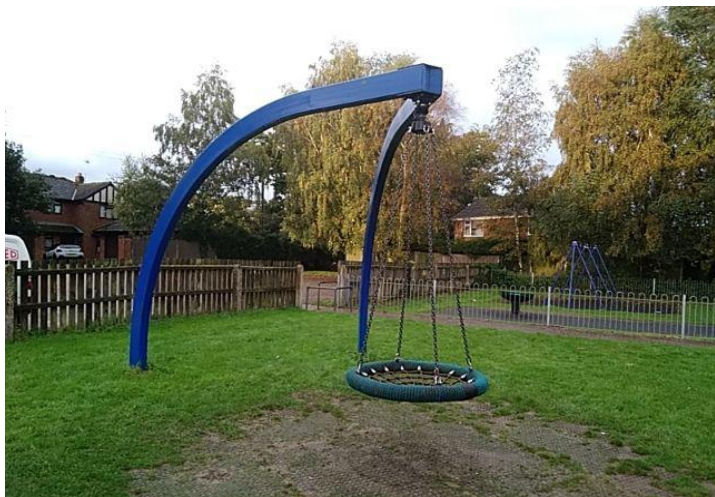
**Item:** Swings - Cantilever Swing - Type 3  
**Manufacturer:** Wicksteed Playgrounds

There are gaps opening between the grass mat tiles -  
Monitor for deterioration but advise budget for surface upgrade

**Finding:** There are gaps opening between the grass mat tiles

**Action:** Monitor for deterioration but advise budget for surface upgrade

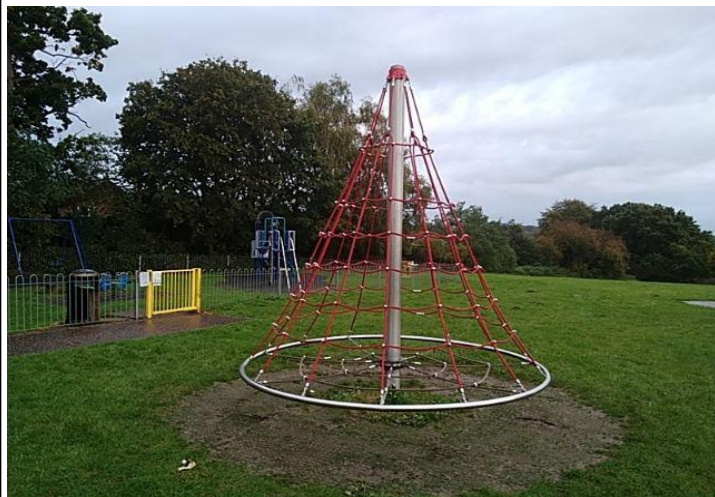
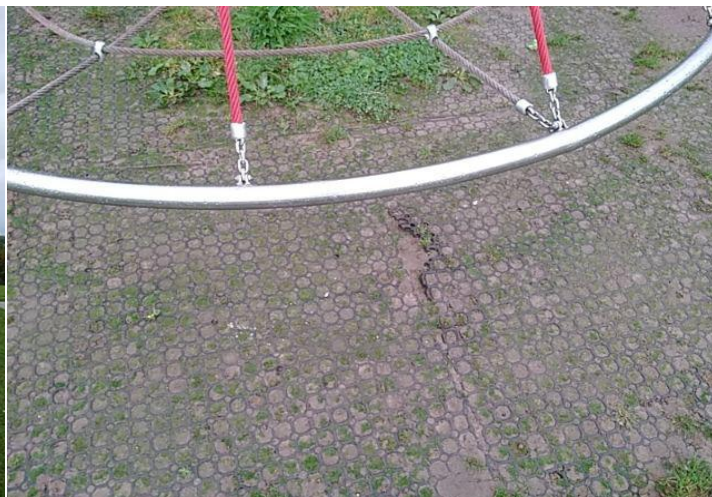
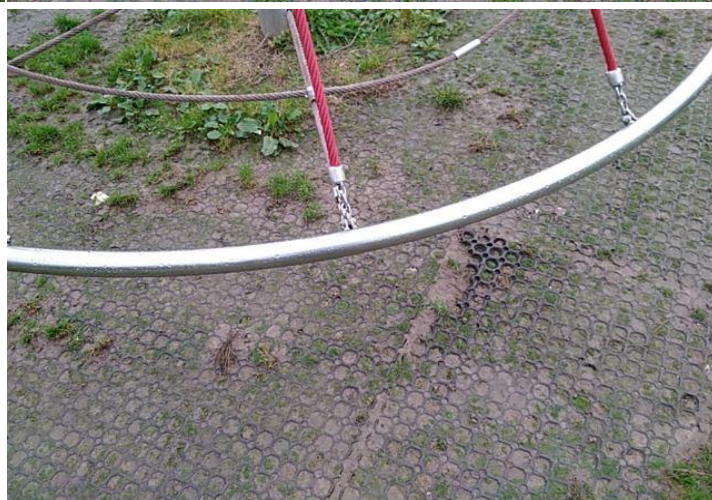
**Item:** Rotor Play - Rotating Net  
**Manufacturer:** Wicksteed Playgrounds

Two grass mats under this unit has been damaged -  
Replace the affected grass mats

**Finding:** Two grass mats under this unit has been damaged **Action:** Replace the affected grass mats

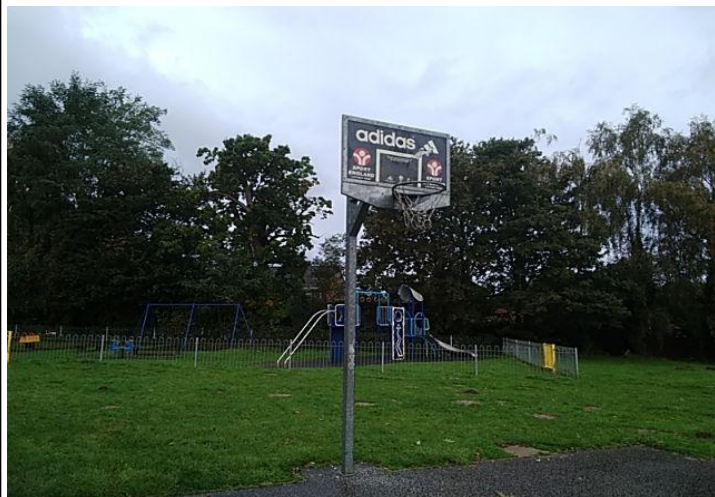
**Item:** Multi Use Games Area - Basketball Post  
**Manufacturer:** Adidas

The backboard is damaged - Consider replacing the damaged insert panel

**Finding:** The backboard is damaged

**Action:** Consider replacing the damaged insert panel

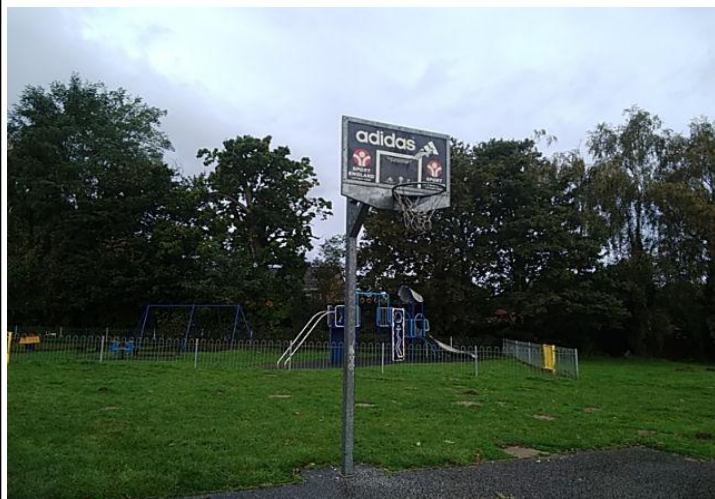
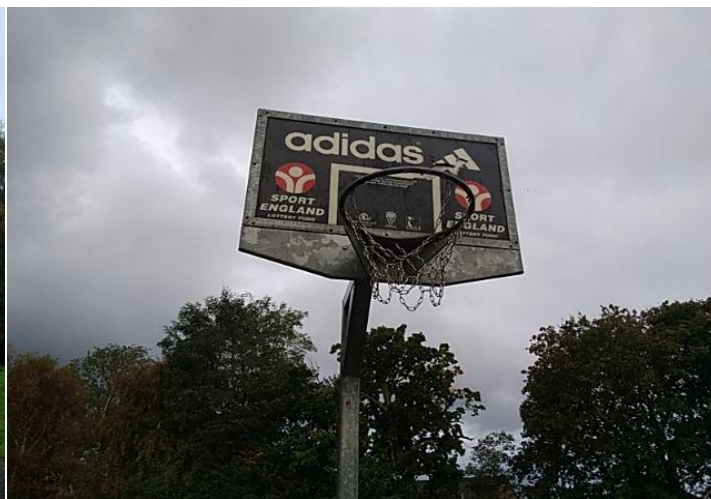
**Item:** Multi Use Games Area - Basketball Post  
**Manufacturer:** Adidas

Hoop net attachments damaged/missing, loose chain net could create snagging hazard - Secure or remove chain net

**Finding:** Hoop net attachments damaged/missing, loose chain net could create snagging hazard

**Action:** Secure or remove chain net

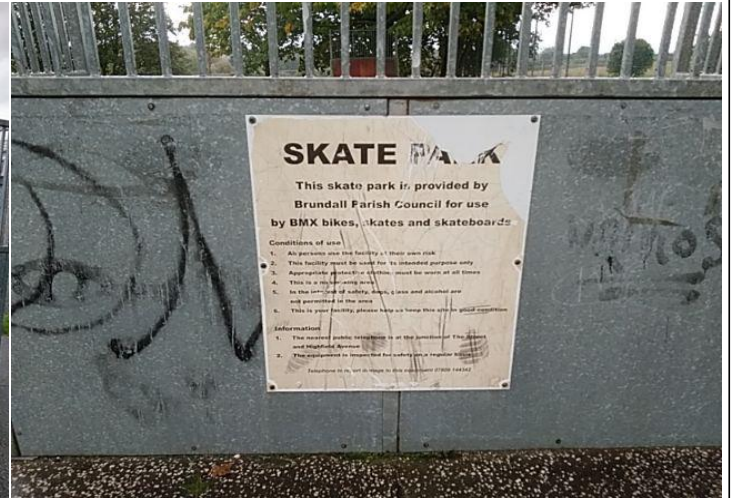
**Item:** Wheeled Sports - Wheeled Sports Area  
**Manufacturer:** Unknown

Signage of the wheeled sports area should be provided as recommended in BS EN 14974; this will include, a) facility for users of skateboards, inline-skates and BMX bikes (with site name or information); b) administrators identification with telephone number of the maintenance personnel and general emergency number; c) the facility is not a playground, its use is for adults, teenagers and children above the age of 8; d) the use of unsuitable equipment such as traditional road bikes, motorised sports equipment or toys is not permitted; e) use of appropriate protective equipment (e.g. helmet, knee pads, elbow pads, etc.) is recommended; f) pay attention to other users; g) the rolling surfaces and skate elements are not a waiting area and shall be kept clear of objects; h) the facility shall not be used when wet, icy or in snow conditions. - Provide signage as recommended by BS EN 14974 for wheeled sports areas

**Finding:** Signage of the wheeled sports area should be provided as recommended in BS EN 14974; this will include, a) facility for users of skateboards, inline-skates and BMX bikes (with site name or information); b) administrators identification with telephone number of the maintenance personnel and general emergency number; c) the facility is not a playground, its use is for adults, teenagers and children above the age of 8; d) the use of unsuitable equipment such as traditional road bikes, motorised sports equipment or toys is not permitted; e) use of appropriate protective equipment (e.g. helmet, knee pads, elbow pads, etc.) is recommended; f) pay attention to other users; g) the rolling surfaces and skate elements are not a waiting area and shall be kept clear of objects; h) the facility shall not be used when wet, icy or in snow conditions.

**Action:** Provide signage as recommended by BS EN 14974 for wheeled sports areas

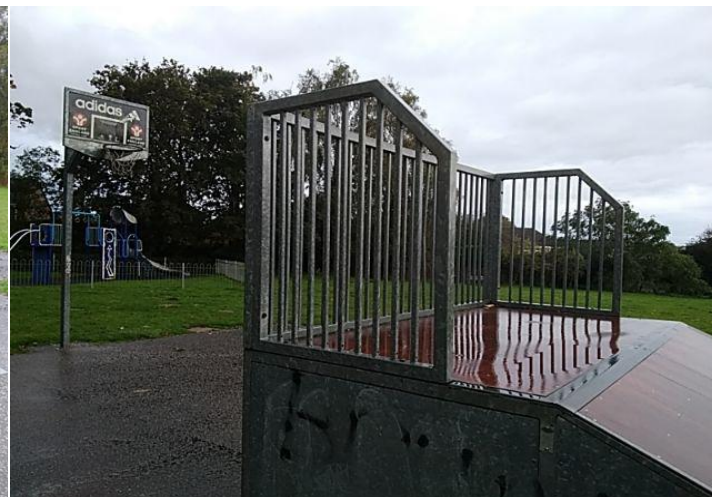
**Item:** Wheeled Sports - Flat Bank  
**Manufacturer:** Unknown

**Finding:** The height of the barrier is less than 1200mm and fails the requirements of BS EN 14974  
**Action:** Monitor - No remedial work recommended

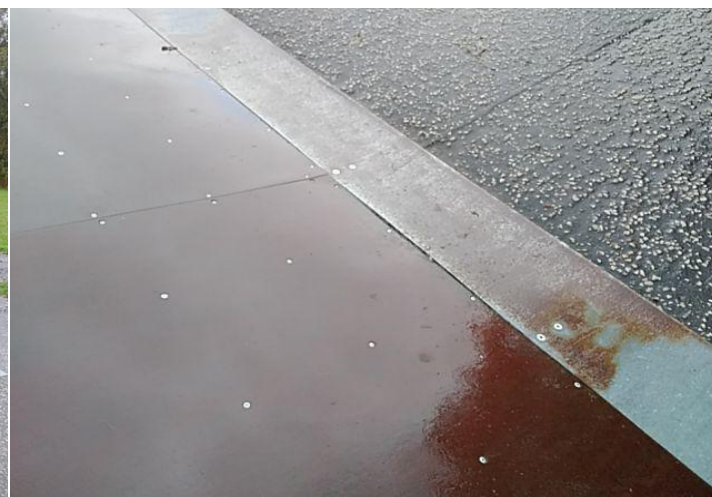
**Item:** Wheeled Sports - Flat Bank  
**Manufacturer:** Unknown

Riding surface / footplate transition deformation - Monitor for deterioration (variation of 3mm or over could create trip hazard)

**Finding:** Riding surface / footplate transition deformation  
**Action:** Monitor for deterioration (variation of 3mm or over could create trip hazard)

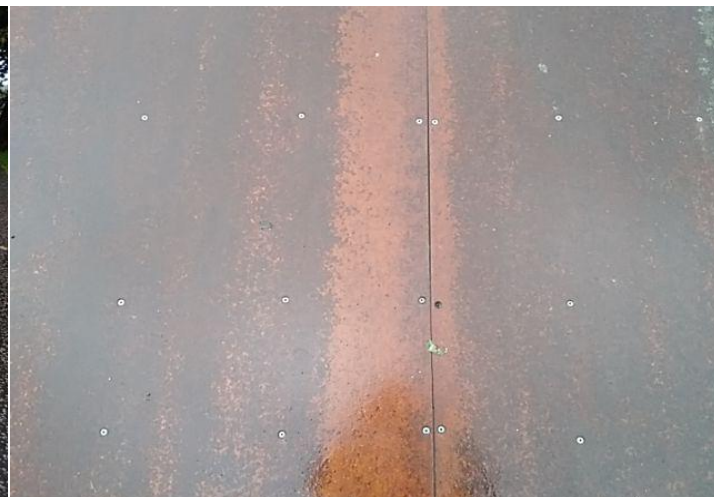
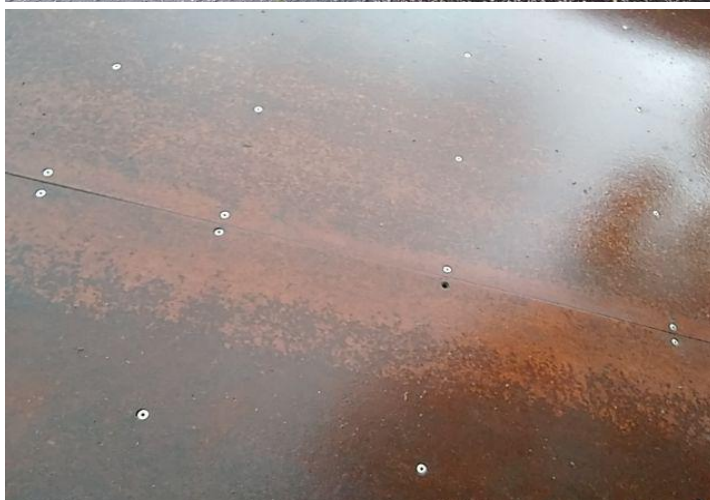
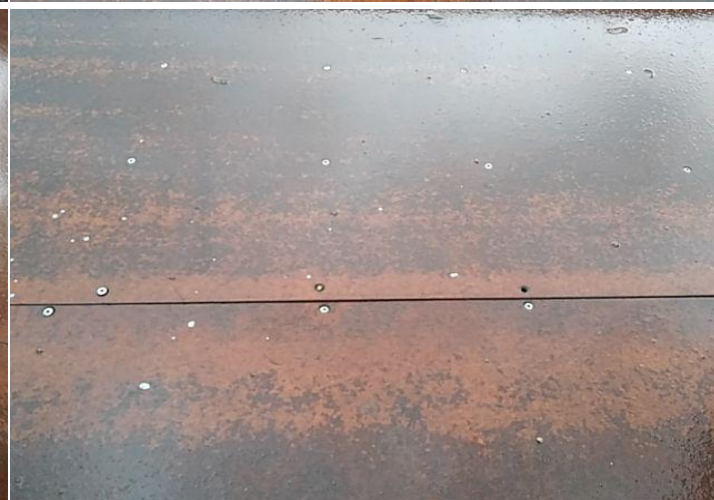
**Item:** Wheeled Sports - Driveway  
**Manufacturer:** Unknown

Several driveway panel fixings are missing - Replace missing pop-rivet fixings

**Finding:** Several driveway panel fixing are missing

**Action:** Replace missing pop-rivet fixings

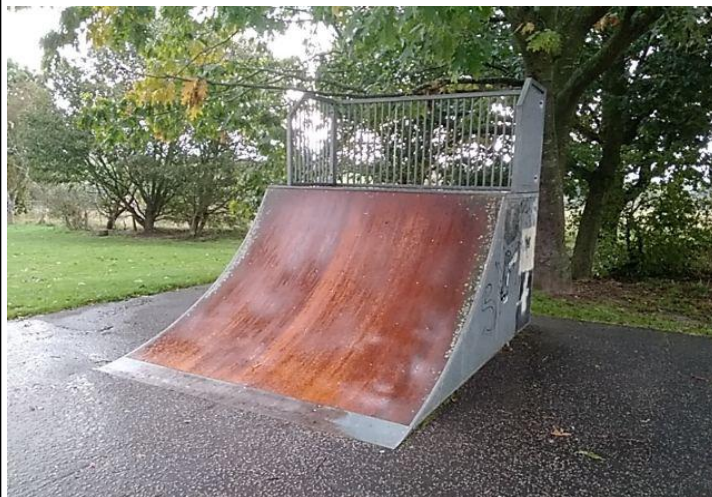
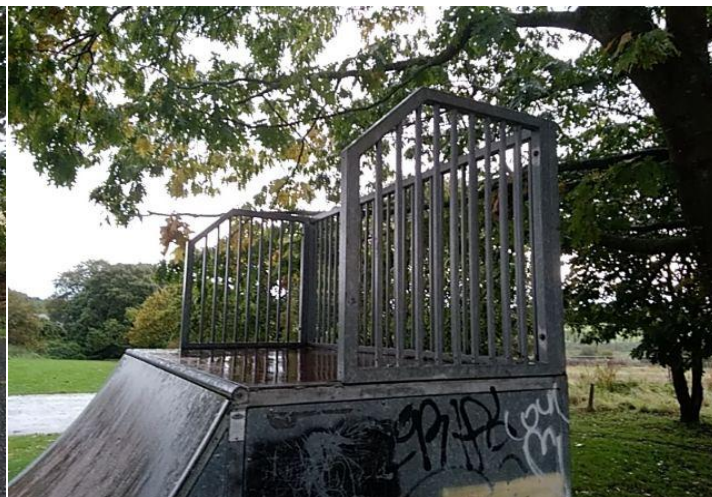
**Item:** Wheeled Sports - Quarter Pipe  
**Manufacturer:** Unknown

**Finding:** The height of the barrier is less than 1200mm and fails the requirements of BS EN 14974  
**Action:** Monitor - No remedial work recommended

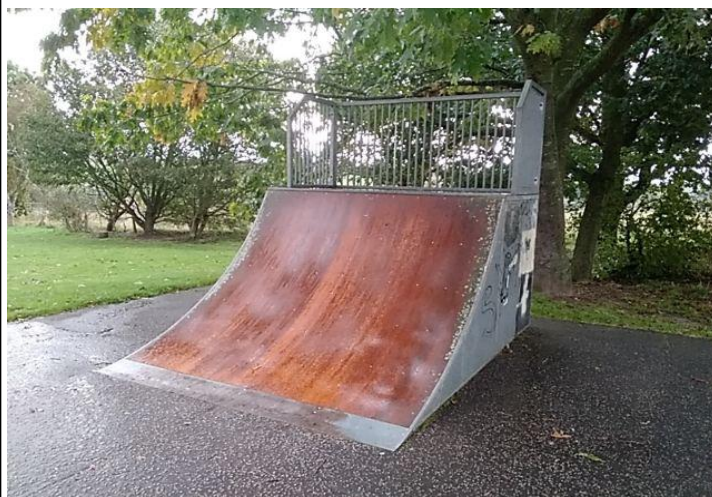
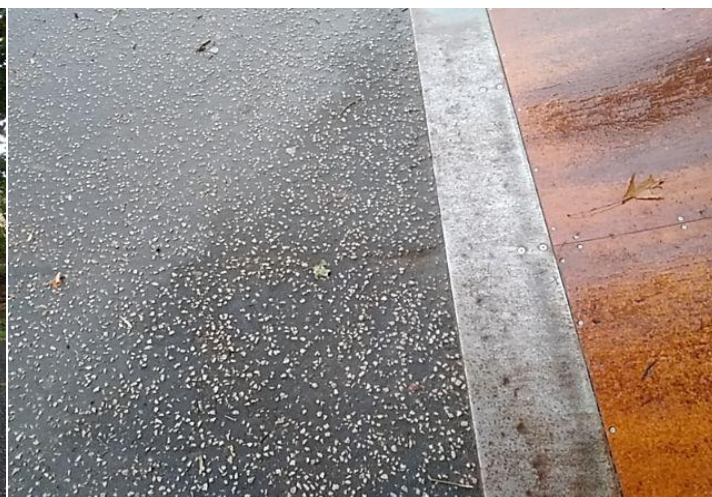
**Item:** Wheeled Sports - Quarter Pipe  
**Manufacturer:** Unknown

Minor tarmac surface damage at footplate transition - Monitor for deterioration, repair when required

**Finding:** Minor tarmac surface damage at footplate transition

**Action:** Monitor for deterioration, repair when required

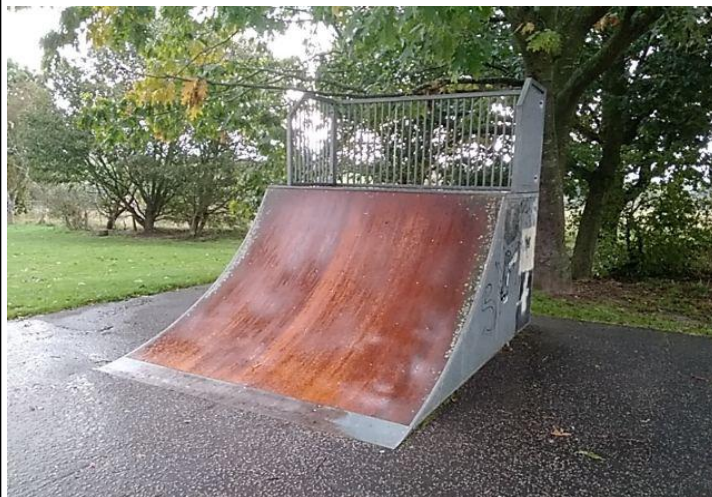
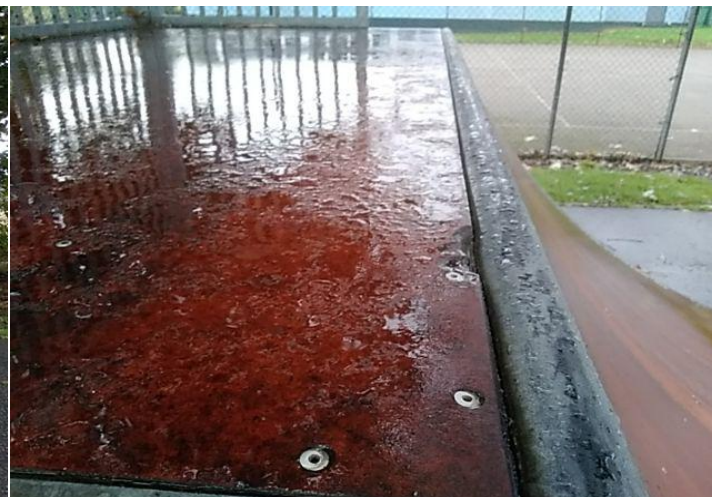
**Item:** Wheeled Sports - Quarter Pipe  
**Manufacturer:** Unknown

The platform edge has been damaged - Monitor for any further deterioration and replace as required

**Finding:** The platform edge has been damaged

**Action:** Monitor for any further deterioration and replace as required

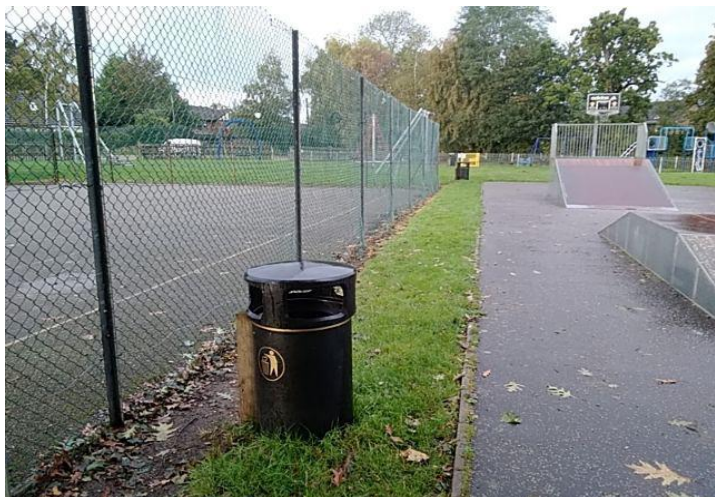
**Item:** Ancillary Items - Litter Bin  
**Manufacturer:** Unknown

**Finding:** There are trip hazards at the edges of the surface

**Action:** Reinststate surrounding surface levels to remove the trip points

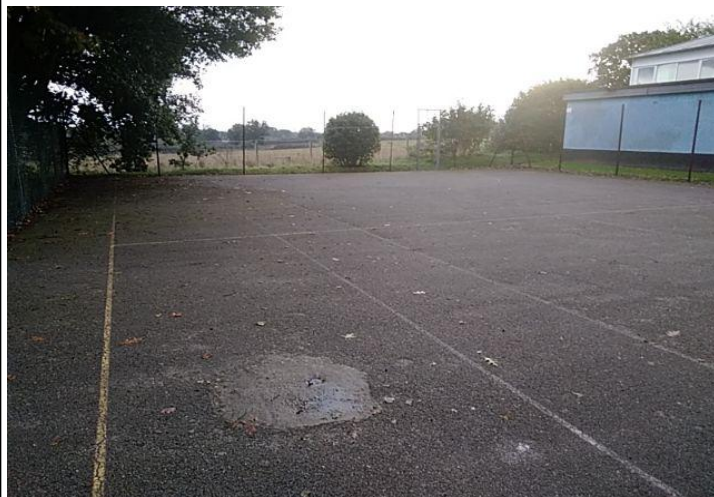
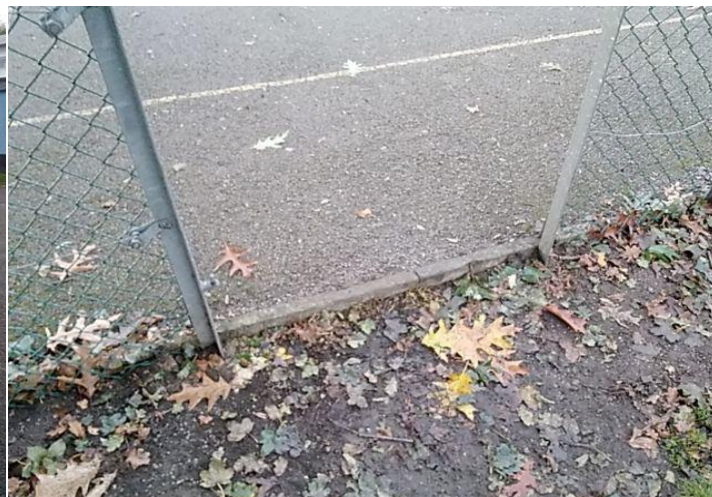
**Item:** Multi Use Games Area - Ball Games Area  
**Manufacturer:** Unknown

There are trip hazards at the entrance points - Reinstate surrounding surface levels to remove the trip points

**Finding:** There are trip hazards at the entrance points

**Action:** Reinstate surrounding surface levels to remove the trip points

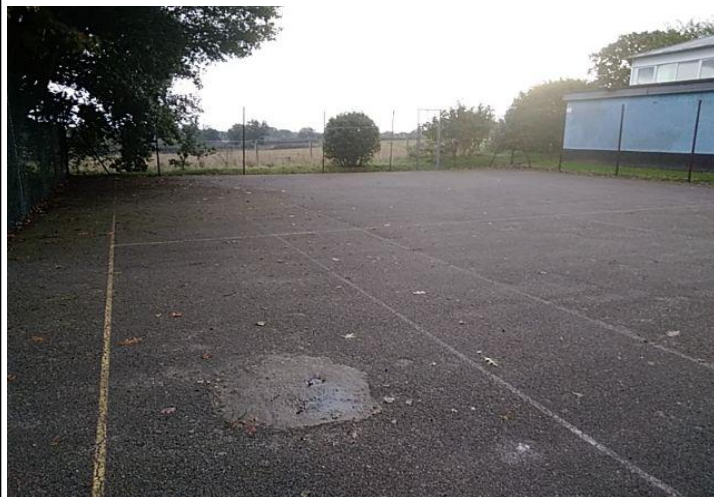
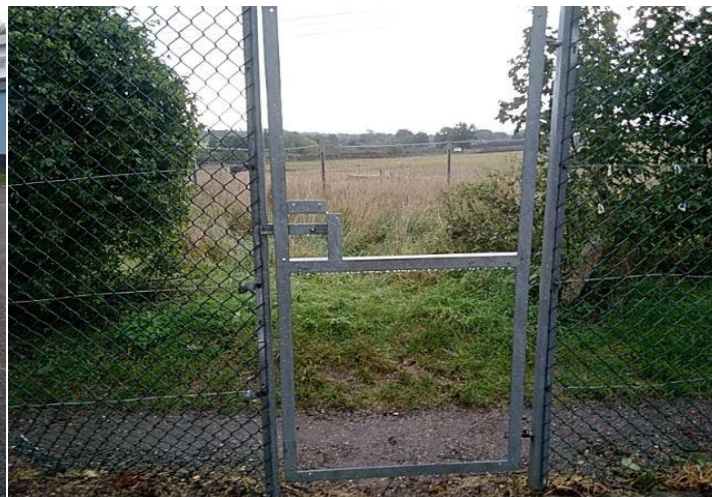
**Item:** Multi Use Games Area - Ball Games Area  
**Manufacturer:** Unknown

There are chainlink sections missing at the single gate - Monitor for any further deterioration and repair as required

**Finding:** There are chainlink sections missing at the single gate

**Action:** Monitor for any further deterioration and repair as required

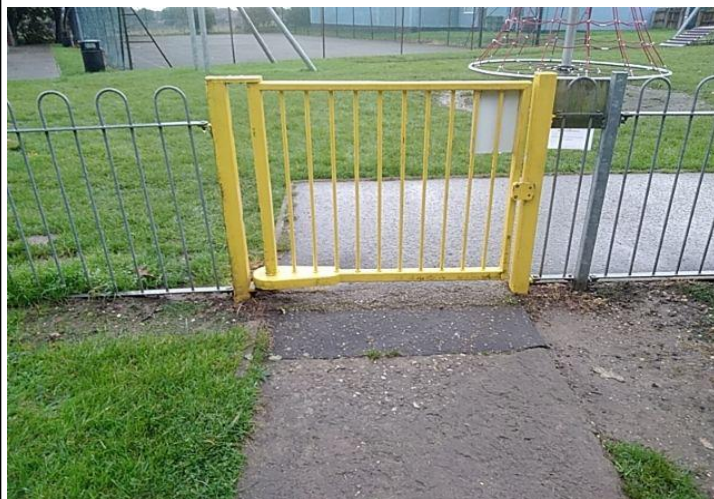
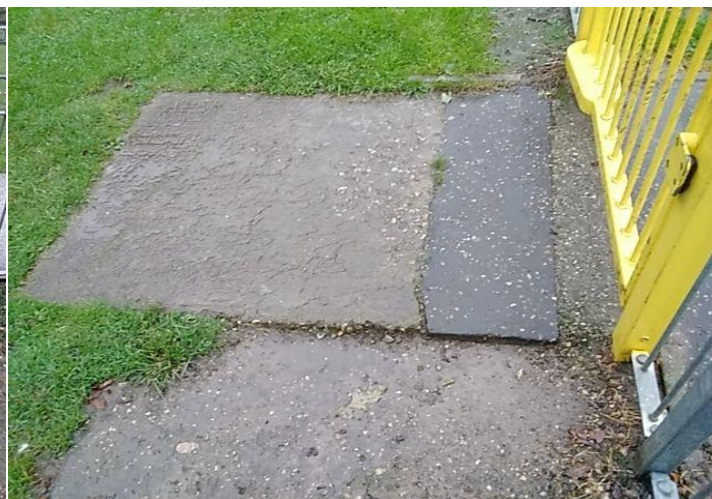
**Item:** Gates - Gate - Self Closing  
**Manufacturer:** I.A.E. Fencing

There are trip hazards at the path edge - Reinstate surrounding surface levels to remove the trip points

**Finding:** There are trip hazards at the path edge

**Action:** Reinstate surrounding surface levels to remove the trip points

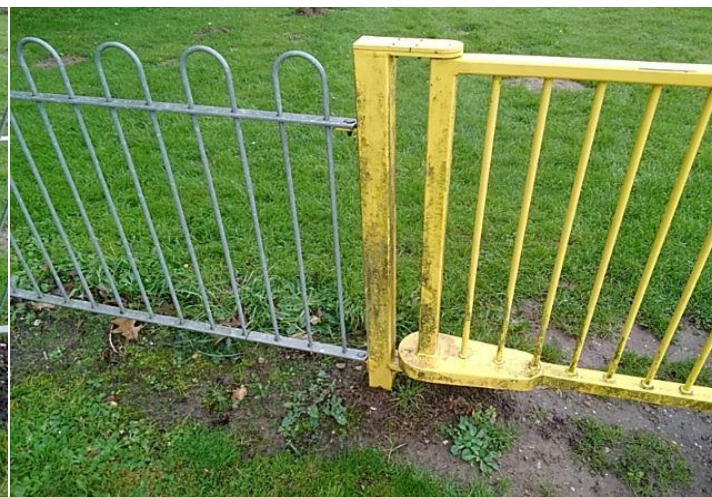
**Item:** Gates - Gate - Self Closing  
**Manufacturer:** I.A.E. Fencing

The gate is slightly loose in its foundations - Monitor for any further deterioration and repair as required

**Finding:** The gate is slightly loose in its foundations

**Action:** Monitor for any further deterioration and repair as required

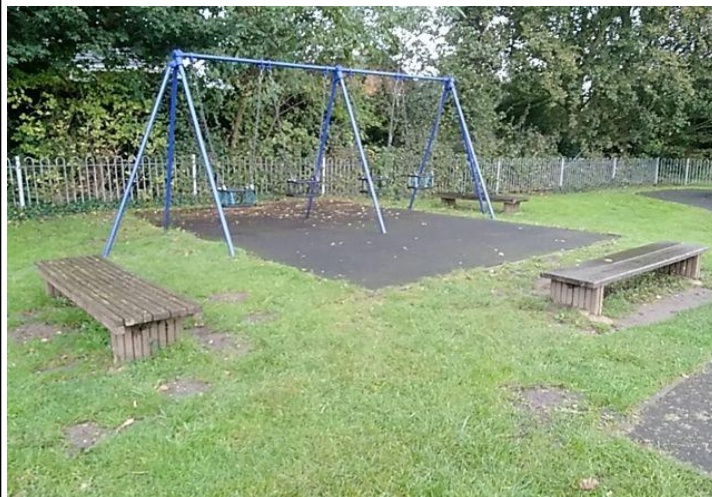
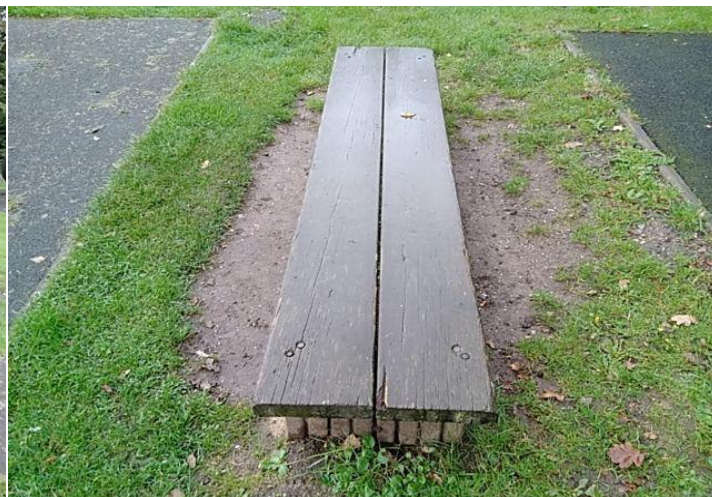
**Item:** Ancillary Items - Bench  
**Manufacturer:** Unknown

**Finding:** Timber condition

**Action:** Monitor for deterioration

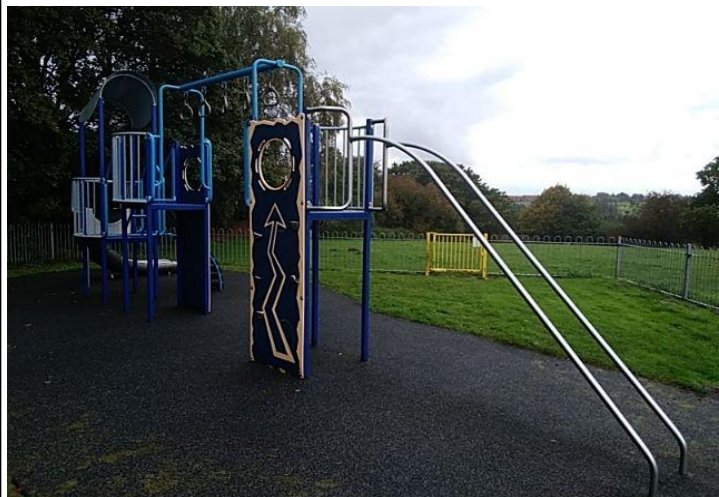
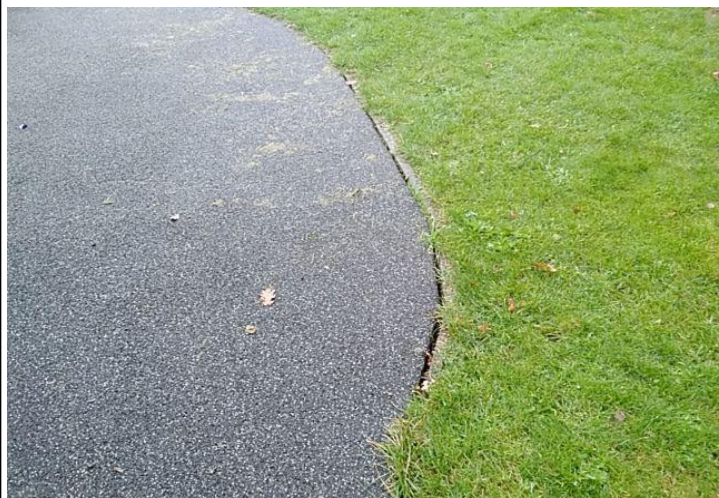
**Item:** Activity Equipment - Multi Play (Junior)  
**Manufacturer:** Wicksteed Playgrounds

**Finding:** There are gaps opening between the surfacing and the edging surround or between the joints in the surfacing  
**Action:** Monitor for any further deterioration and repair as required

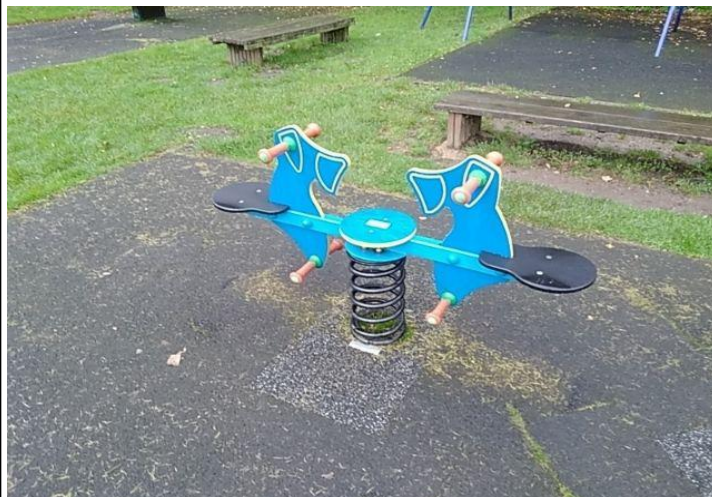
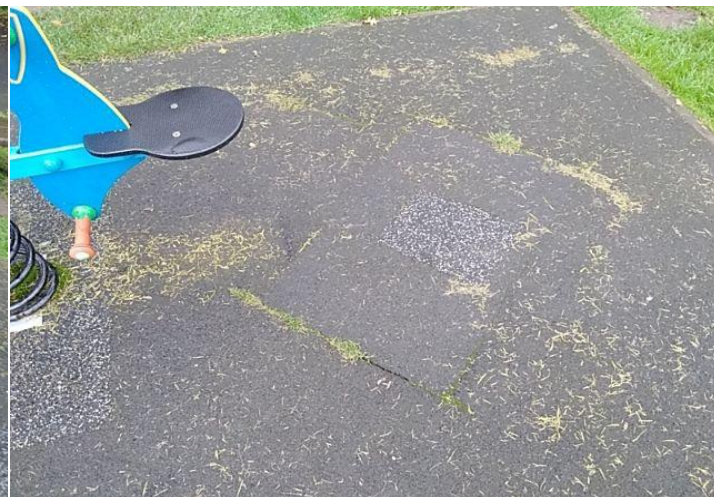
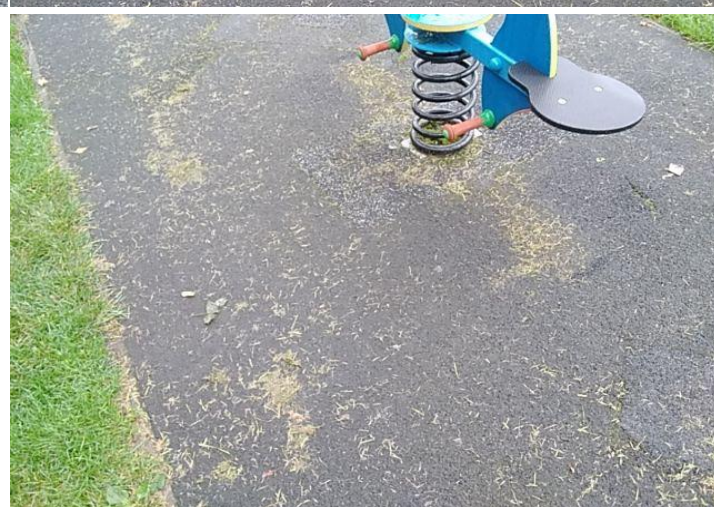
**Item:** Rocking Equipment - Spring See-Saw  
**Manufacturer:** Wicksteed Playgrounds

**Finding:** The safety surface around the area is beginning to wear

**Action:** Monitor for any further deterioration and repair as required

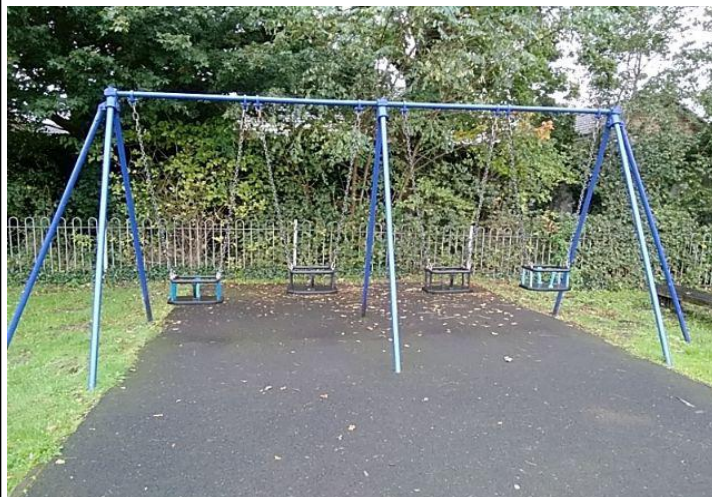
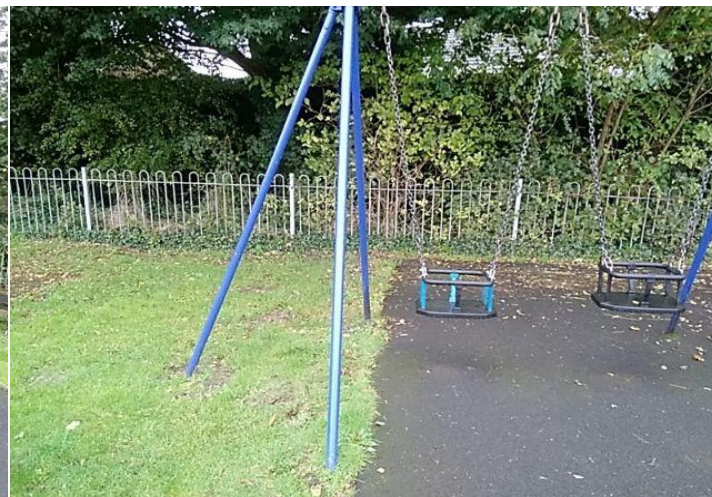
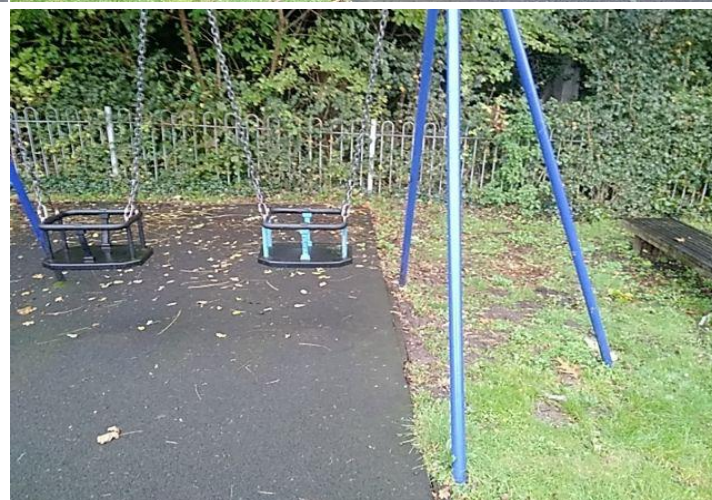
**Item:** Swings - 2 Bay 4 Seat (Cradle)  
**Manufacturer:** Wicksteed Playgrounds

The seats are too close to the frame as defined in BS EN 1176 Part 2; this is a low risk failure and no remedial action is required - Monitor - No remedial work recommended

**Finding:** The seats are too close to the frame as defined in BS EN 1176 Part 2; this is a low risk failure and no remedial action is required

**Action:** Monitor - No remedial work recommended

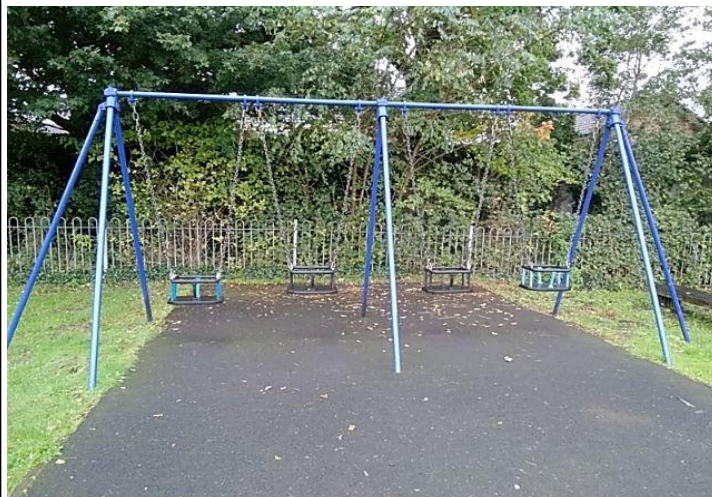
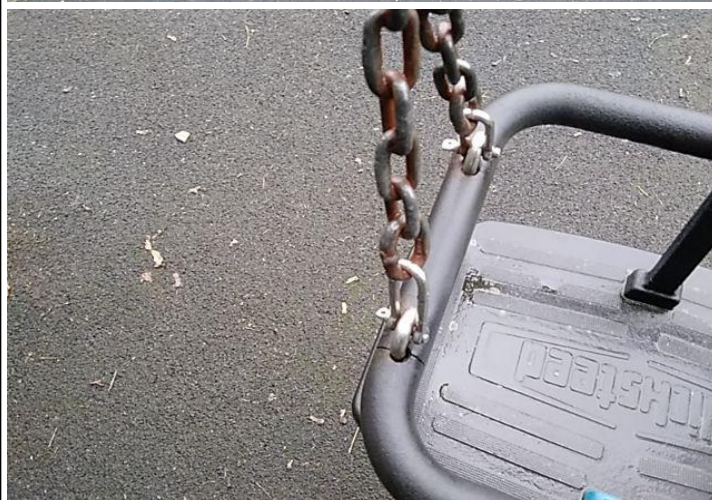
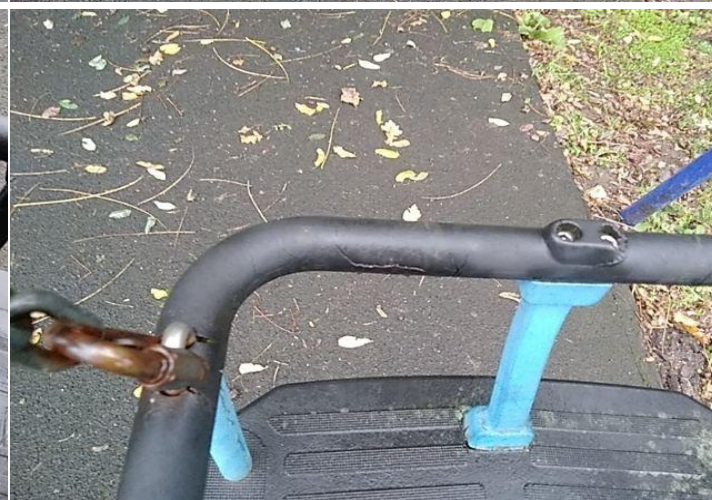
**Item:** Swings - 2 Bay 4 Seat (Cradle)  
**Manufacturer:** Wicksteed Playgrounds

Two seats have minor damage or wear - Monitor for any further deterioration and replace as required

**Finding:** Two seats have minor damage or wear

**Action:** Monitor for any further deterioration and replace as required

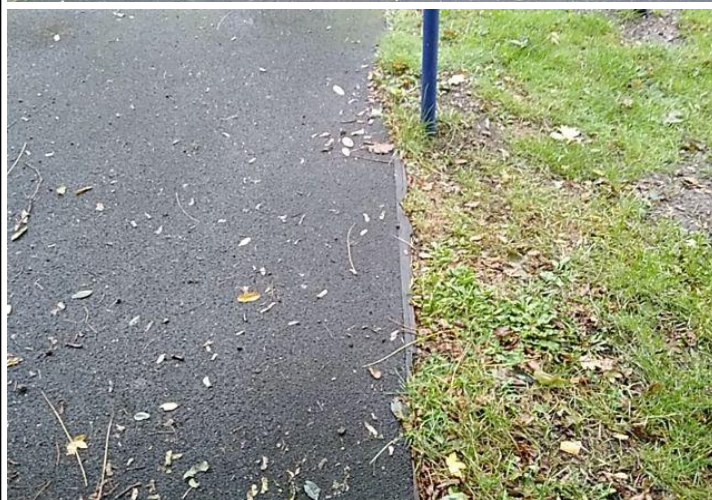
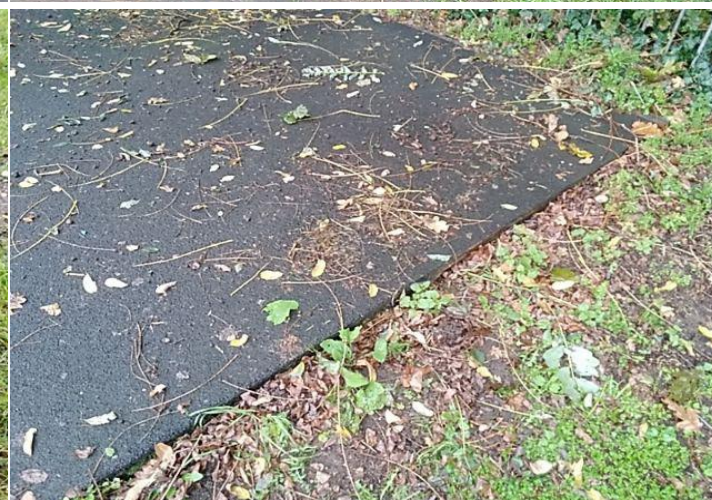
**Item:** Swings - 2 Bay 4 Seat (Cradle)  
**Manufacturer:** Wicksteed Playgrounds

Timber edging rotten or missing - Replace the affected edging (Wicksteed recommend concrete pin kerb edging)

**Finding:** Timber edging rotten or missing

**Action:** Replace the affected edging (Wicksteed recommend concrete pin kerb edging)

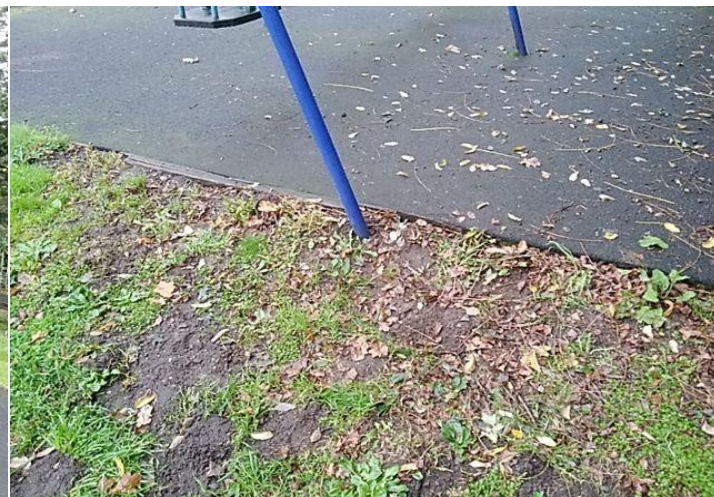
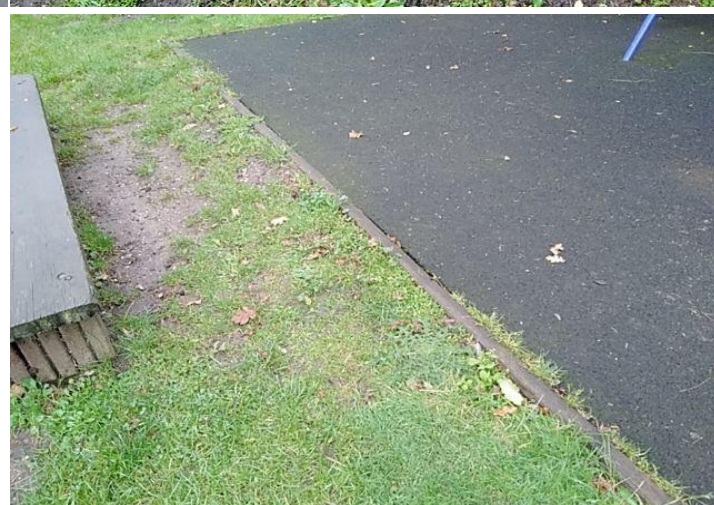
**Item:** Swings - 2 Bay 4 Seat (Cradle)  
**Manufacturer:** Wicksteed Playgrounds

**Finding:** There are trip hazards at the edges of the surface

**Action:** Reinstate surrounding surface levels to remove the trip points
