## Annual Inspection

Brundall Parish Council

Memorial Hall Play Area

Links Avenue, Brundall, Norfolk, NR13 5LL

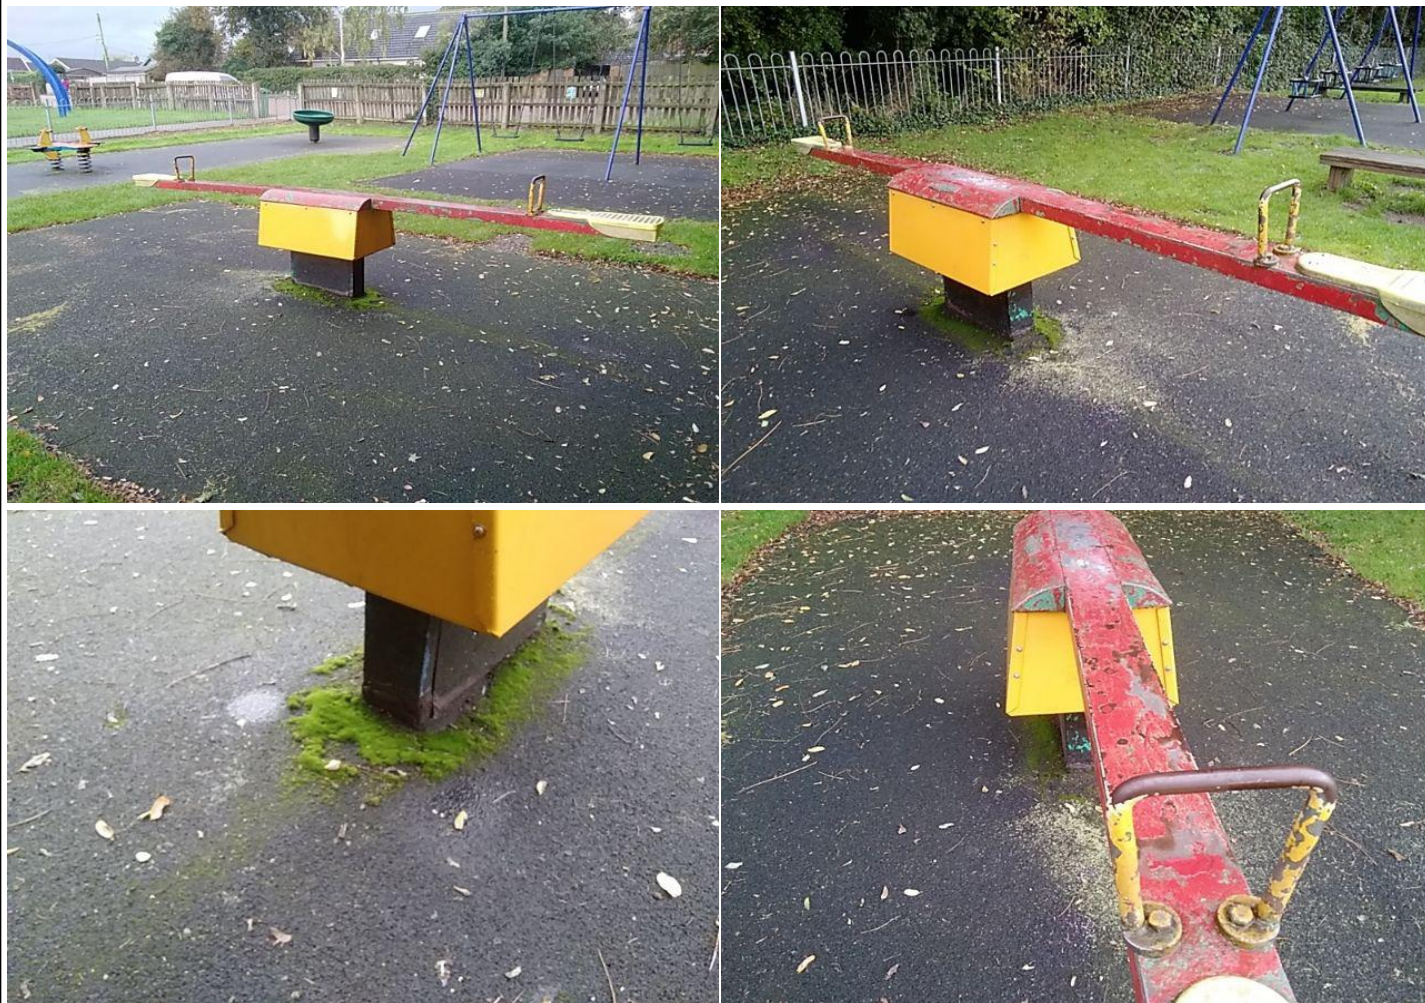
**Item:** Rocking Equipment - See Saw  
**Manufacturer:** Wicksteed Playgrounds

Paint condition - Consider treating the item

**Finding:** Paint condition

**Action:** Consider treating the item

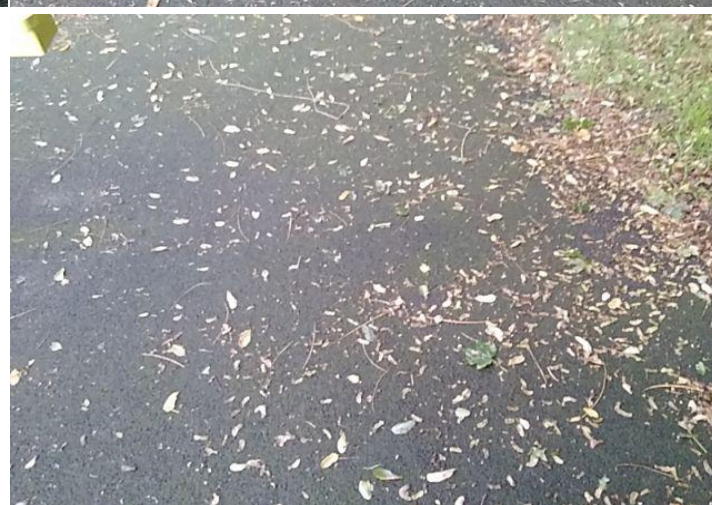
Uneven surface - Cause cannot be determined without disturbing the wetpour, monitor for deterioration

**Finding:** Uneven surface

**Action:** Cause cannot be determined without disturbing the wetpour, monitor for deterioration

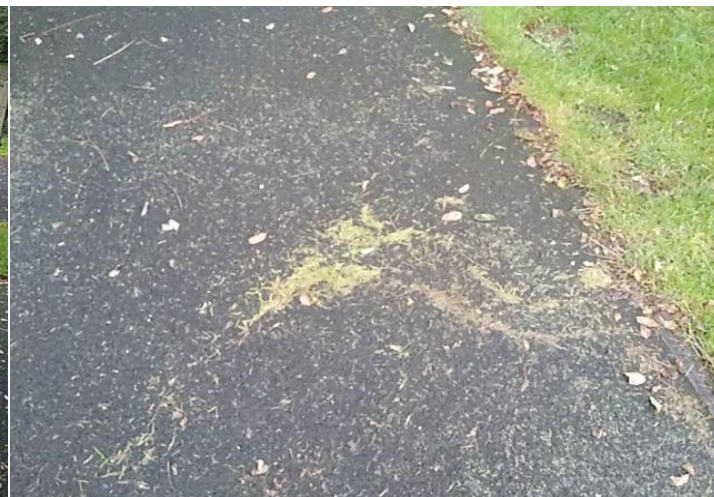
**Item:** Rocking Equipment - See Saw  
**Manufacturer:** Wicksteed Playgrounds

**Finding:** The safety surface around this unit has been damaged

**Action:** Monitor for any further deterioration and repair as required

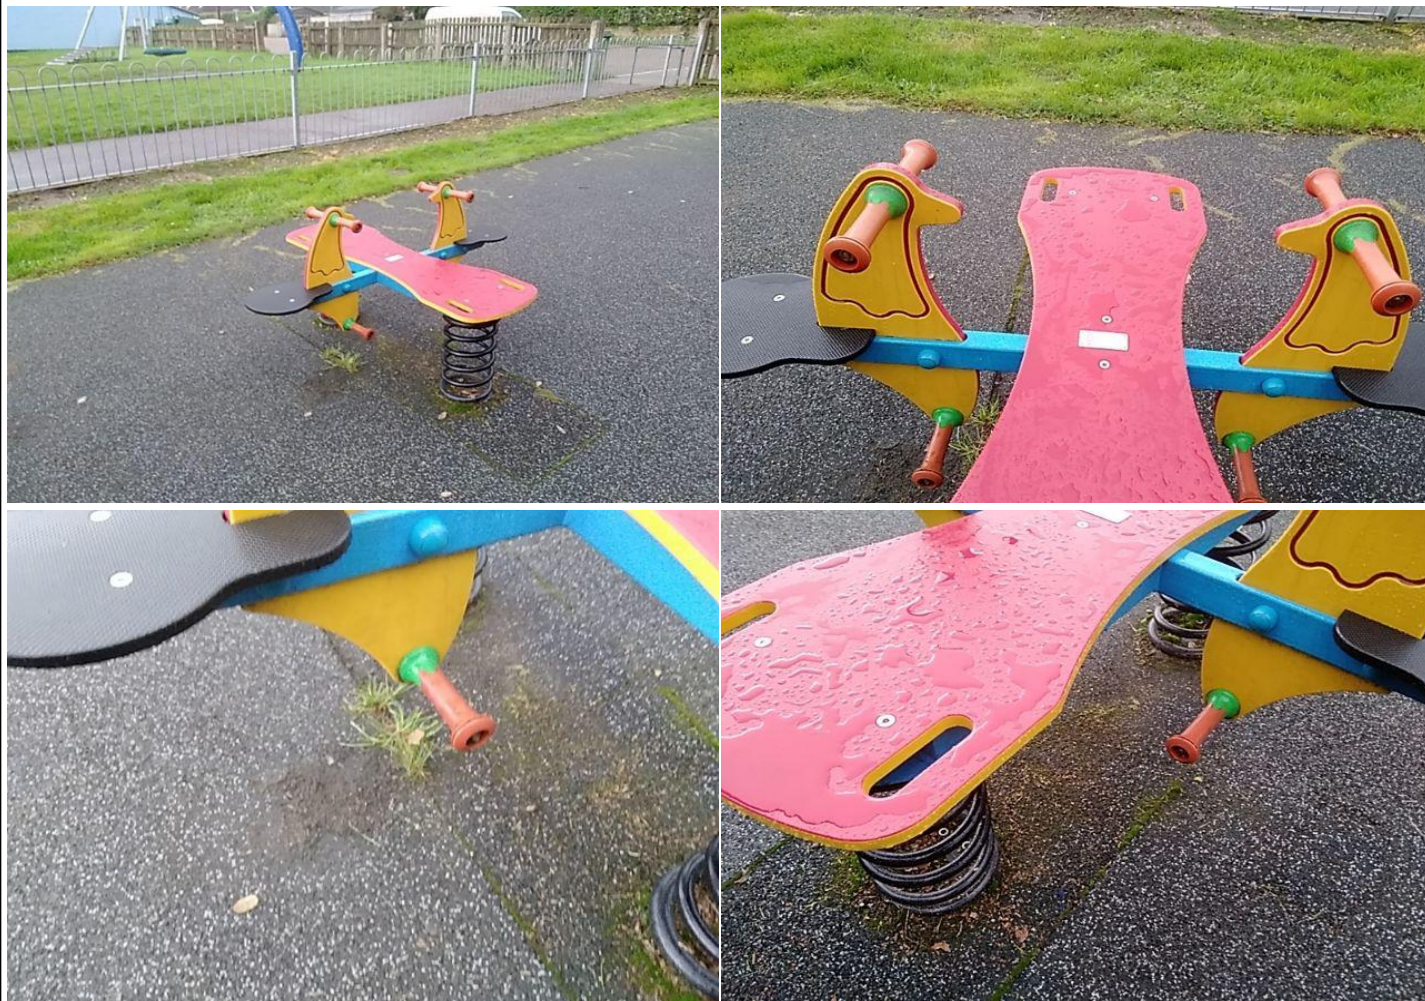
**Item:** Rocking Equipment - Four Way Springer  
**Manufacturer:** Wicksteed Playgrounds

There are four bolt cap covers missing on the item - Replace missing bolt cap covers

**Finding:** There are four bolt cap covers missing on the item **Action:** Replace missing bolt cap covers

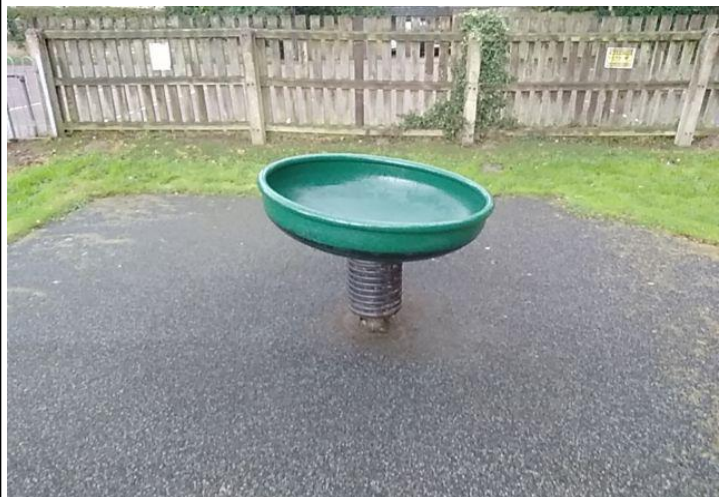
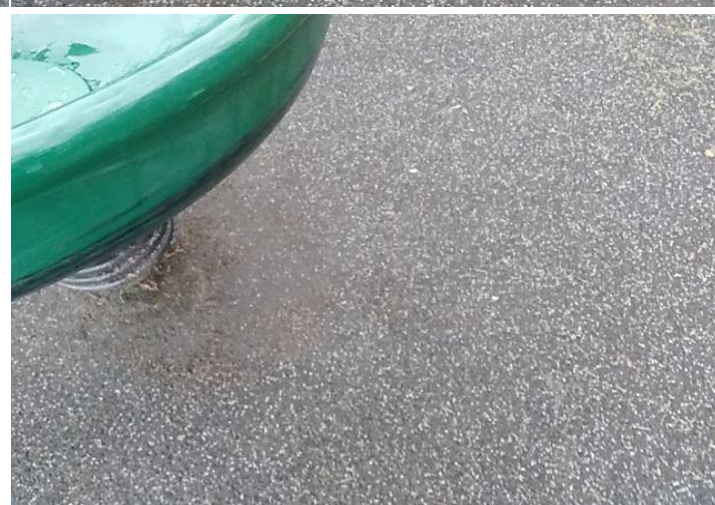
**Item:** Rotor Play - Dish Roundabout  
**Manufacturer:** Wicksteed Playgrounds

**Finding:** The safety surface around this unit has been damaged

**Action:** Monitor for any further deterioration and repair as required

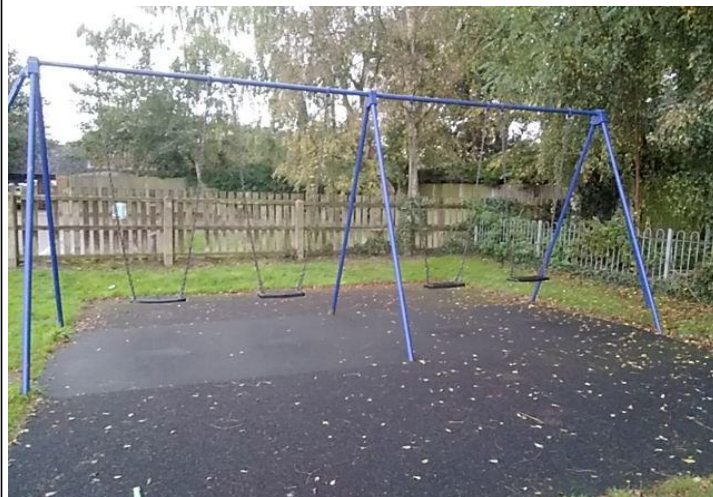
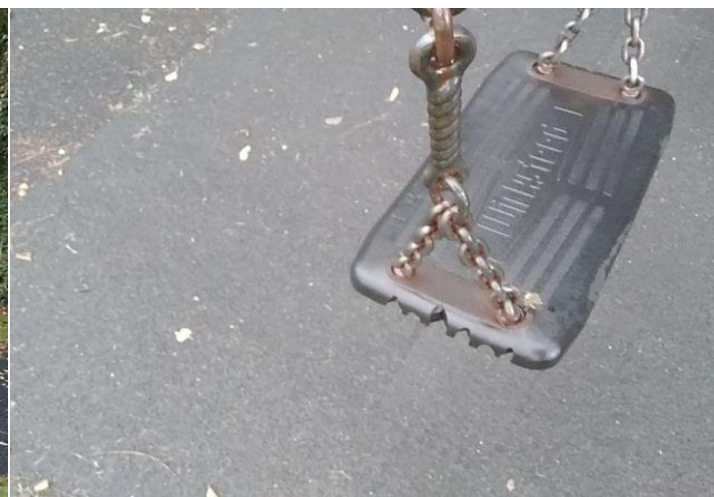
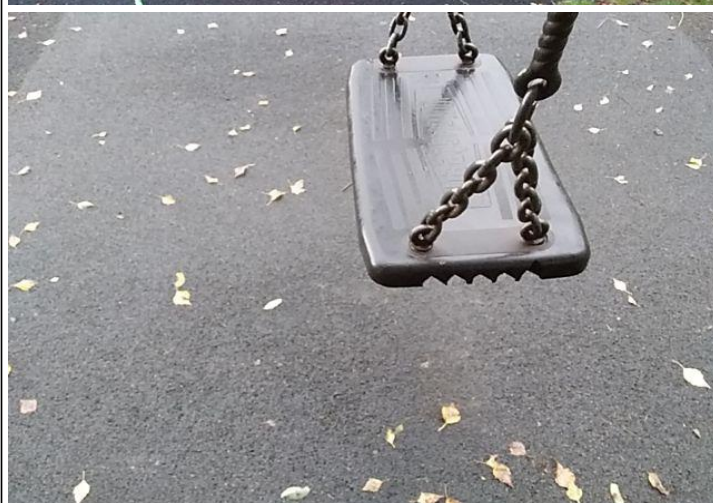
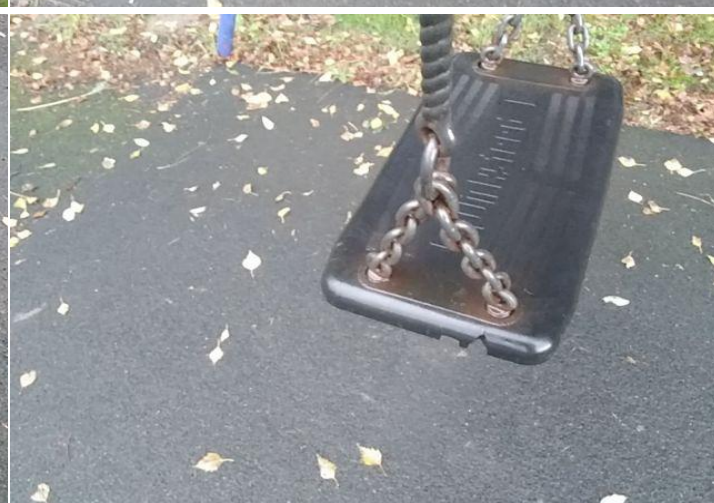
**Item:** Swings - 2 Bay 4 Seat (Flat)  
**Manufacturer:** Wicksteed Playgrounds

Two seats have minor vandalism damage - Monitor for any further deterioration and replace as required

**Finding:** Two seats have minor vandalism damage

**Action:** Monitor for any further deterioration and replace as required

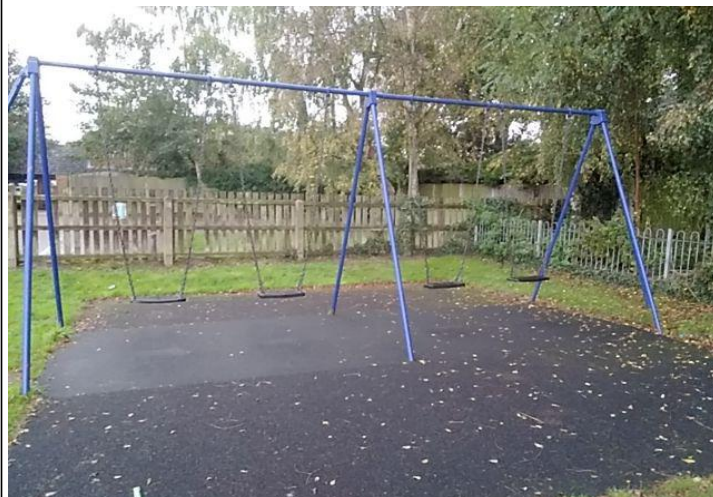
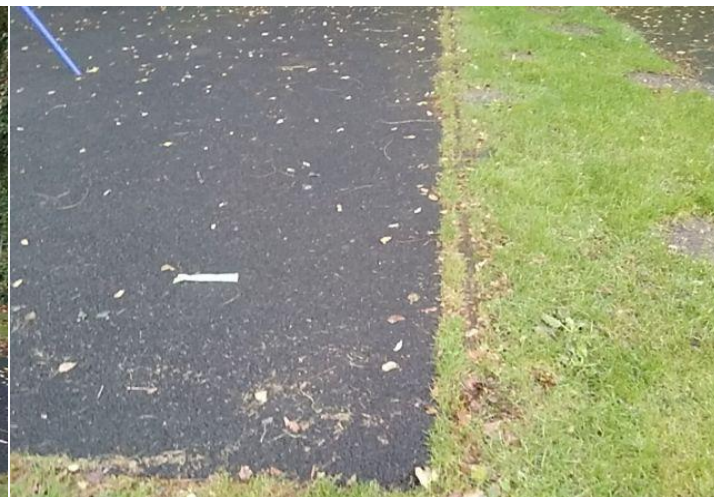
**Item:** Swings - 2 Bay 4 Seat (Flat)  
**Manufacturer:** Wicksteed Playgrounds

**Finding:** There are gaps opening between the surfacing and the edging surround or between the joints in the surfacing  
**Action:** Monitor for any further deterioration (see timber edging note)

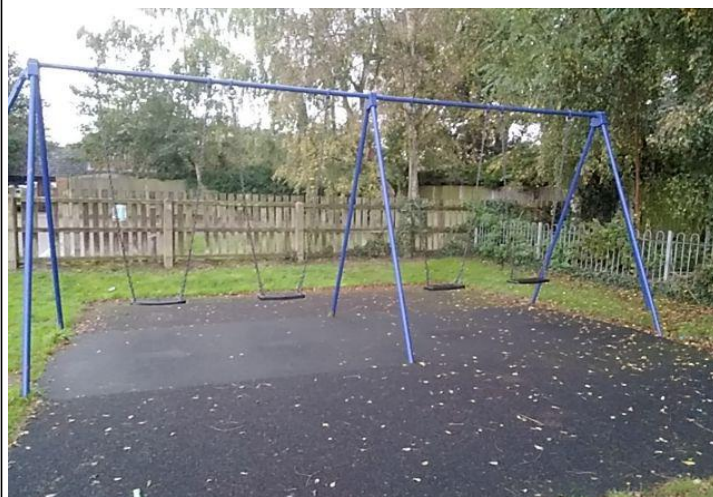
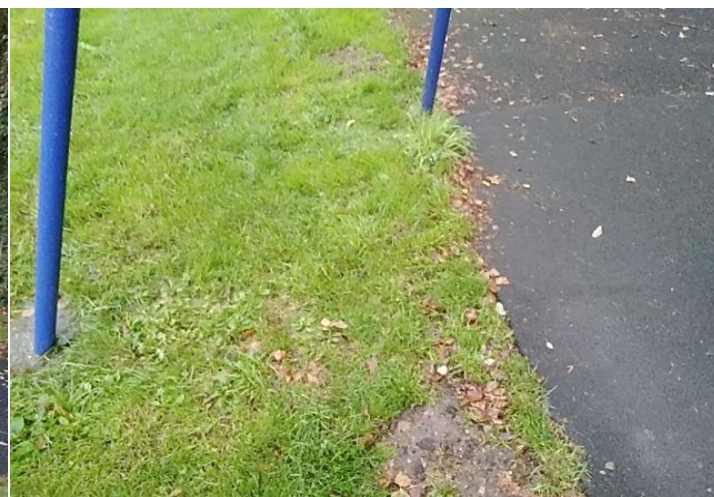
**Item:** Swings - 2 Bay 4 Seat (Flat)  
**Manufacturer:** Wicksteed Playgrounds

Timber edging rotten or missing - Replace the affected timber edging (Wicksteed recommend concrete pin kerb edging)

**Finding:** Timber edging rotten or missing  
**Action:** Replace the affected timber edging (Wicksteed recommend concrete pin kerb edging)

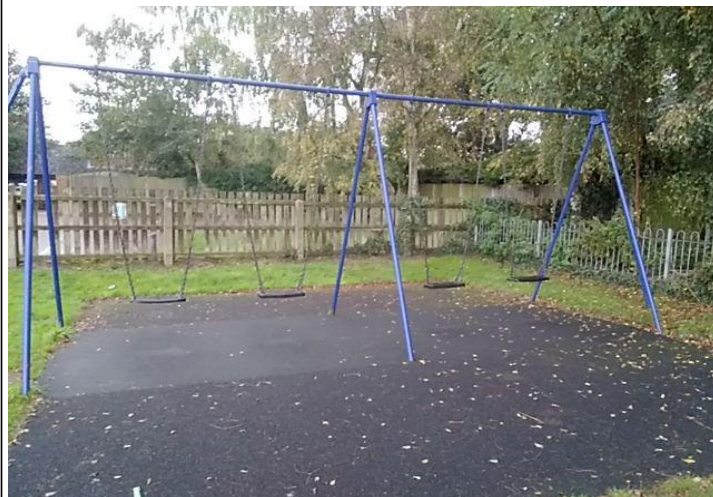
**Item:** Swings - 2 Bay 4 Seat (Flat)  
**Manufacturer:** Wicksteed Playgrounds

**Finding:** The safety surface around the area is beginning to wear  
**Action:** Monitor for any further deterioration and repair as required
