## Tree Hazard Assessment & Tree Work Recommendation Report

Brundall Cemetery  
Allotments  
and  
Church Fen  
Brundall  
Norfolk

December 2024  
Report number: CA/BPC.12.24.1

Report prepared by Conservation Arboriculture  
for Brundall Parish Council

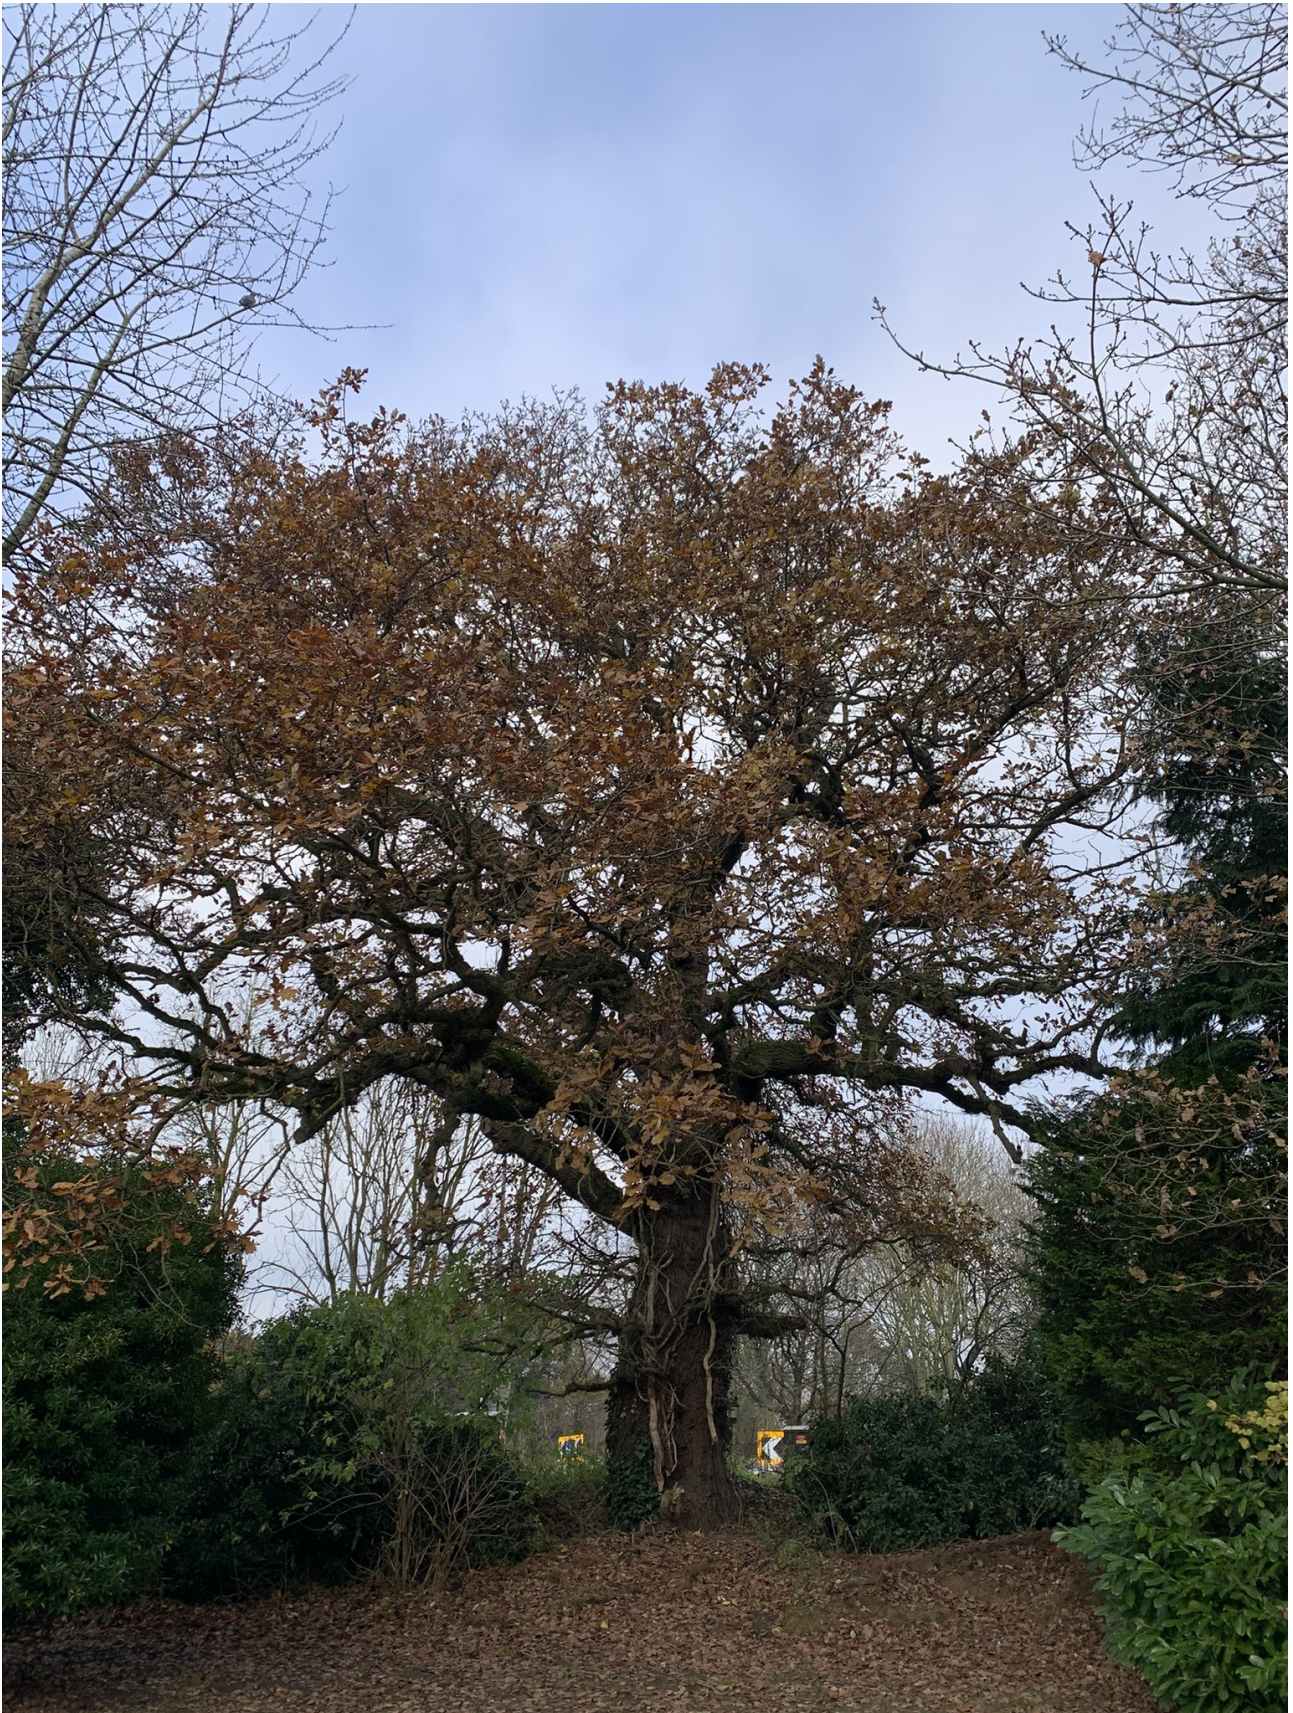
| Tree No. | Species | Ht (m) | SD (mm) | Age | Condition -Survey findings - Comments. | Identified hazards | Size of hazard | Risk Factor | Target zone | Recommended Works | Priority | ERC | PRF Y/N |
|---|---|---|---|---|---|---|---|---|---|---|---|---|---|
| 430 | Oak | 18 | 1600 | V | Veteran oak, Laetiporus / Chicken of the woods at base to south | Branches | H | L | MU 2 | Add to Ancient tre inventory (done) ATI number 269448. Within the next 5 years some 'halo' removal of conifers and cherry to allow space and light for the veteran. | P2 | >40 | Y |

**T1430 – Veteran Oak – No works but some ‘halo’ removal of cherry and lawsons cypress would be prudent within the next few years**

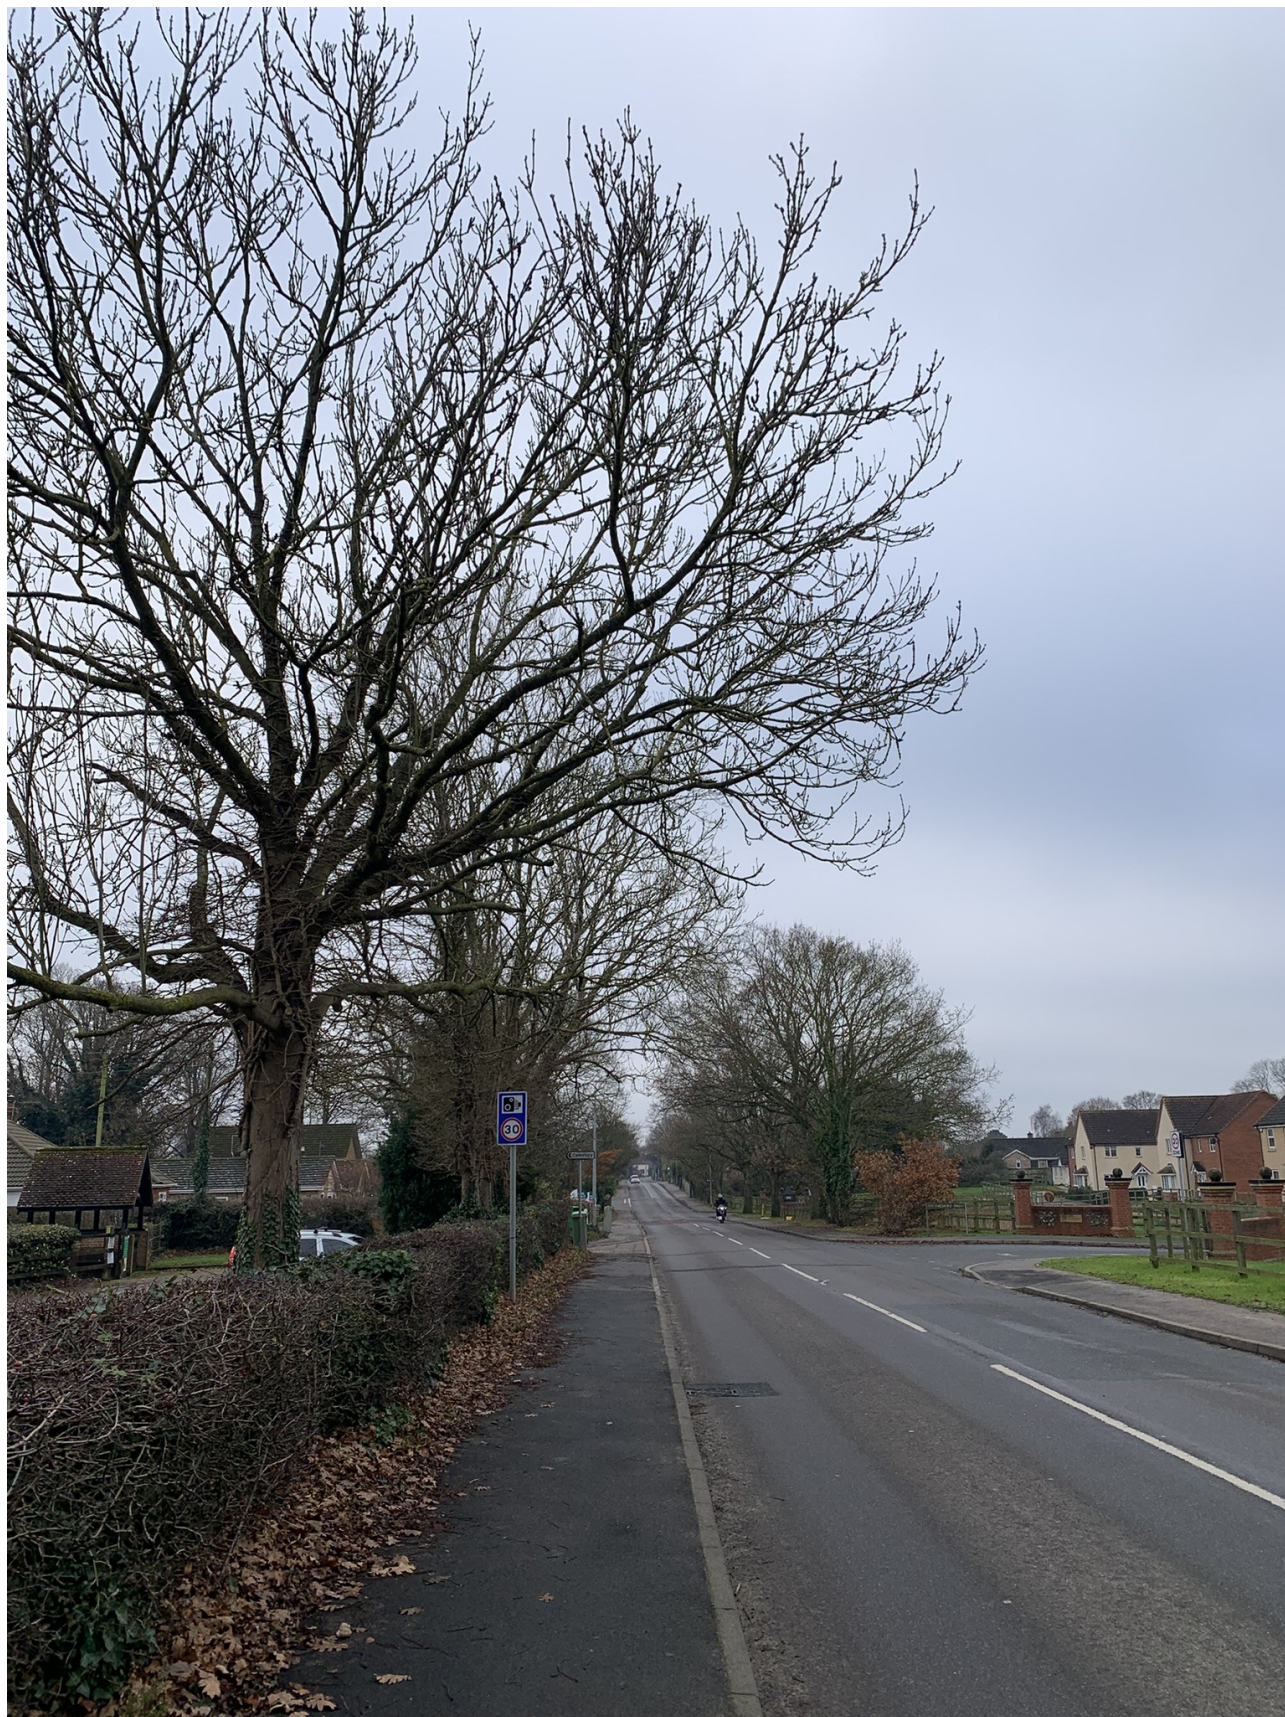
| Tree No. | Species | Ht (m) | SD (mm) | Age | Condition -Survey findings - Comments. | Identified hazards | Size of hazard | Risk Factor | Target zone | Recommended Works | Priority | ERC | PRF Y/N |
|---|---|---|---|---|---|---|---|---|---|---|---|---|---|
| 134 | Ash | 12 | 400 | M | Roadside ash, small diameter low branches over main road | Branches | L | L | HU | Crown lift to highway specification shown in appendix 1 | P2<br>M1 | >40 | N |
| 135 | Ash | 12 | 400 | M | Roadside ash, small diameter low branches over main road | Branches | L | L | HU | Crown lift to highway specification shown in appendix 1 | P2<br>M1 | >40 | N |
| 137 | Ash | 12 | 400 | M | Roadside ash, small diameter low branches over main road | Branches | L | L | HU | Crown lift to highway specification shown in appendix 1 | P2<br>M1 | >40 | N |

**T 134,135 &137 – Ash – Crown lift to Highways specification - Appendix 1.**

**Required clearance dimensions:** The Highways Act 1980 specifies that the cause of the danger, obstruction or interference is removed. Although no dimensions are specified within the Act, we recommend the following:

**Footway clearance** - minimum headroom of 2.6m (8' 6") ideally back to the highway boundary or otherwise stated.

**Road clearance** - minimum headroom of 5.2m (17') and a minimum sideways clearance of 500mm (1' 8") In both cases, all vegetation should be cut back vertically. See the diagrams below for further clarification.

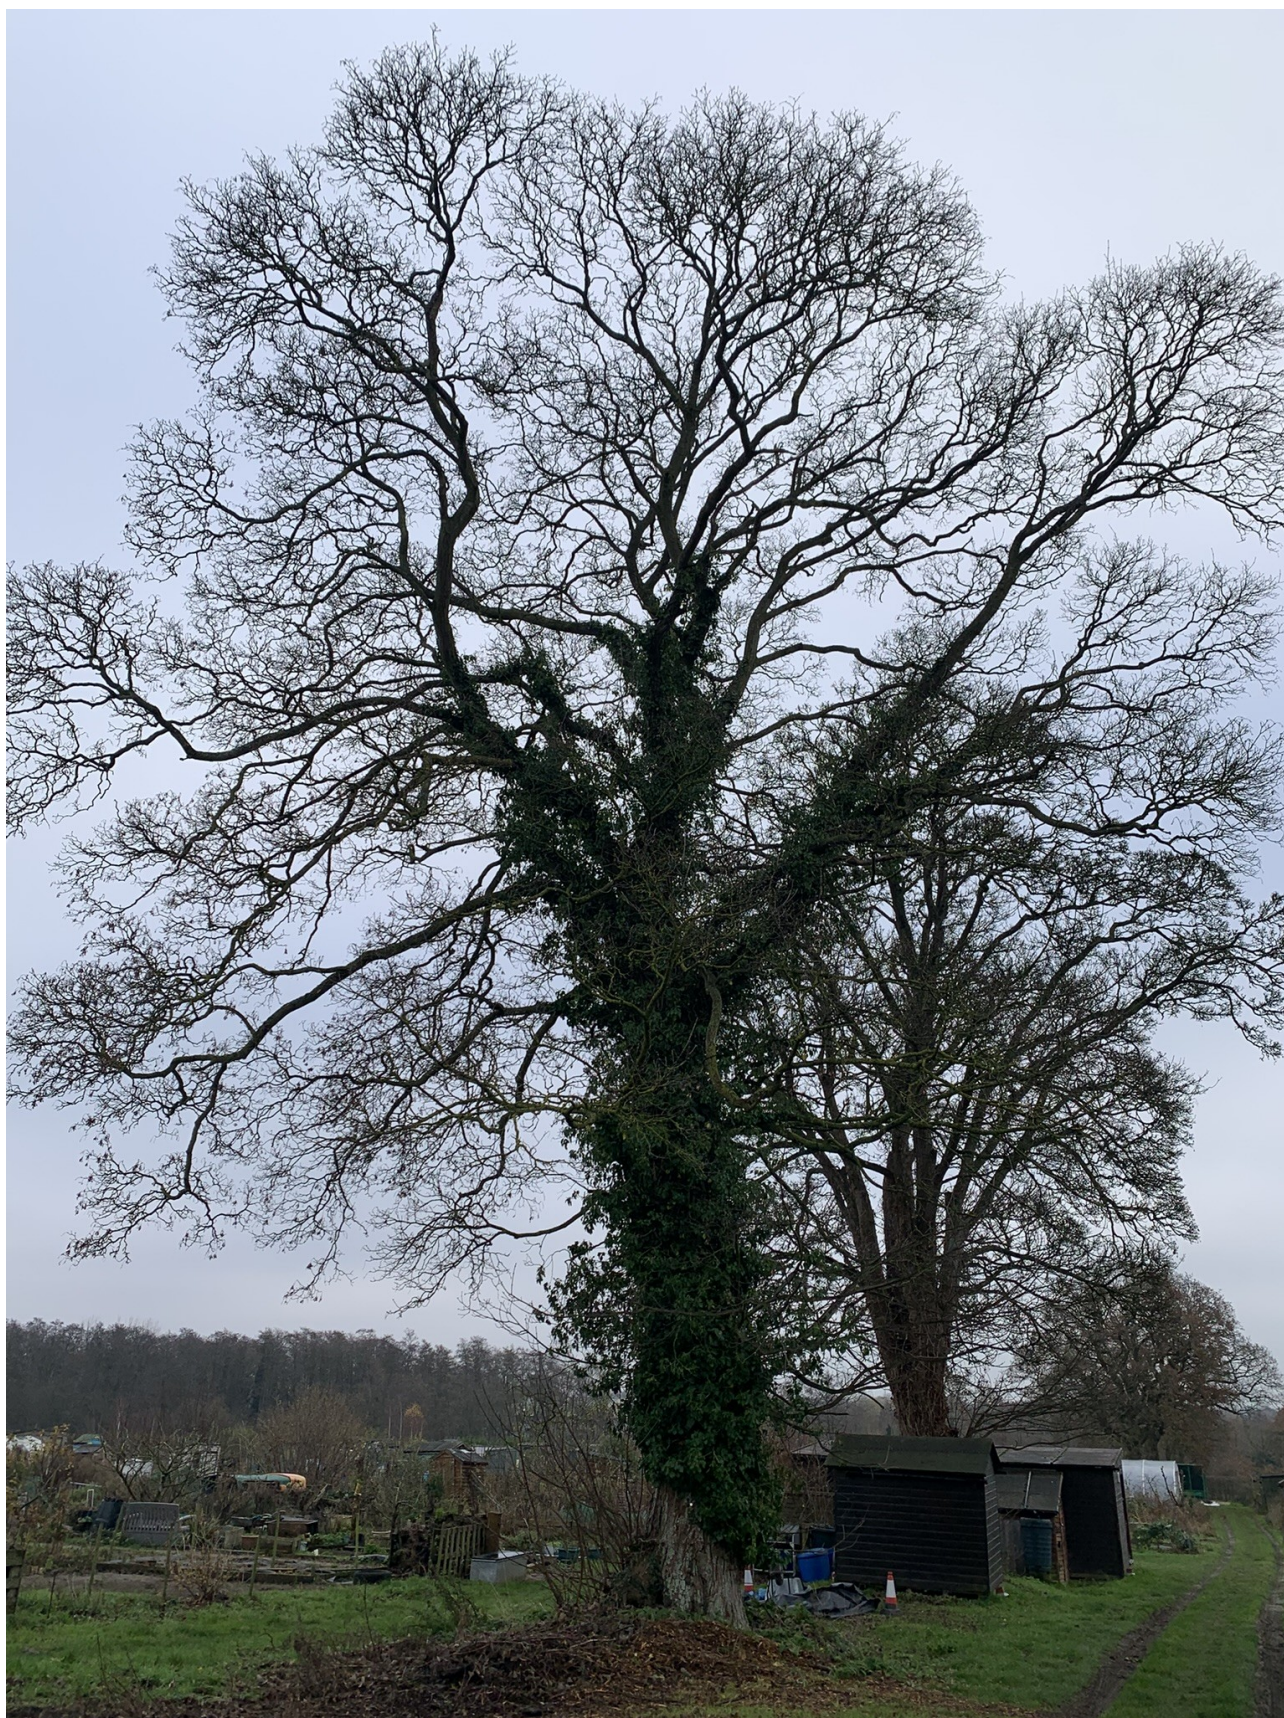
| Tree No. | Species | Ht (m) | SD (mm) | Age | Condition -Survey findings - Comments. | Identified hazards | Size of hazard | Risk Factor | Target zone | Recommended Works | Priority | ERC | PRF Y/N |
|---|---|---|---|---|---|---|---|---|---|---|---|---|---|
| 130 | Sycamore | 23 | 1200 | FM | Decay at base on west side. Good reaction growth. Minor hollowing at base. Good branch structure throughout canopy. Bonfire site to north too close to tree. Sheds under canopy. | Tree / Branches | L | L | MU 2 | No works to tree, recommend moving fire pit to >15 metres from base of tree. No additional structures beneath canopy of tree. | P3 | >40 | N |
| 131 | Sycamore | 23 | 1200 | FM | Good branch structure throughout canopy. Minor hollowing at base. Sheds under canopy. | Tree / Branches | L | L | MU 2 | No additional structures beneath canopy of tree. | P3 | >40 | N |
| 132 | Oak | 17 | 1100 | FM/<br>V | Decay at base on west side. Good reaction growth. Minor hollowing at base. Good branch structure throughout canopy. Poly tunnel under canopy to north. | Tree / Branches | L | L | MU 2 | No additional structures beneath canopy of tree. | P3 | >40 | Y |
| 133 | Oak | 17 | 1100 | FM/<br>V | Decay at base on west side. Good reaction growth. Minor hollowing at base. Good branch structure throughout canopy. Poly tunnel under canopy to north. | Tree / Branches | L | L | MU 2 | No works to tree, recommend moving fire pit to >15 metres from base of tree. No additional structures beneath canopy of tree. | P3 | >40 | Y |

**T0130 – T0133 – Recommendation that no additional ‘targets’ - Buildings, sheds, poly tunnels etc. to be located within 15 metres of trees.**

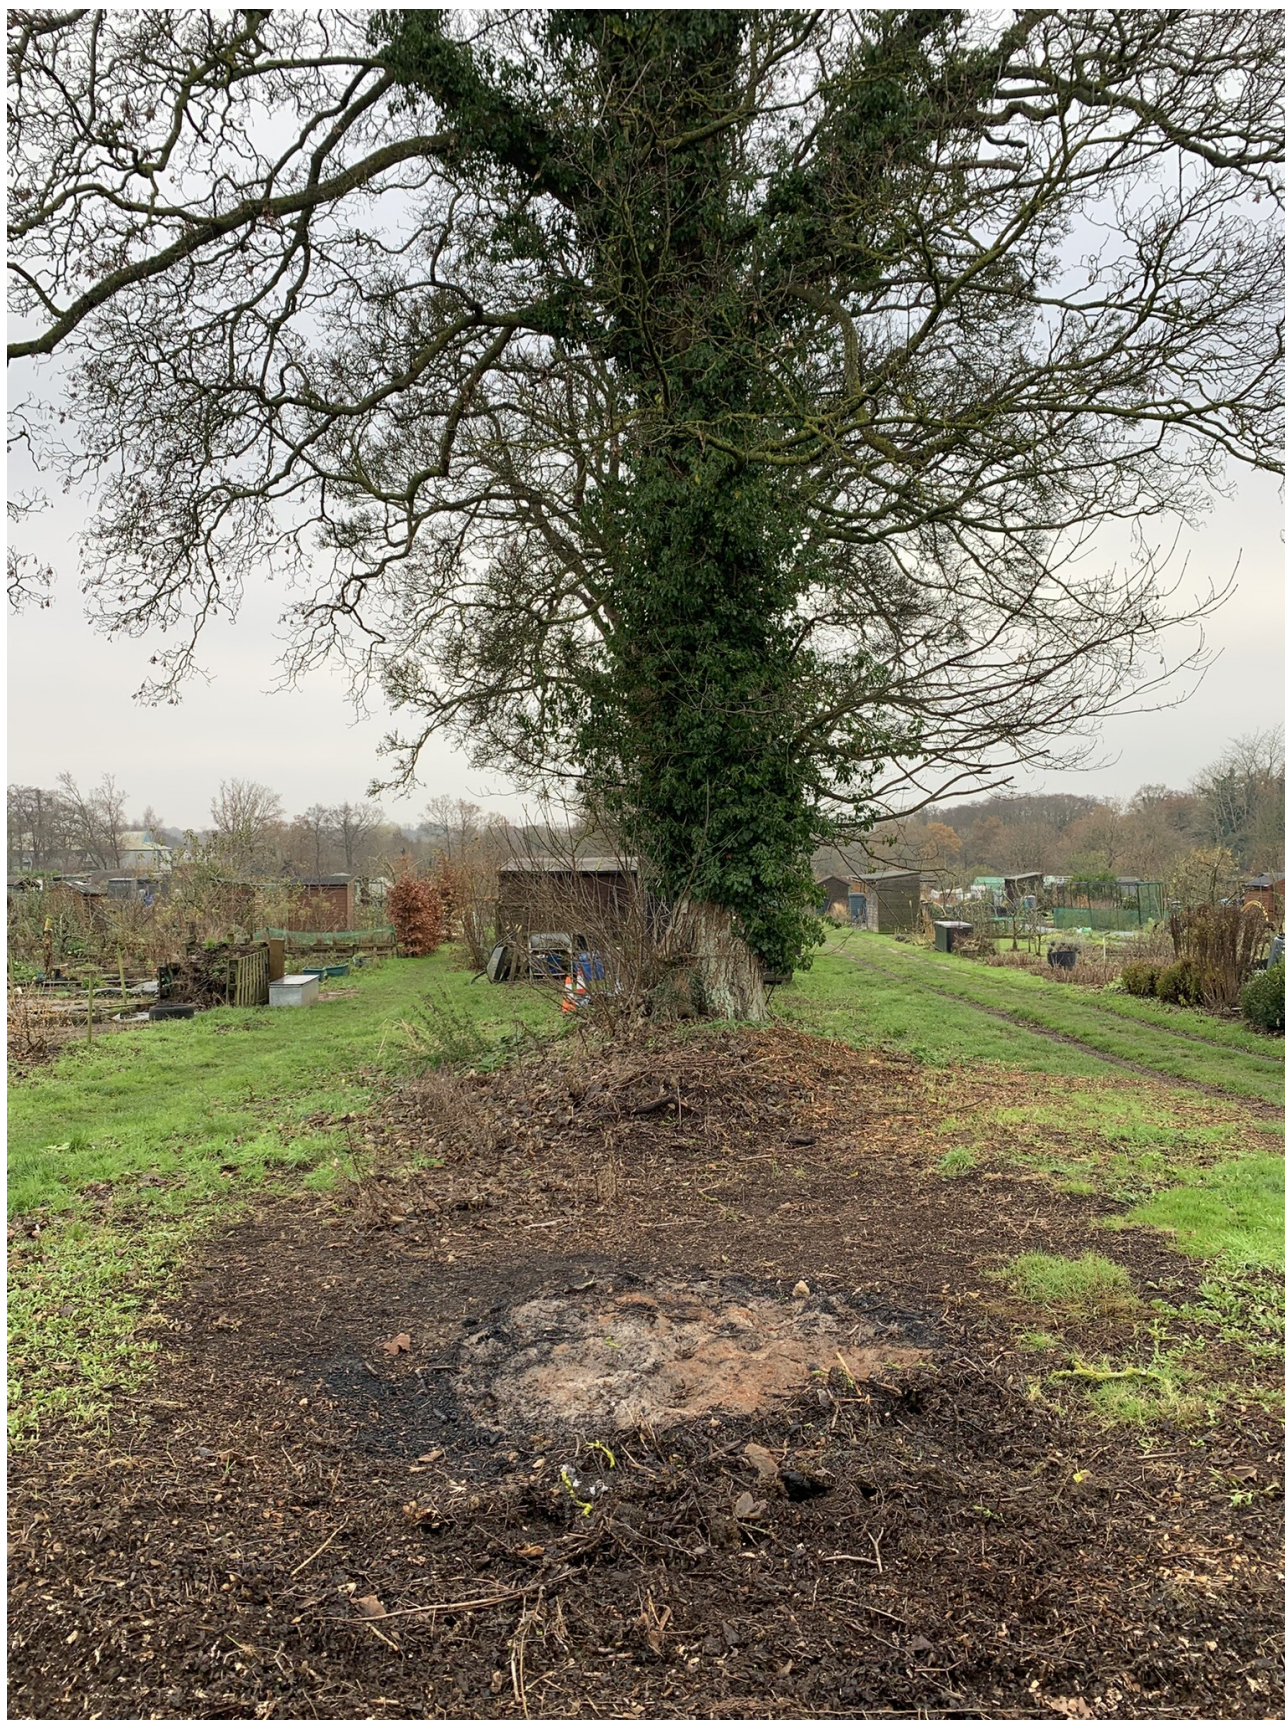
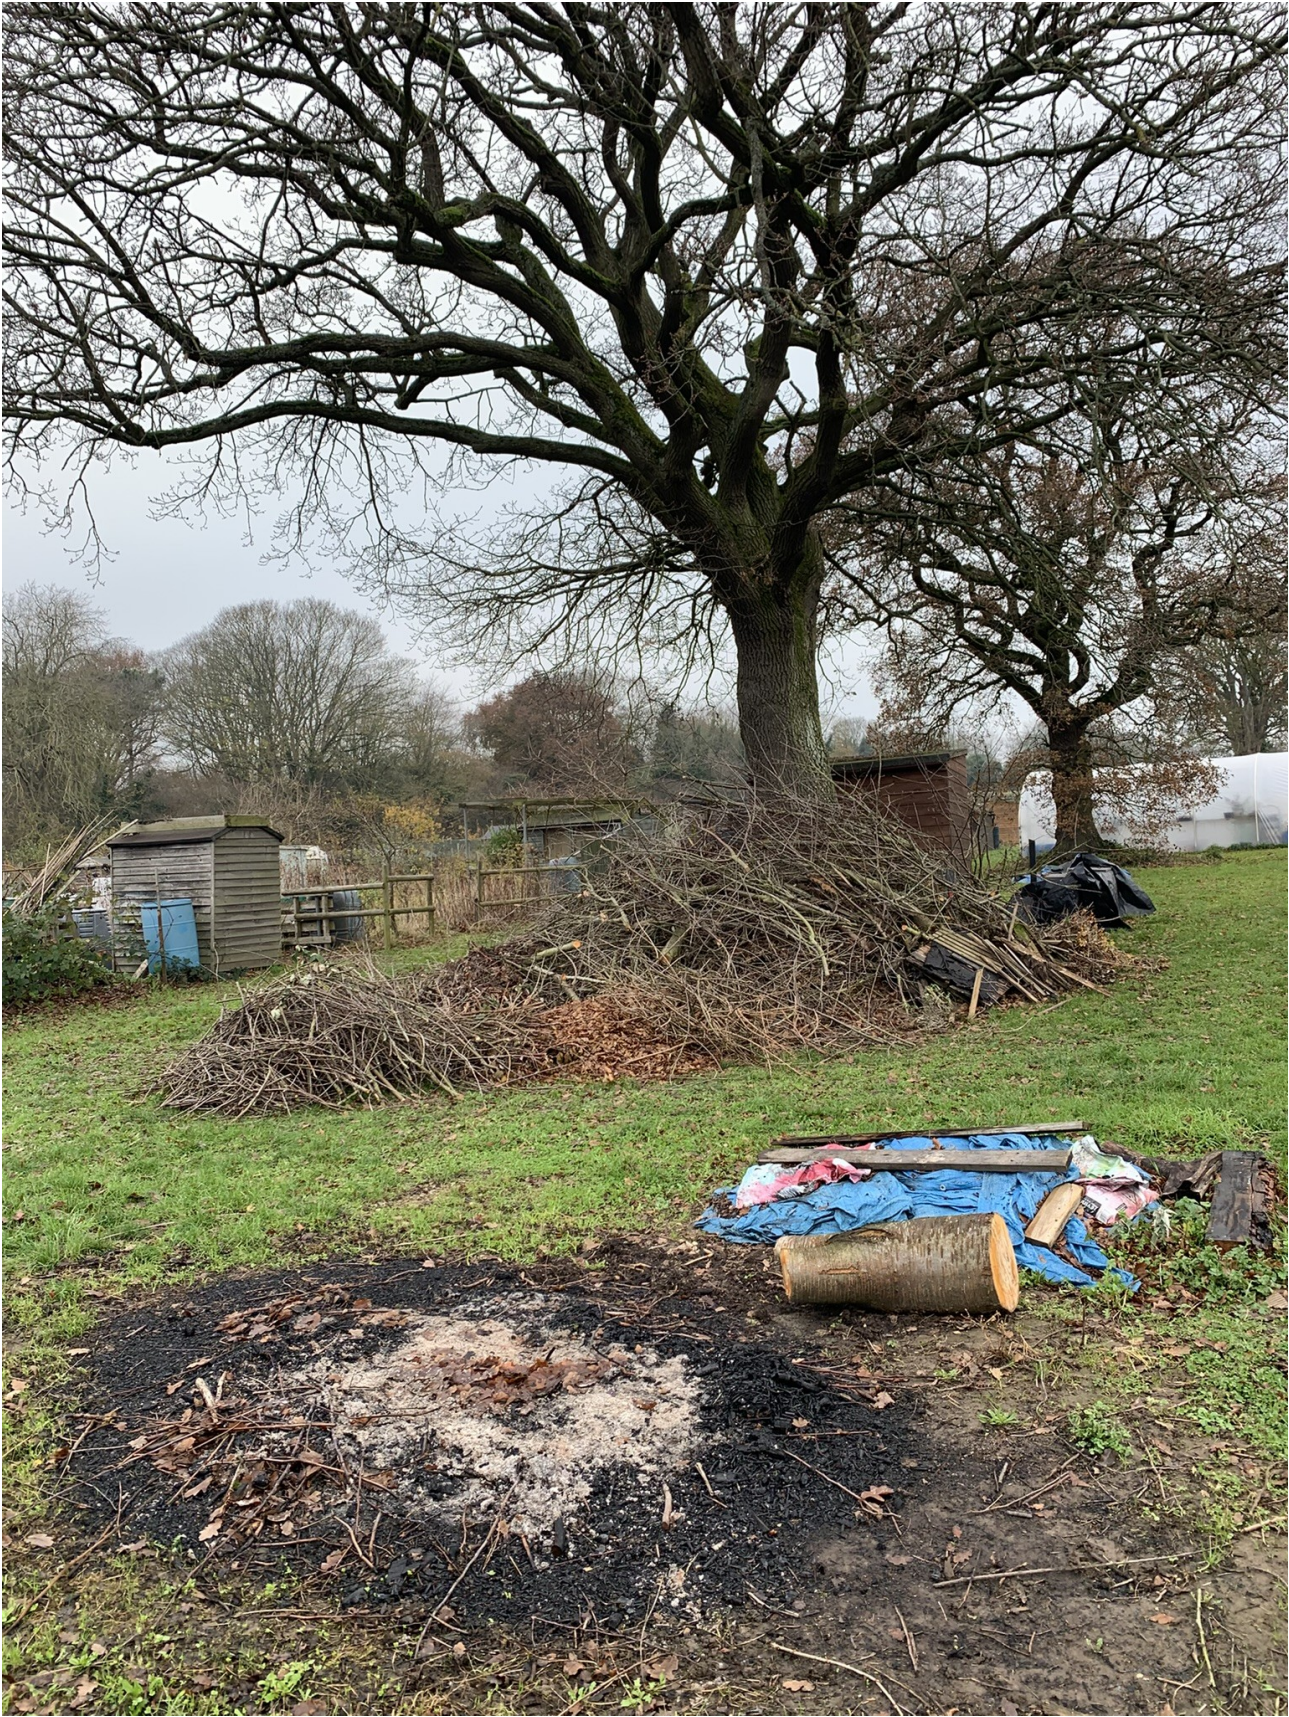
**T0130 and 0133 – Fires located too close to the trees – minimum 15 metres distance to protect roots and branches is recommended.**
