## Annual Inspection

Brundall Parish Council

Memorial Hall Play Area

Links Avenue, Brundall, Norfolk, NR13 5LL

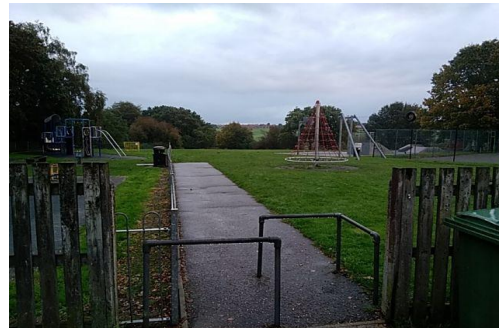
It is recommended that signage, with information including the site address, contact information for maintenance issues and emergency contact details are provided for the facility - Provide in accordance with the recommendations

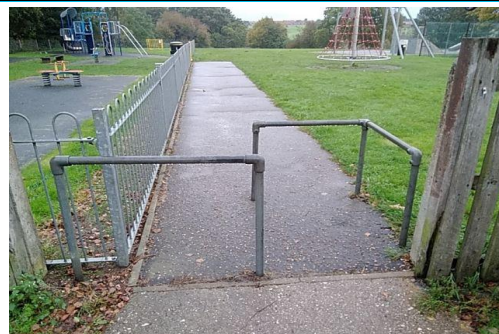
There is a trip hazard at the edge of the surface - Monitor for deterioration, repair as required

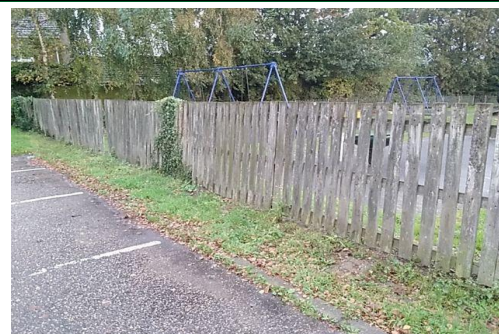
There are a number of timber slats missing from the fence - Replace missing slats

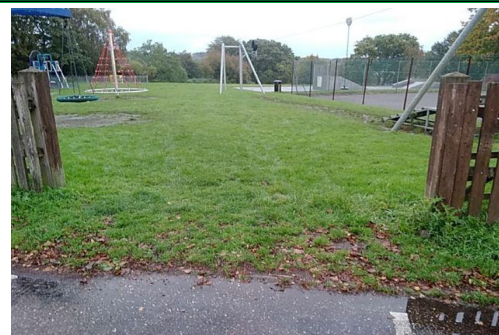
Gates are not secured, open at time of inspection - Secure gate when not in use

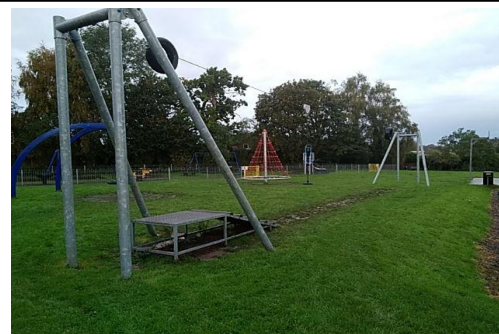
We have completed a visual inspection of the cable and fixing points from ground level, however it is not possible to fully inspect the cable and fixings without either hiring equipment to gain access or removing the cable and inspecting at ground level. We recommend that the main cable and fixing security is thoroughly inspected at least in accordance with the manufacturers recommendations to check for damage, security or internal rusting, this will help to ensure the continued safe use of the equipment - Inspect in accordance with the manufacturers recommendations

Ramp foot grip timber condition - Monitor for deterioration

There is some notable evidence of chain wear - Monitor for any further deterioration and replace when 40% worn

The surface has eroded and the foundations are exposed - Reinstate surrounding surfaces to cover the foundations

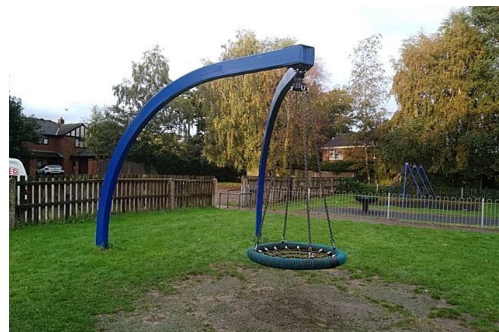
Manufacturer recommends bearing housing assembly is replaced every five years, last replaced 2017/2018 -  
Replace bearing housing assembly

There are gaps opening between the grass mat tiles -  
Monitor for deterioration but advise budget for surface upgrade

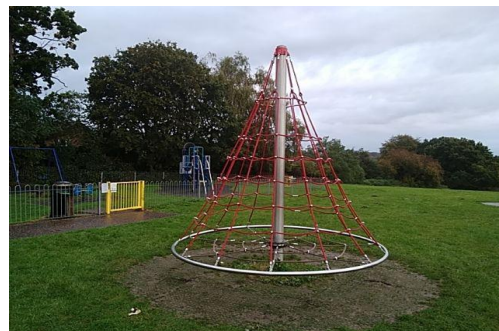
Two grass mats under this unit has been damaged -  
Replace the affected grass mats

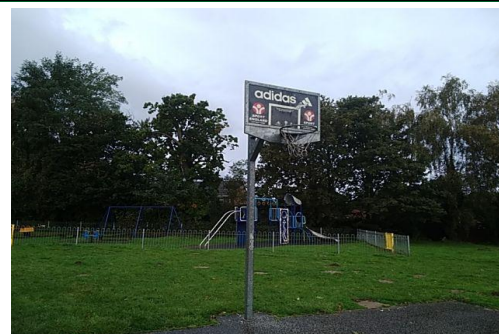
The backboard is damaged - Consider replacing the damaged insert panel

Hoop net attachments damaged/missing, loose chain net could create snagging hazard - Secure or remove chain net

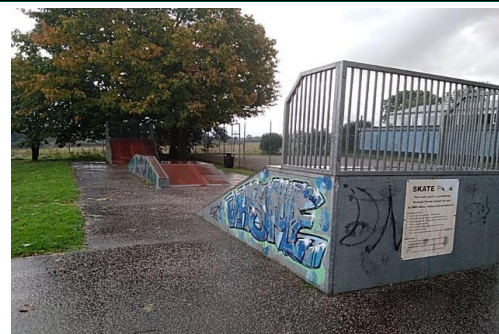
Signage of the wheeled sports area should be provided as recommended in BS EN 14974; this will include, a) facility for users of skateboards, inline-skates and BMX bikes (with site name or information); b) administrators identification with telephone number of the maintenance personnel and general emergency number; c) the facility is not a playground, its use is for adults, teenagers and children above the age of 8; d) the use of unsuitable equipment such as traditional road bikes, motorised sports equipment or toys is not permitted; e) use of appropriate protective equipment (e.g. helmet, knee pads, elbow pads, etc.) is recommended; f) pay attention to other users; g) the rolling surfaces and skate elements are not a waiting area and shall be kept clear of objects; h) the facility shall not be used when wet, icy or in snow conditions. - Provide signage as recommended by BS EN 14974 for wheeled sports areas

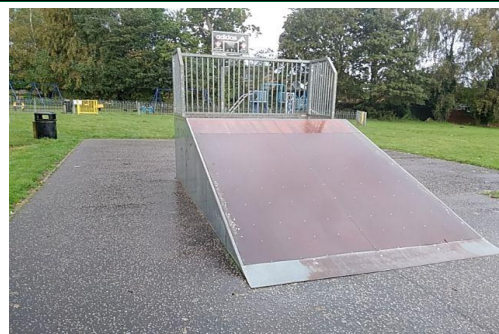
The height of the barrier is less than 1200mm and fails the requirements of BS EN 14974 - Monitor - No remedial work recommended

Riding surface / footplate transition deformation - Monitor for deterioration (variation of 3mm or over could create trip hazard)

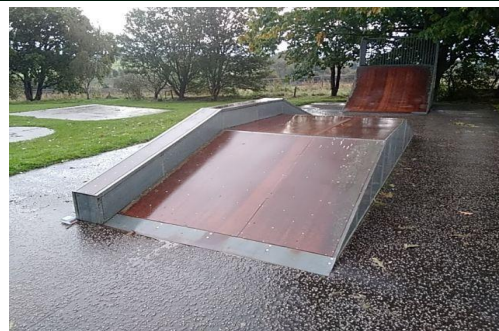
Several driveway panel fixings are missing - Replace missing pop-rivet fixings

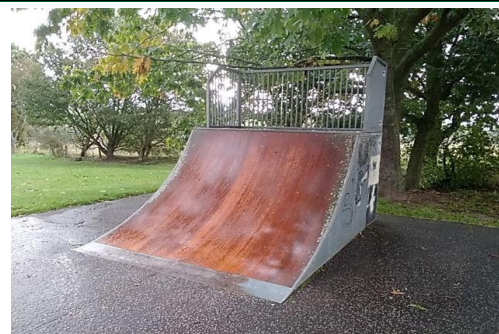
The height of the barrier is less than 1200mm and fails the requirements of BS EN 14974 - Monitor - No remedial work recommended

The platform edge has been damaged - Monitor for any further deterioration and replace as required

Minor tarmac surface damage at footplate transition - Monitor for deterioration, repair when required

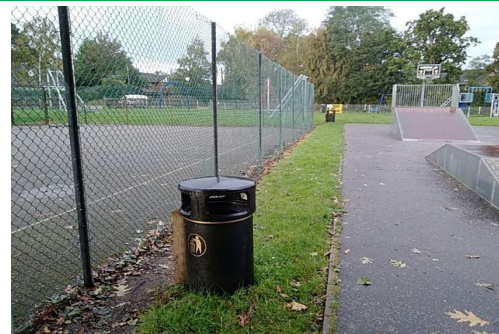
The surface has eroded in some areas - Reinstate the surface

There are trip hazards at the edges of the surface - Reinstate surrounding surface levels to remove the trip points

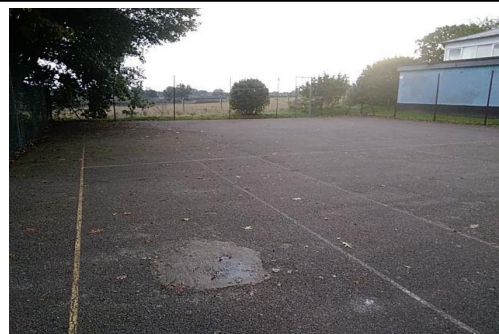
There are trip hazards at the entrance points - Reinstate surrounding surface levels to remove the trip points

There are chainlink sections missing at the single gate - Monitor for any further deterioration and repair as required

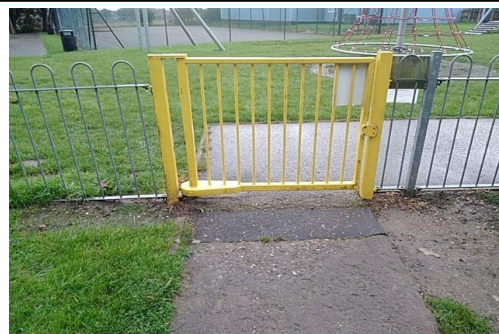
There are trip hazards at the path edge - Reinstate surrounding surface levels to remove the trip points

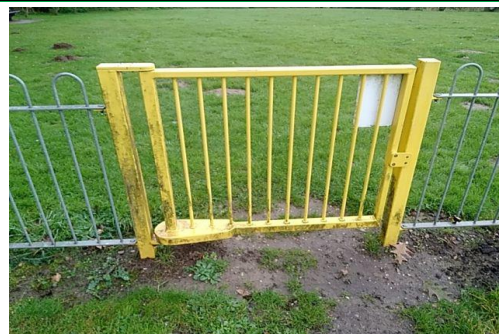
The surface has eroded in entrance - Reinstate the surface

The gate is slightly loose in its foundations - Monitor for any further deterioration and repair as required

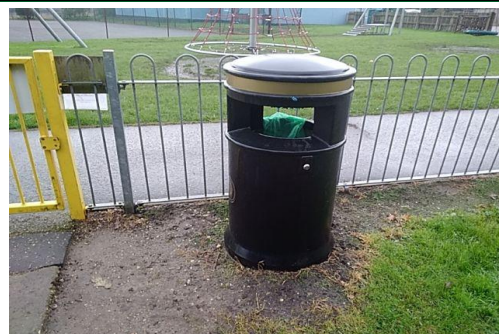
The surface has eroded in some areas - Reinststate the surface

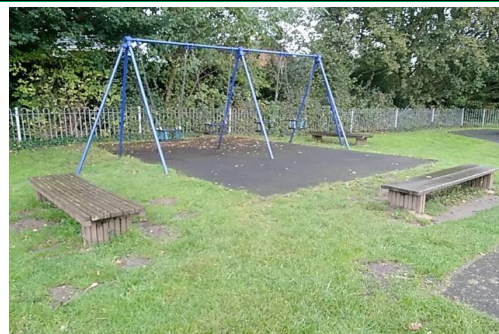
The surface has eroded in some areas - Reinststate the surface

Timber condition - Monitor for deterioration

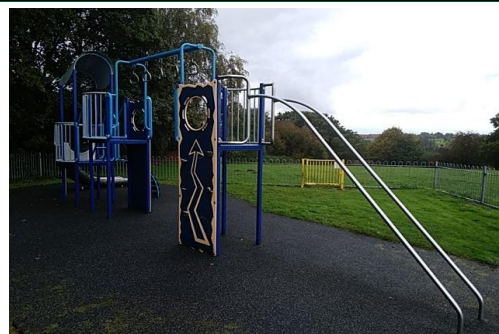
There is some graffiti present - Remove the graffiti

There are gaps opening between the surfacing and the edging surround or between the joints in the surfacing - Monitor for any further deterioration and repair as required

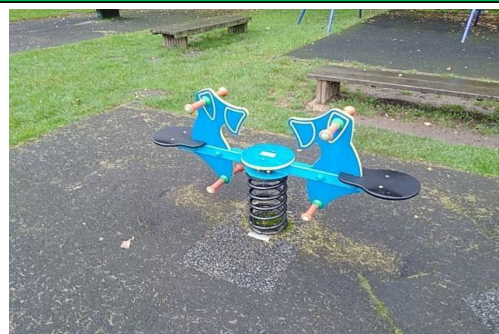
The safety surface around the area is beginning to wear - Monitor for any further deterioration and repair as required

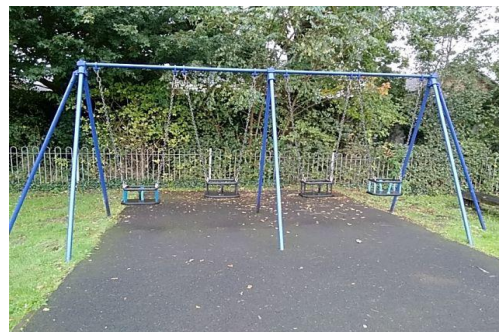
The seats are too close to the frame as defined in BS EN 1176 Part 2; this is a low risk failure and no remedial action is required - Monitor - No remedial work recommended

There is some notable evidence of chain wear - Monitor for any further deterioration and replace when 40% worn (note chains can be fitted directly onto the seats, additional fixing links are not required)

There are gaps opening between the surfacing and the edging surround or between the joints in the surfacing - Monitor for any further deterioration (see timber edging note)

Two seats have minor damage or wear - Monitor for any further deterioration and replace as required

Timber edging rotten or missing - Replace the affected edging (Wicksteed recommend concrete pin kerb edging)

There are trip hazards at the edges of the surface - Reinstate surrounding surface levels to remove the trip points

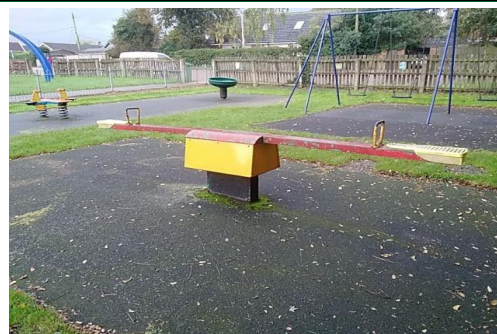
Paint condition - Consider treating the item

Uneven surface - Cause cannot be determined without disturbing the wetpour, monitor for deterioration

The safety surface around this unit has been damaged - Monitor for any further deterioration and repair as required

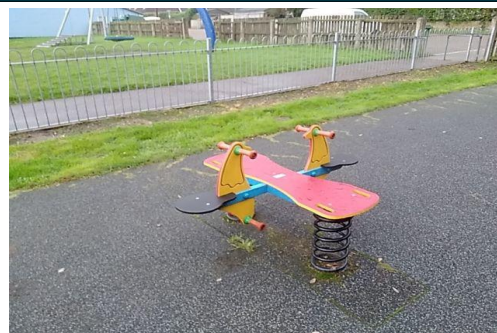
There are four bolt cap covers missing on the item - Replace missing bolt cap covers

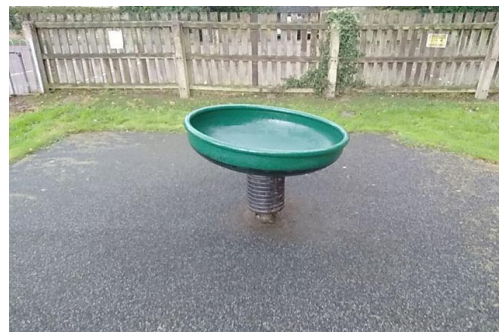
The safety surface around this unit has been damaged - Monitor for any further deterioration and repair as required

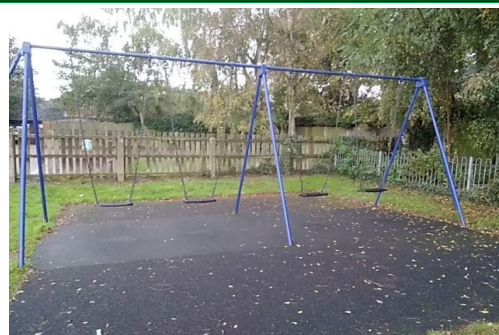
Two seats have minor vandalism damage - Monitor for any further deterioration and replace as required

There are gaps opening between the surfacing and the edging surround or between the joints in the surfacing - Monitor for any further deterioration (see timber edging note)

Timber edging rotten or missing - Replace the affected timber edging (Wicksteed recommend concrete pin kerb edging)

The safety surface around the area is beginning to wear - Monitor for any further deterioration and repair as required

There are a number of molehills within the area and these may present unforeseen hazards for users - Remove moles by appropriate means, reinstate surfaces to level and maintain the area

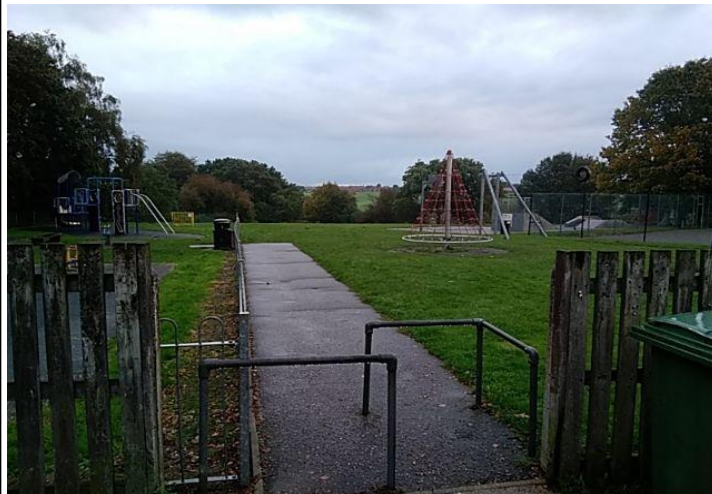
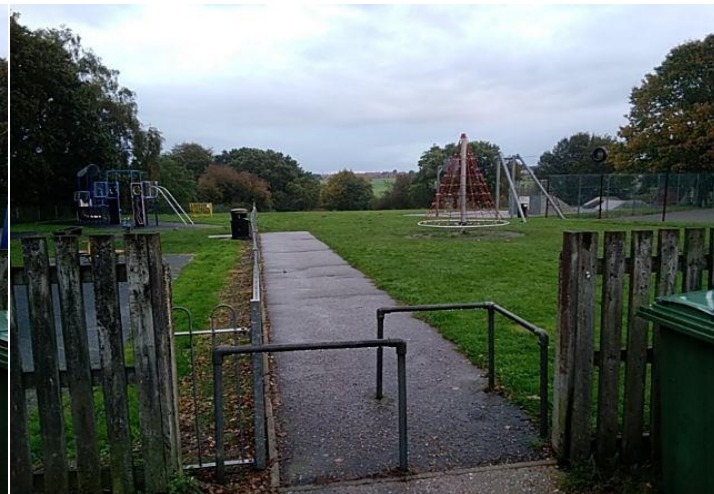
**Item:** Signs - Playground Sign  
**Manufacturer:** Not Applicable

**Finding:** It is recommended that signage, with information including the site address, contact information for maintenance issues and emergency contact details are provided for the facility

**Action:** Provide in accordance with the recommendations

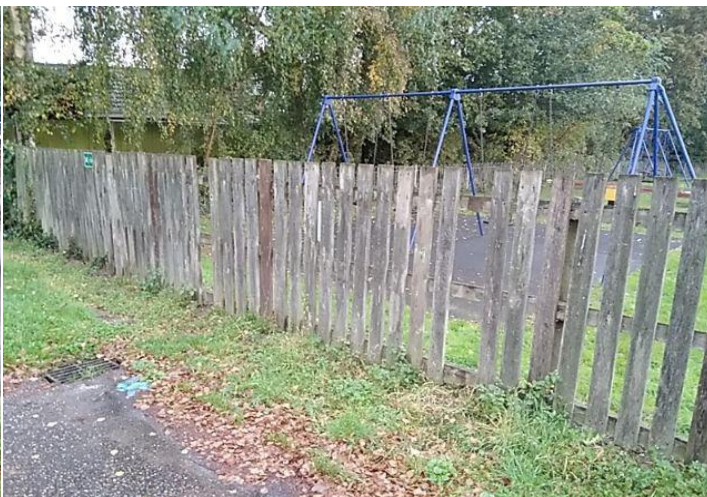
**Item:** Fences - Fencing - Timber  
**Manufacturer:** Unknown

**Finding:** There are a number of timber slats missing from the fence

**Action:** Replace missing slats

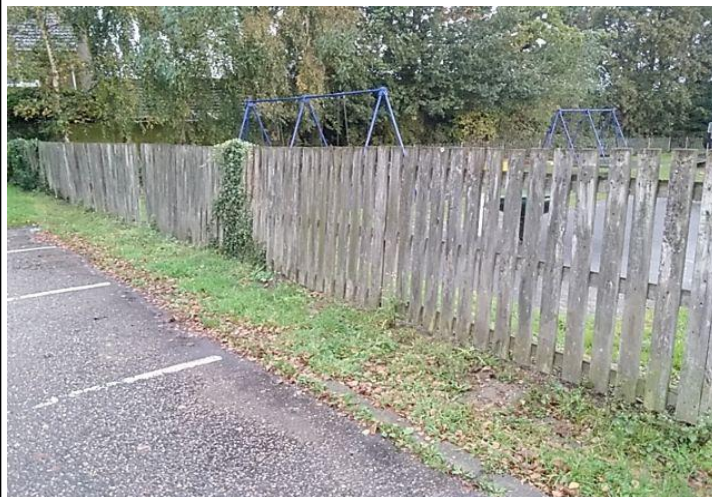
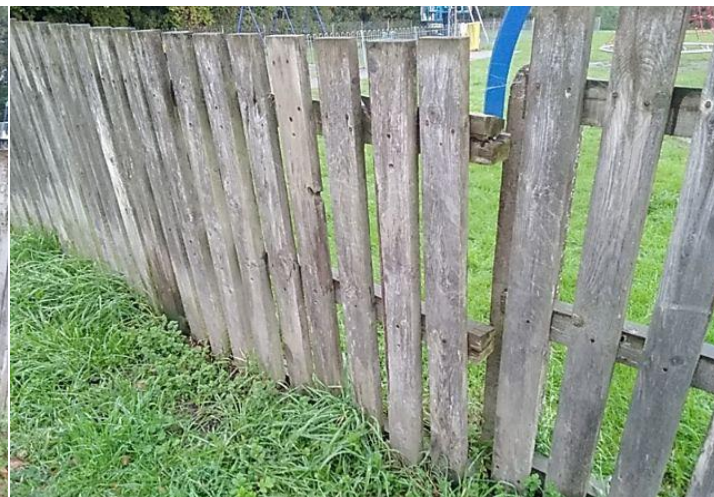
**Item:** Fences - Fencing - Timber  
**Manufacturer:** Unknown

**Finding:** One fence panel is insecure

**Action:** Secure to concrete post

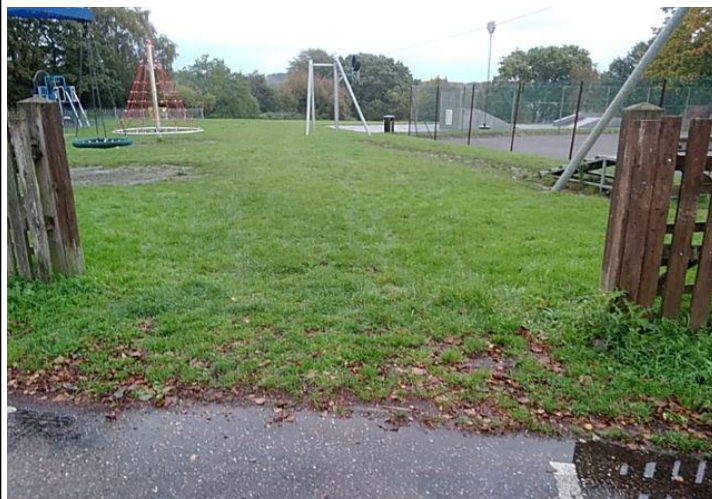
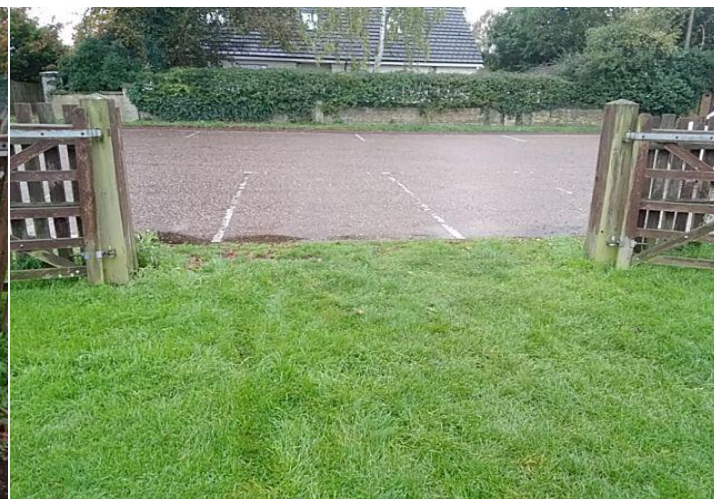
**Item:** Gates - Gate - Maintenance  
**Manufacturer:** Unknown

**Finding:** Gates are not secured, open at time of inspection

**Action:** Secure gate when not in use

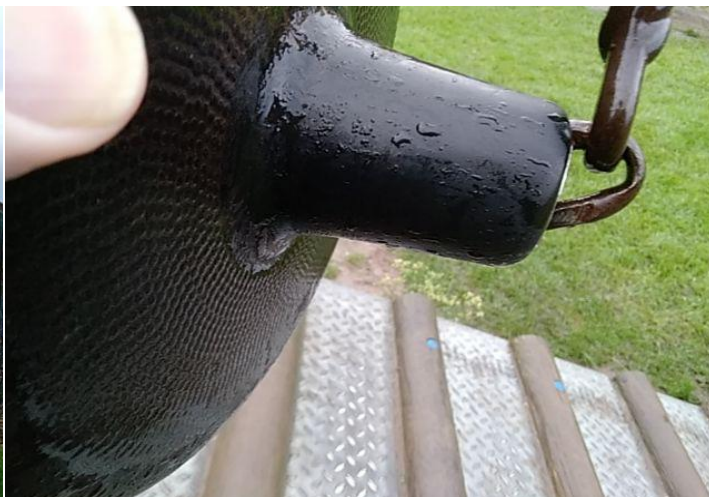
**Item:** Other - Cable Runway  
**Manufacturer:** Wicksteed Playgrounds

**Finding:** There is some notable evidence of chain wear

**Action:** Monitor for any further deterioration and replace when 40% worn

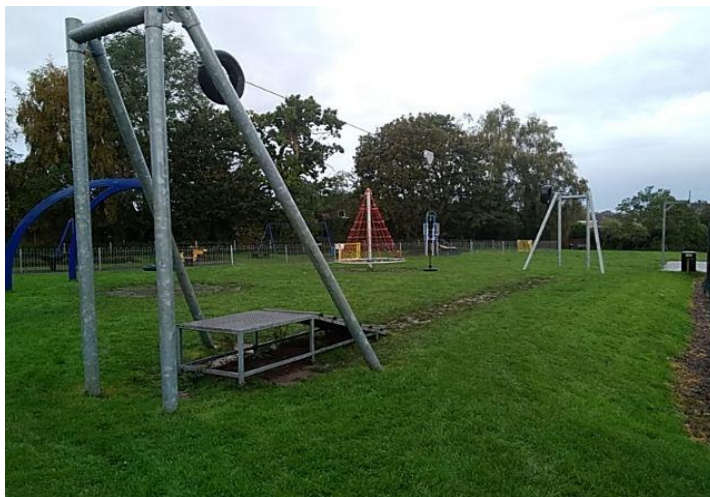
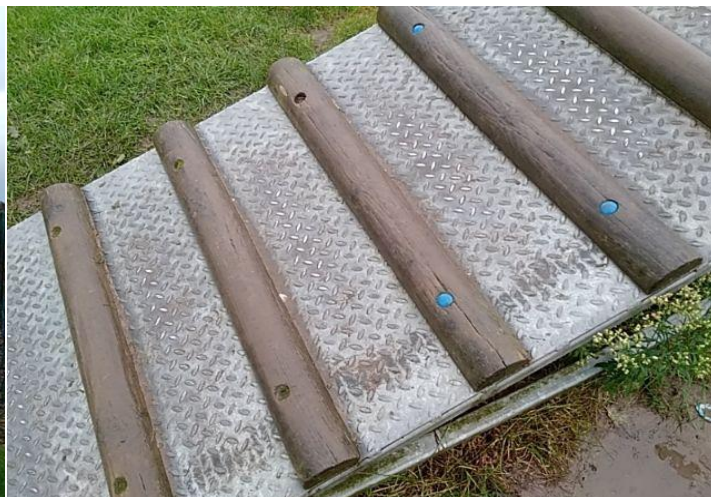
**Finding:** Ramp foot grip timber condition

**Action:** Monitor for deterioration

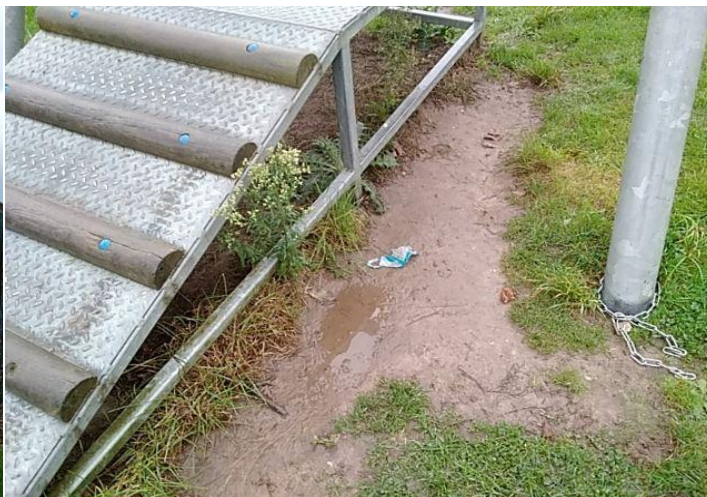
**Finding:** The surface has eroded and the foundations are exposed

**Action:** Reinstall surrounding surfaces to cover the foundations

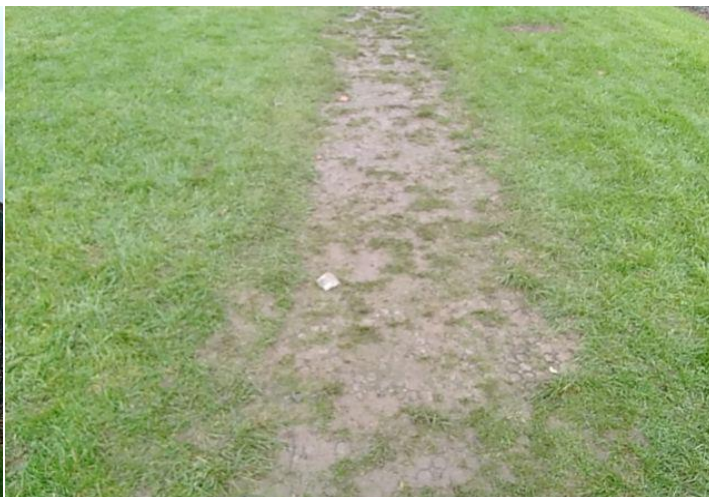
**Finding:** The grass mats are silted up, the soil is compacted and the area will become very slippery when the soil is wet. **Action:** Reinststate as required

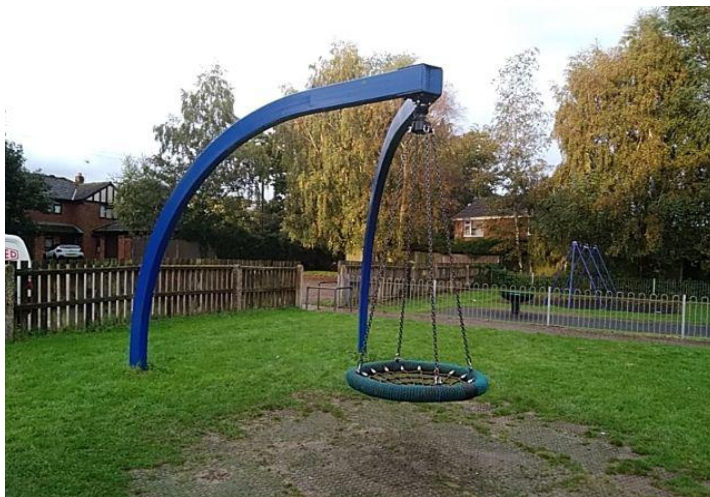
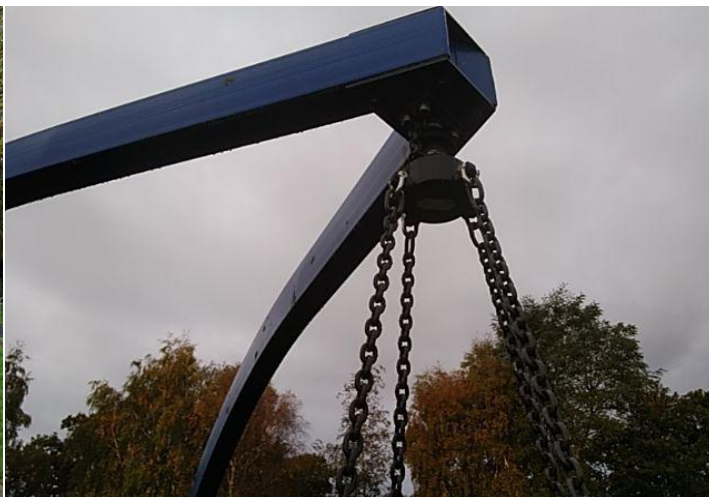
**Finding:** Manufacturer recommends bearing housing assembly is replaced every five years, last replaced 2017/2018

**Action:** Replace bearing housing assembly

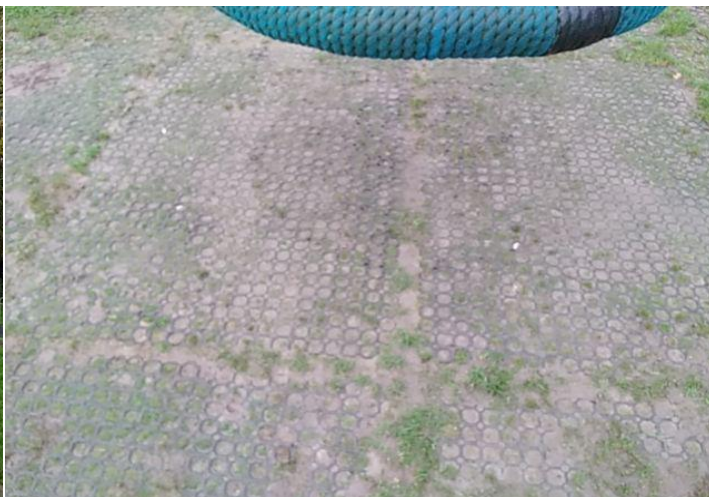
**Finding:** There are gaps opening between the grass mat tiles

**Action:** Monitor for deterioration but advise budget for surface upgrade

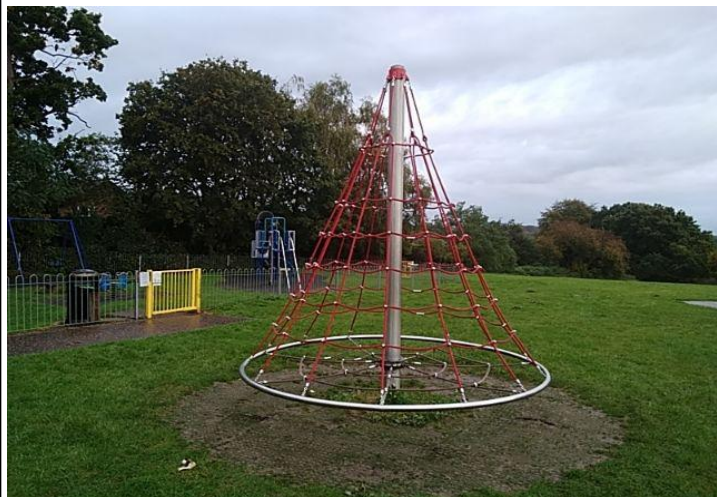
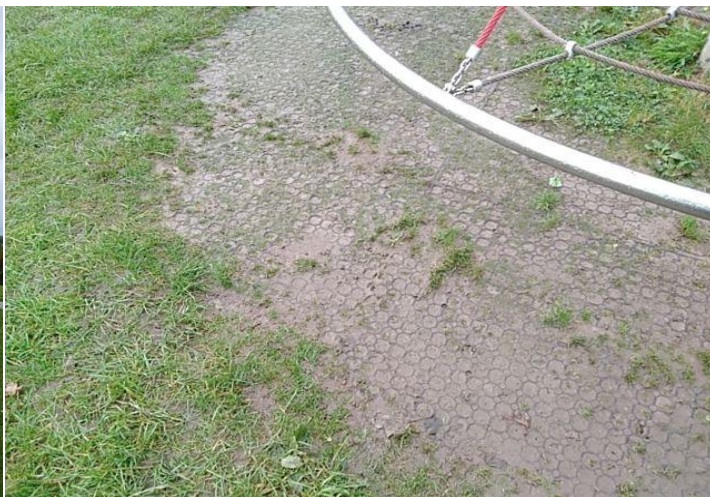
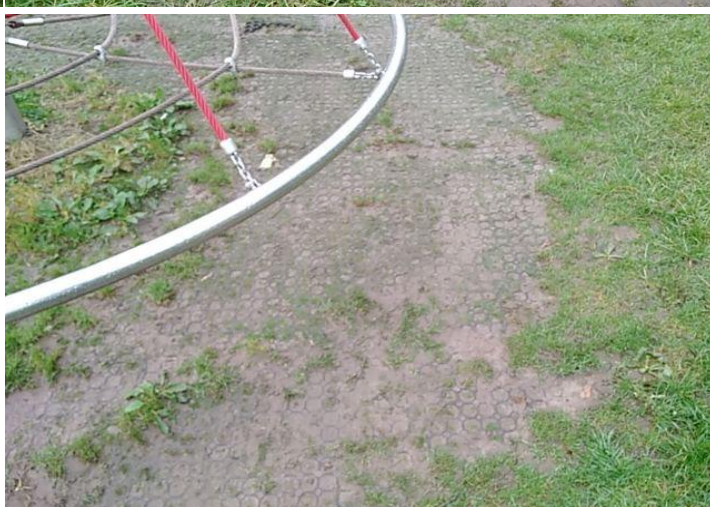
**Finding:** The grass mats are silted up, the soil is compacted and the area will become very slippery when the soil is wet. **Action:** Reinstall as required

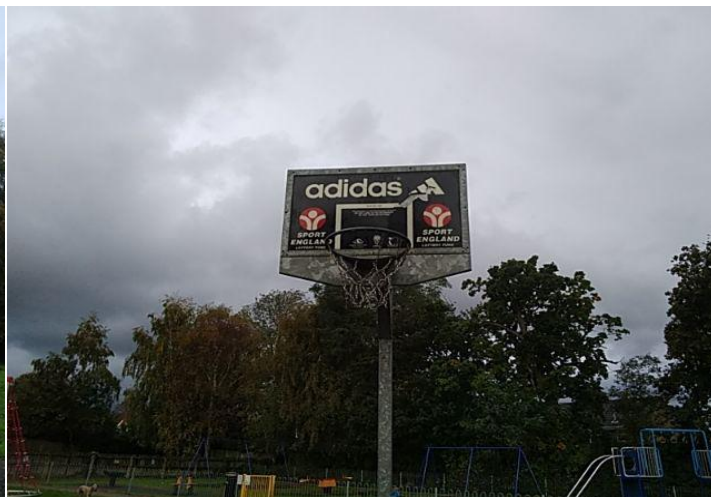
**Finding:** The backboard is damaged

**Action:** Consider replacing the damaged insert panel

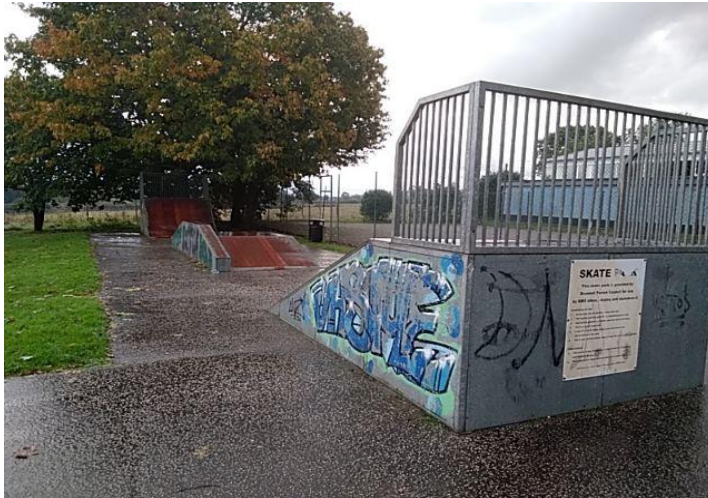
**Finding:** Signage of the wheeled sports area should be provided as recommended in BS EN 14974; this will include, a) facility for users of skateboards, inline-skates and BMX bikes (with site name or information); b) administrators identification with telephone number of the maintenance personnel and general emergency number; c) the facility is not a playground, its use is for adults, teenagers and children above the age of 8; d) the use of unsuitable equipment such as traditional road bikes, motorised sports equipment or toys is not permitted; e) use of appropriate protective equipment (e.g. helmet, knee pads, elbow pads, etc.) is recommended; f) pay attention to other users; g) the rolling surfaces and skate elements are not a waiting area and shall be kept clear of objects; h) the facility shall not be used when wet, icy or in snow conditions.

**Action:** Provide signage as recommended by BS EN 14974 for wheeled sports areas

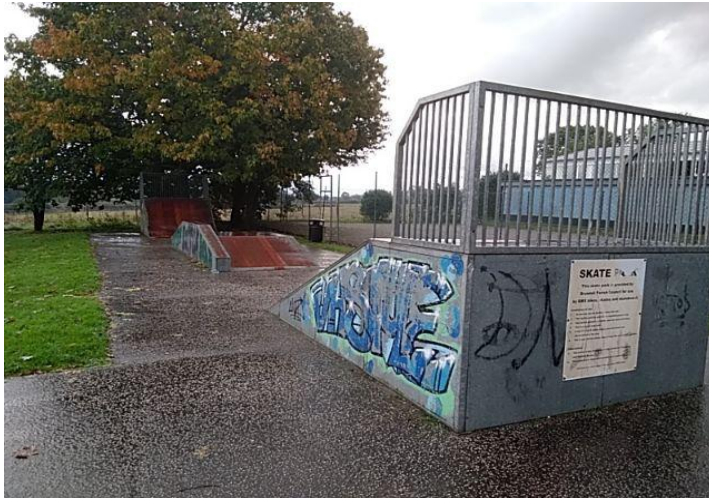
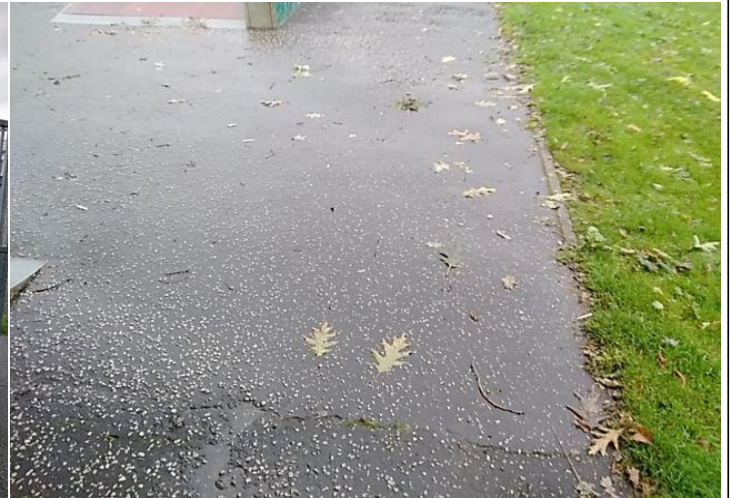
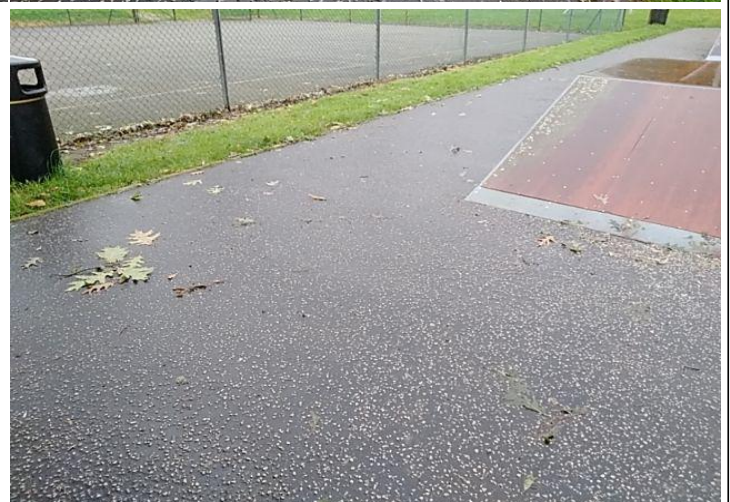
**Finding:** There is some tree debris in the area

**Action:** Remove and maintain

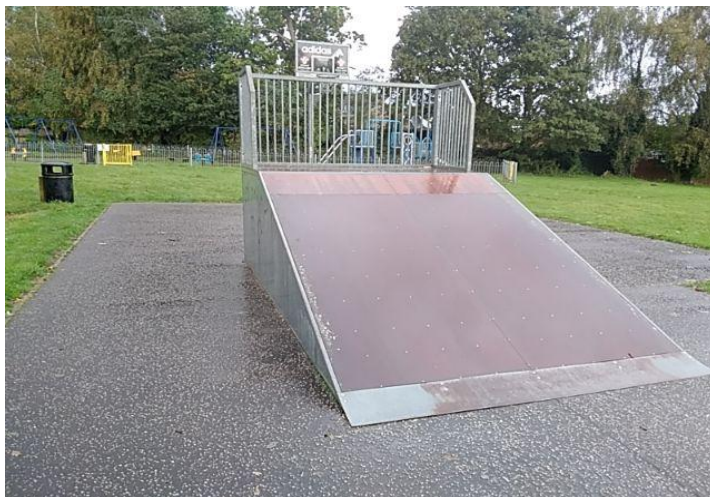
**Finding:** The height of the barrier is less than 1200mm and fails the requirements of BS EN 14974  
**Action:** Monitor - No remedial work recommended

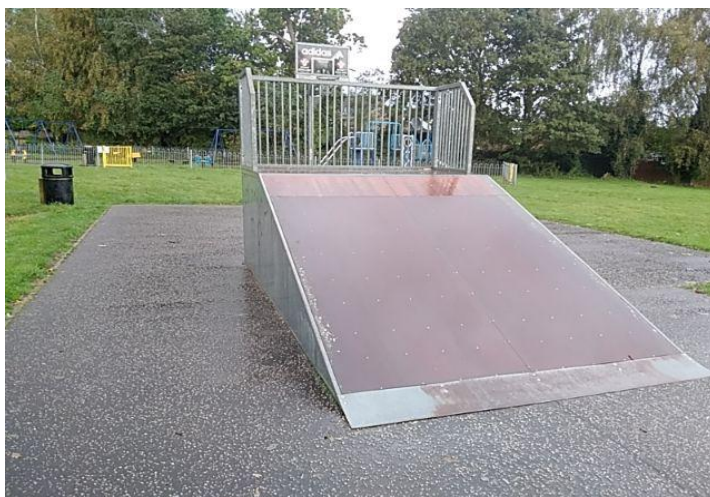
**Finding:** Riding surface / footplate transition deformation  
**Action:** Monitor for deterioration (variation of 3mm or over could create trip hazard)

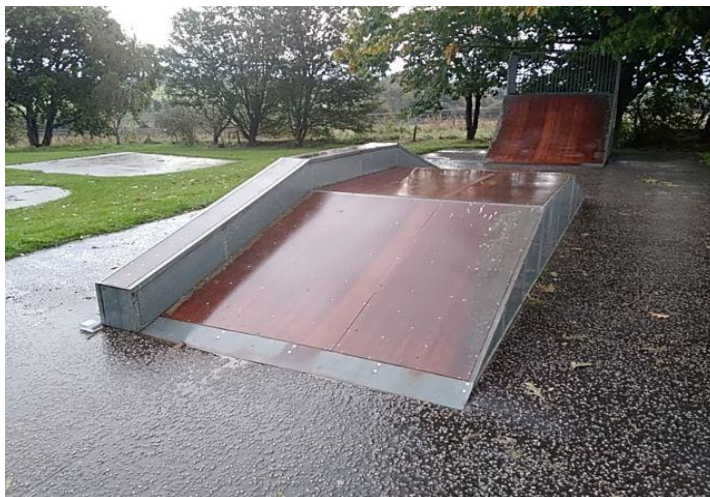
**Finding:** Several driveway panel fixing are missing

**Action:** Replace missing pop-rivet fixings

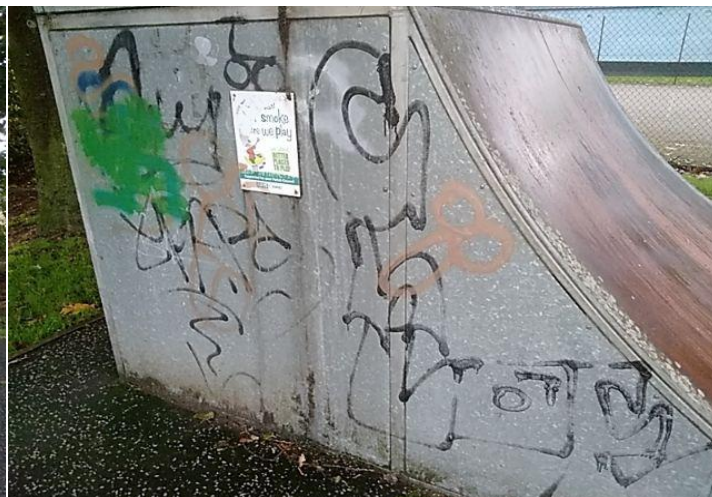
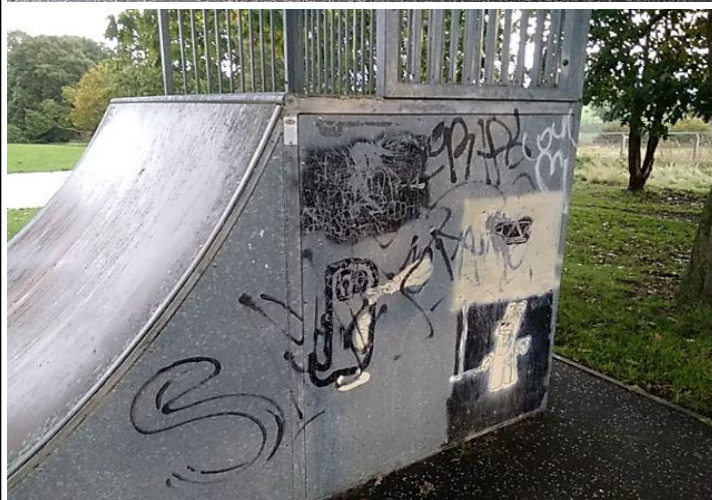
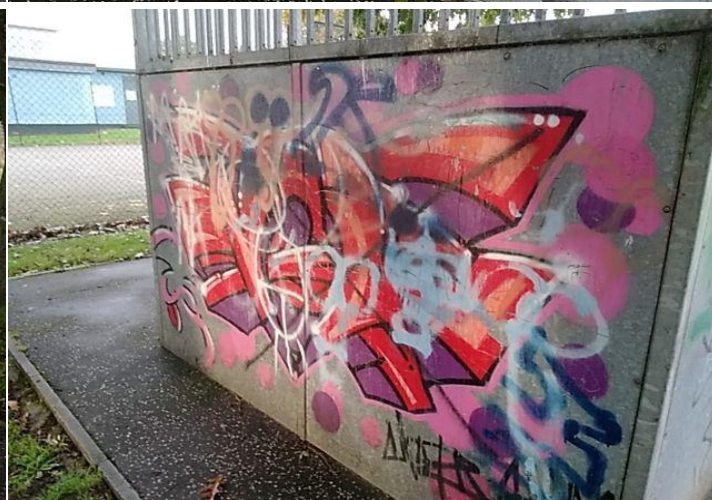
**Finding:** There is some graffiti present

**Action:** Remove the graffiti

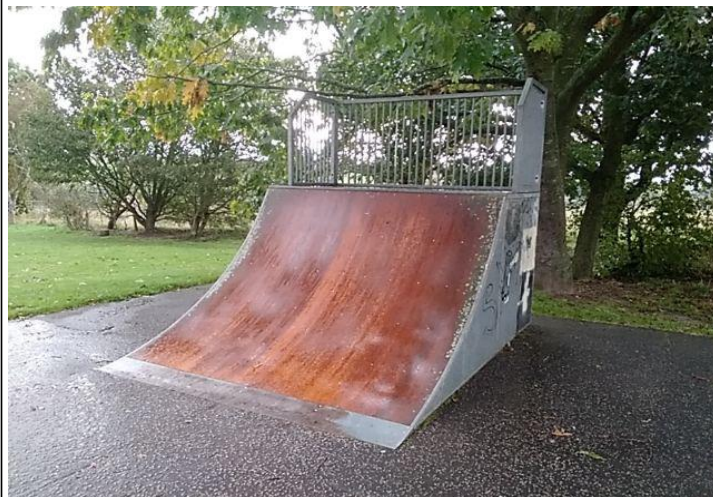
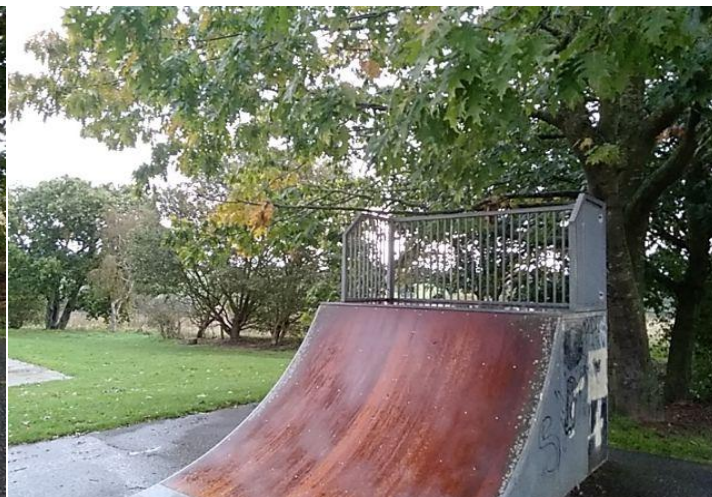
**Finding:** The adjacent foliage is overhanging

**Action:** Cut back and maintain

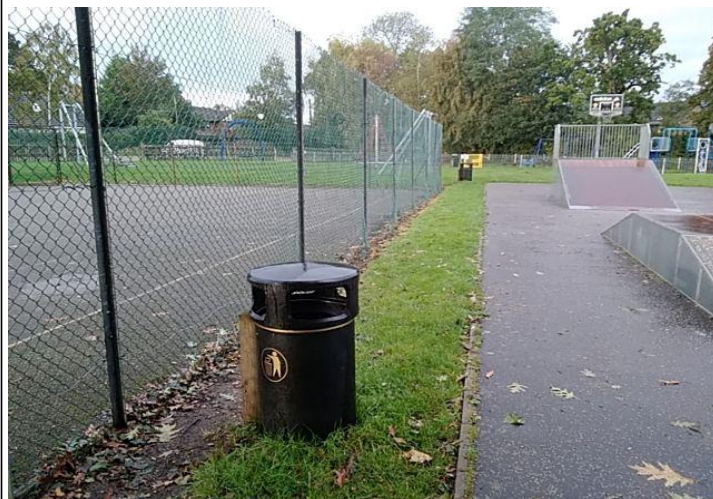
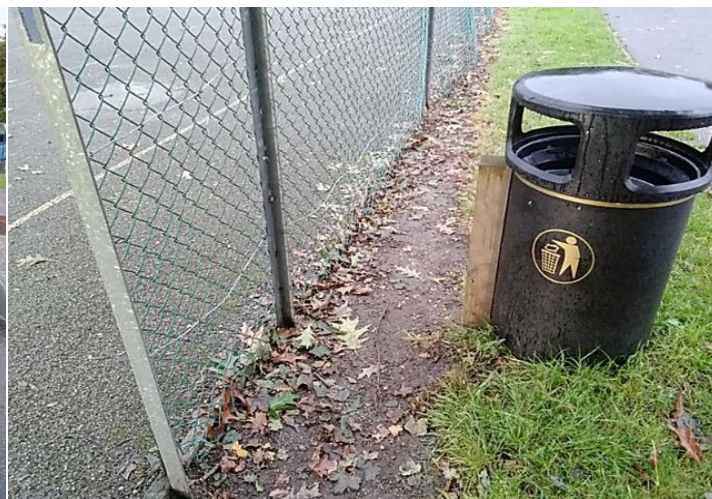
**Finding:** The surface has eroded in some areas

**Action:** Reinstate the surface

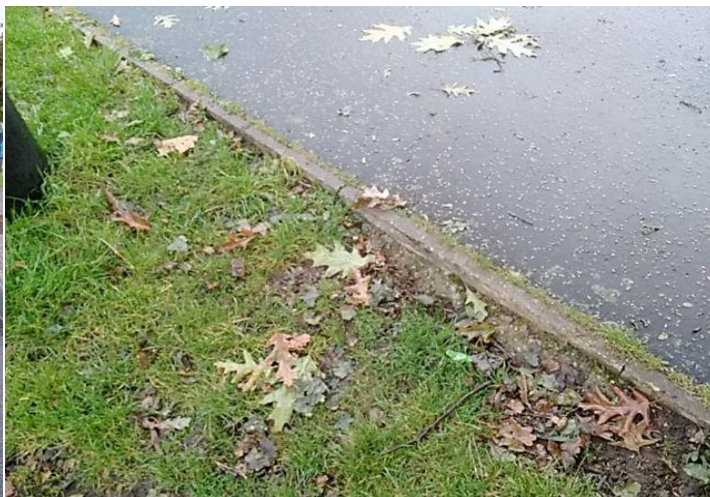
**Finding:** There are trip hazards at the edges of the surface

**Action:** Reinststate surrounding surface levels to remove the trip points

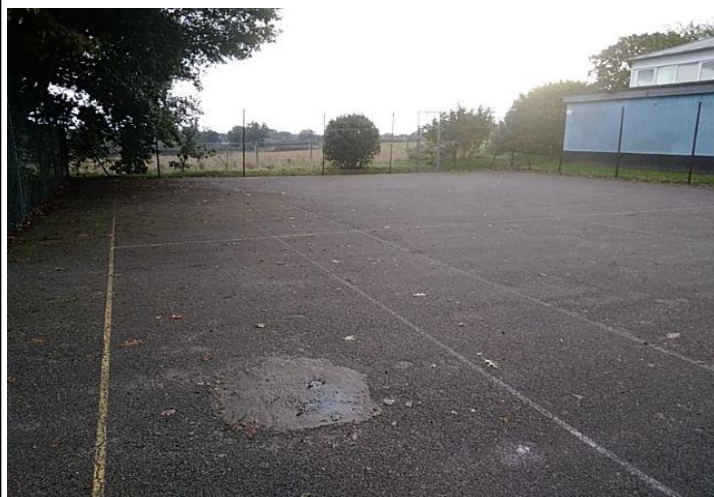
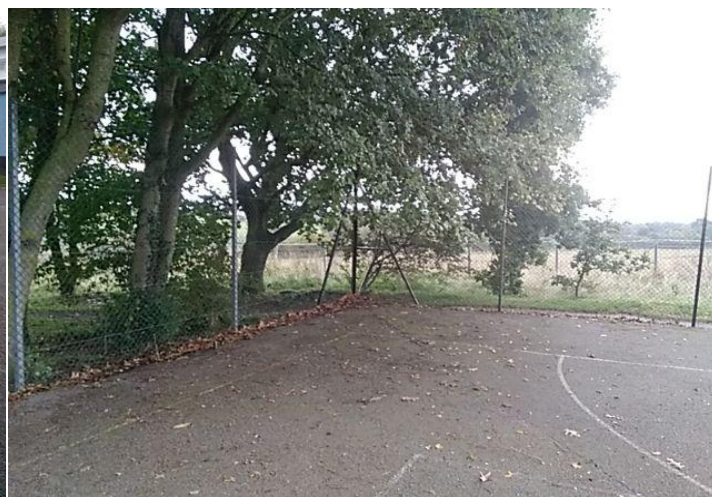
**Finding:** The adjacent foliage is overhanging

**Action:** Cut back and maintain

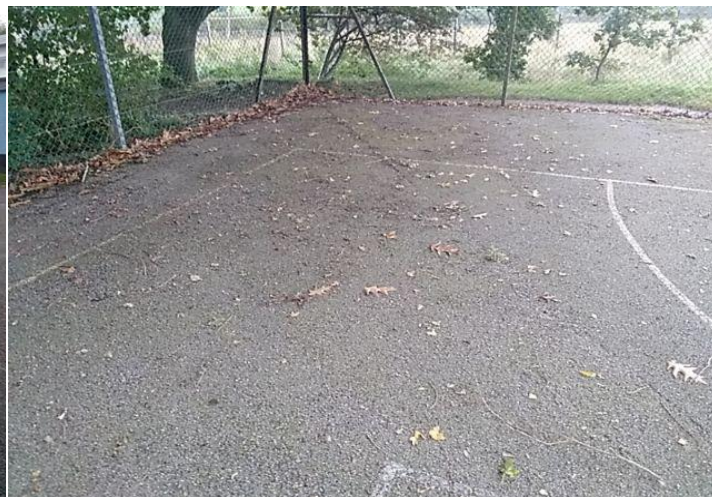
**Finding:** There is some tree debris in the area

**Action:** Remove and maintain

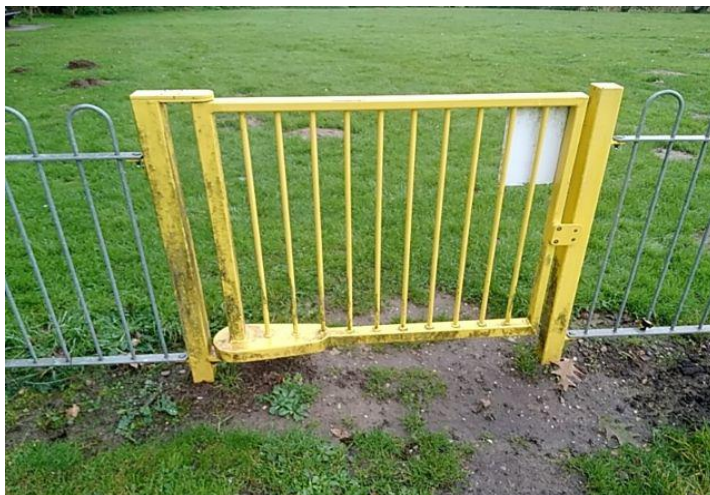
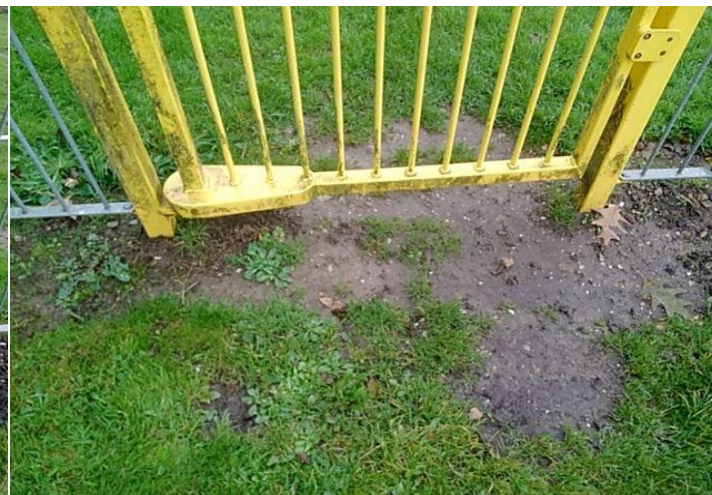
**Finding:** The surface has eroded in entrance

**Action:** Reinstate the surface

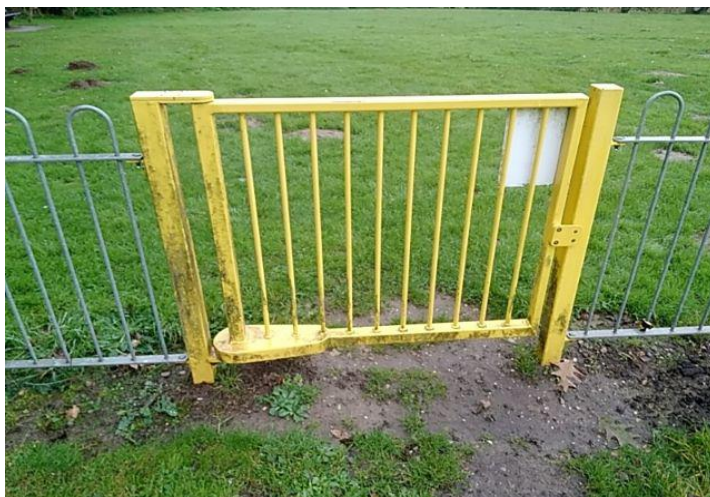
**Finding:** The gate is slightly loose in its foundations

**Action:** Monitor for any further deterioration and repair as required

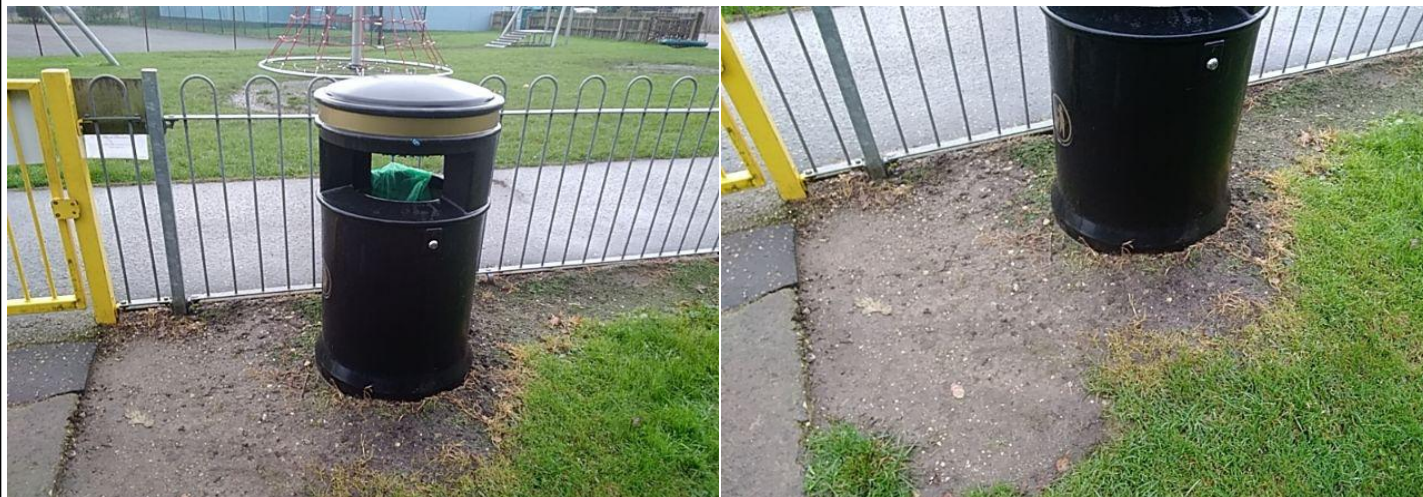
**Finding:** The surface has eroded in some areas

**Action:** Reinstate the surface

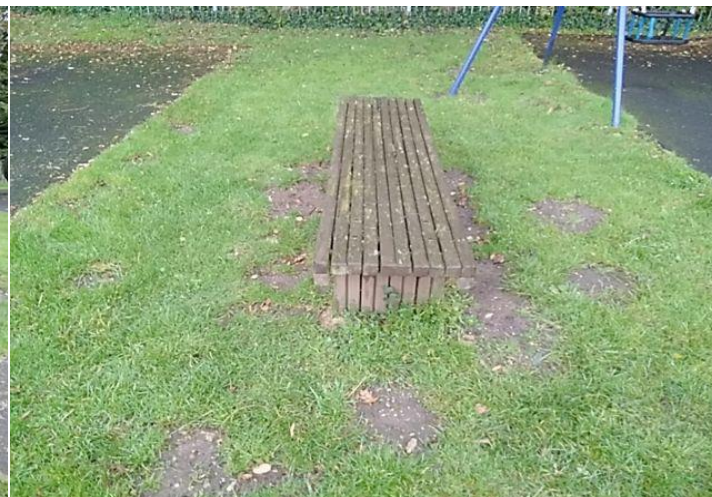
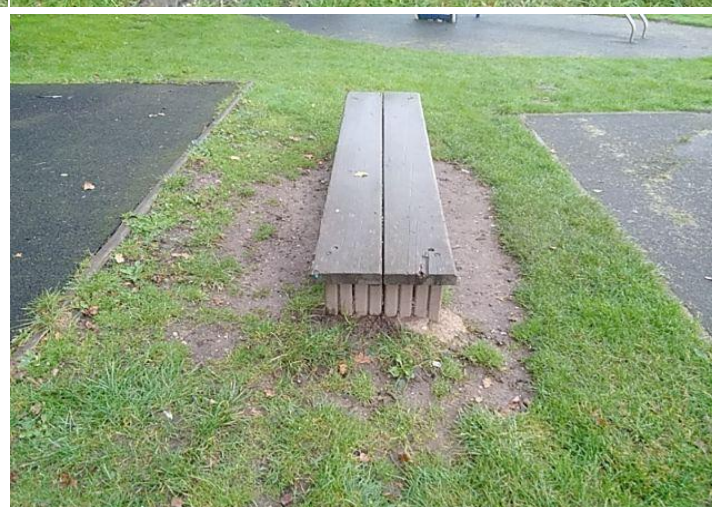
**Finding:** The surface has eroded in some areas

**Action:** Reinststate the surface
