## Annual Inspection

Brundall Parish Council

Memorial Hall Play Area

Links Avenue, Brundall, Norfolk, NR13 5LL

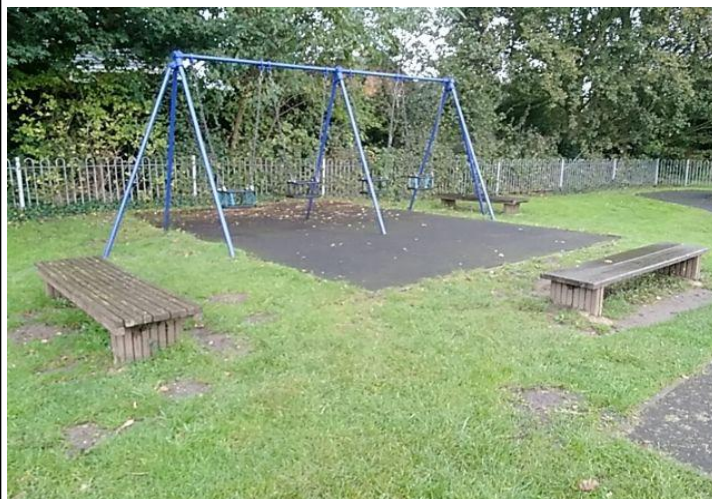
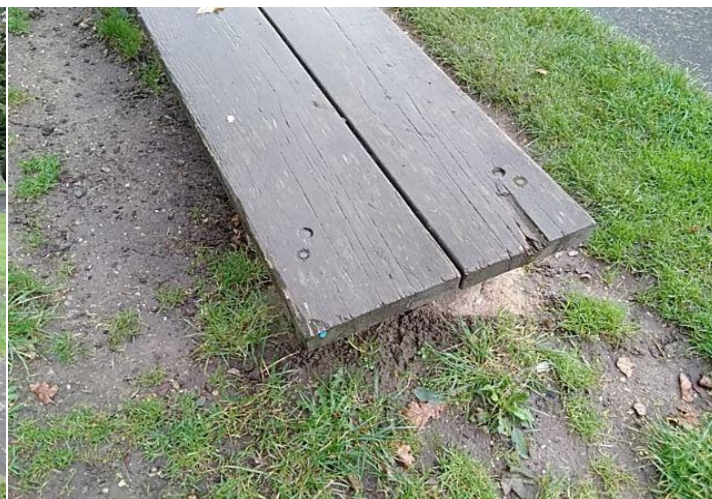
**Finding:** Parts of the timber are rough or splintered

**Action:** Remove all rough or sharp edges

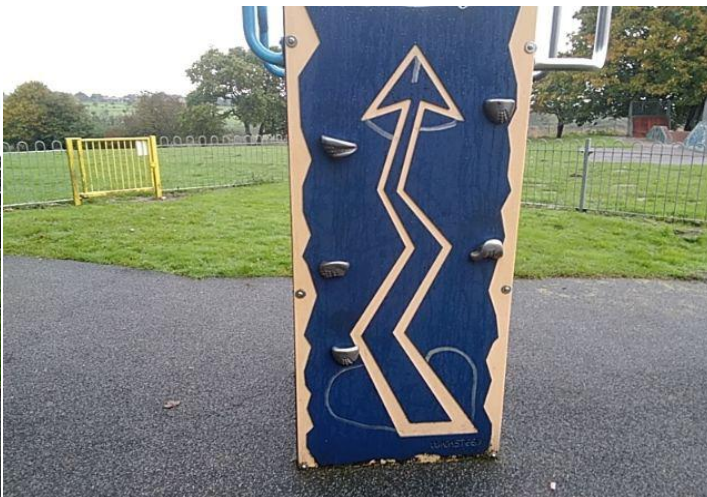
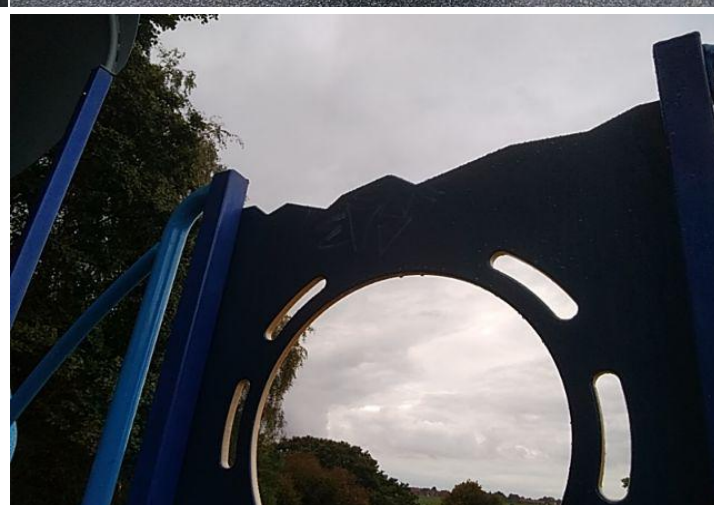
**Finding:** There is some graffiti present

**Action:** Remove the graffiti

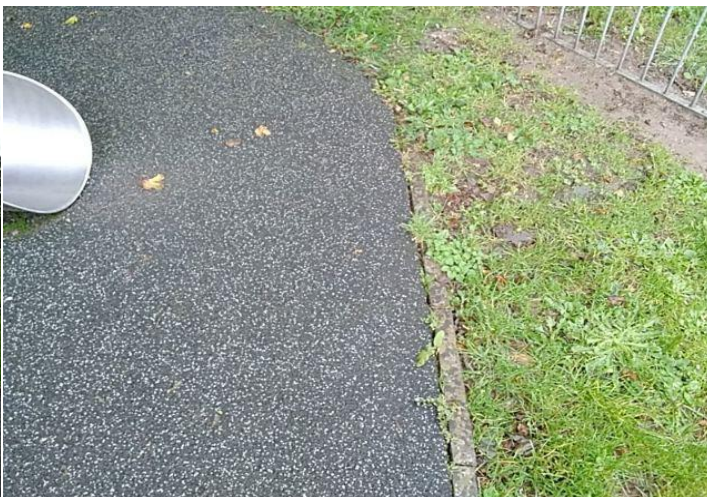
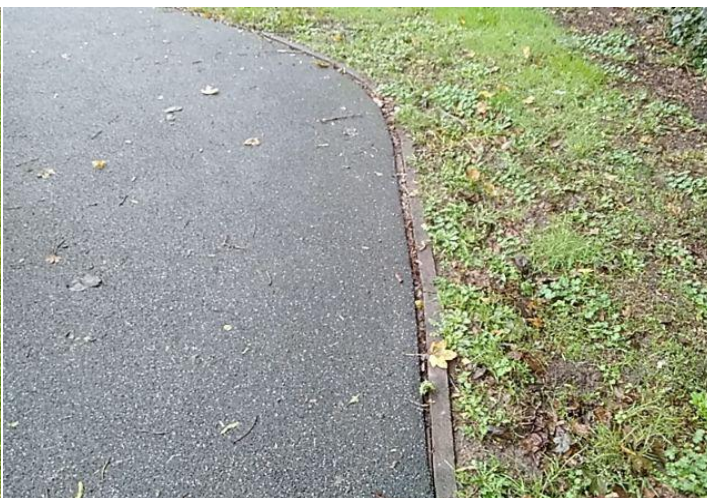
**Finding:** There are gaps opening between the surfacing and the edging surround or between the joints in the surfacing  
**Action:** Monitor for any further deterioration and repair as required

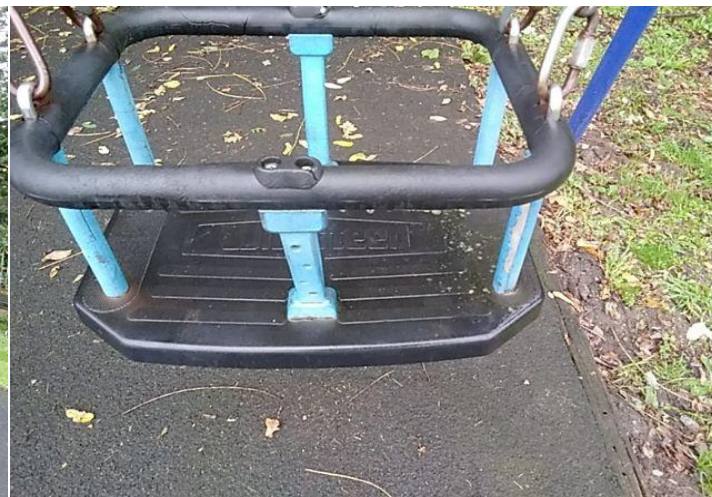
**Finding:** Two seats have minor damage or wear

**Action:** Monitor for any further deterioration and replace as required

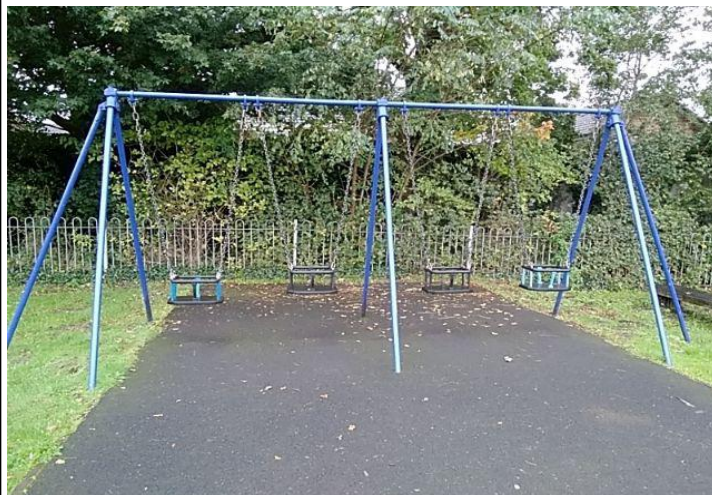
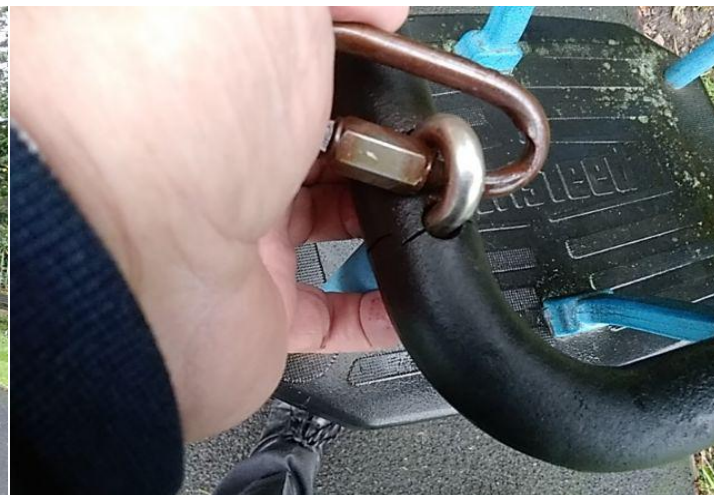
**Finding:** There is some notable evidence of chain wear

**Action:** Monitor for any further deterioration and replace when 40% worn (note chains can be fitted directly onto the seats, additional fixing links are not required)

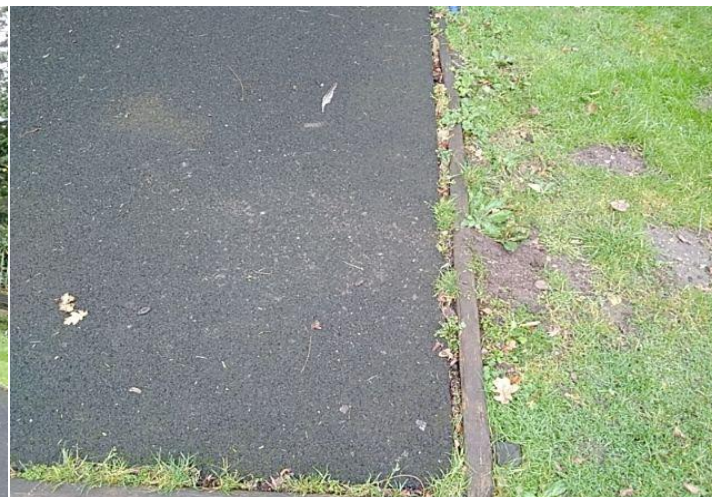
**Finding:** Timber edging rotten or missing

**Action:** Replace the affected edging (Wicksteed recommend concrete pin kerb edging)

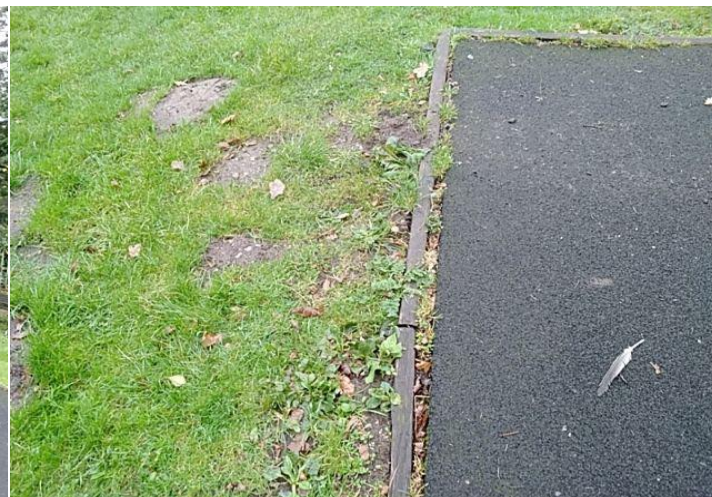
**Finding:** There are gaps opening between the surfacing and the edging surround or between the joints in the surfacing **Action:** Monitor for any further deterioration (see timber edging note)

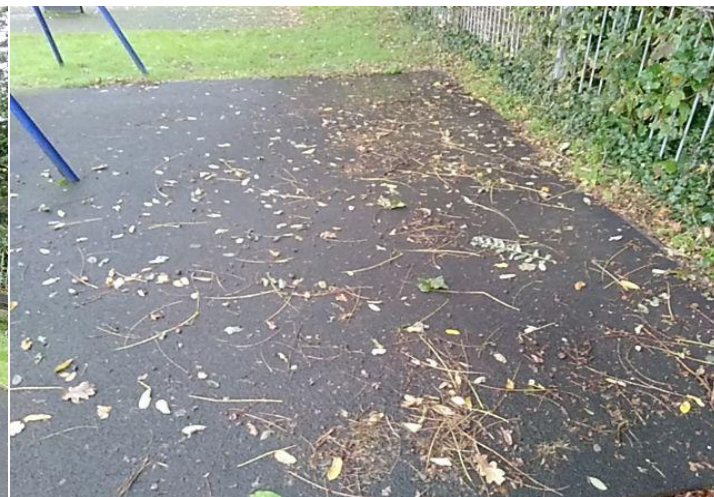
**Finding:** There is some tree debris on the surfacing

**Action:** Remove and maintain

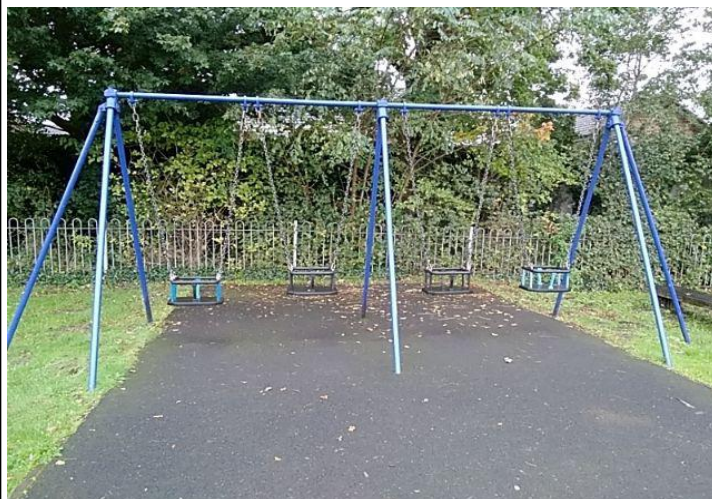
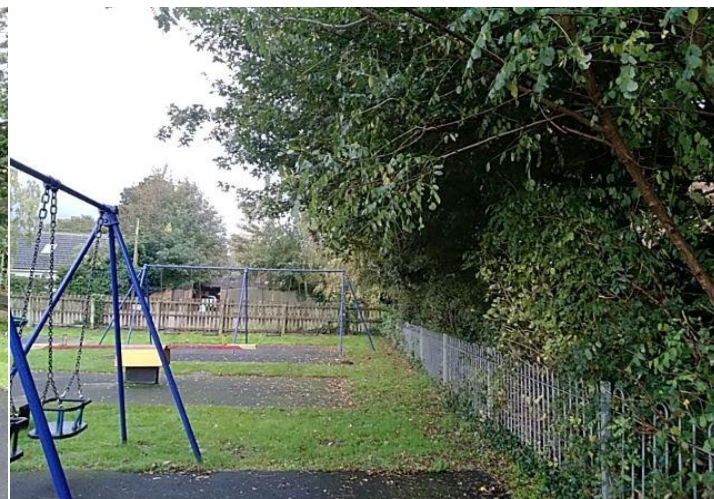
**Finding:** The adjacent foliage is overhanging

**Action:** Cut back and maintain

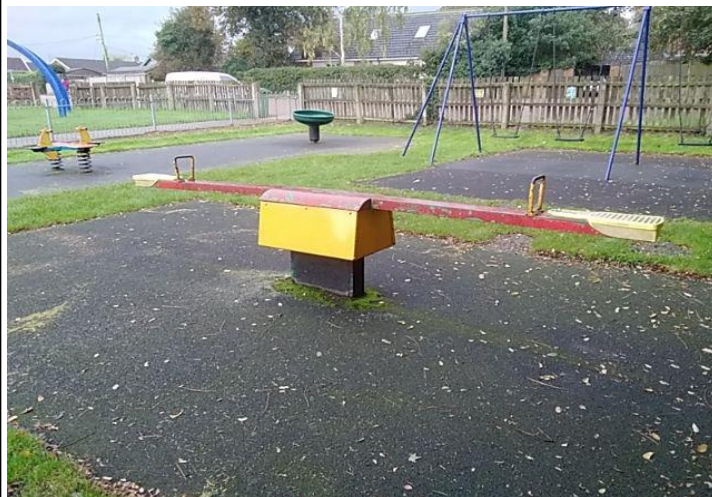
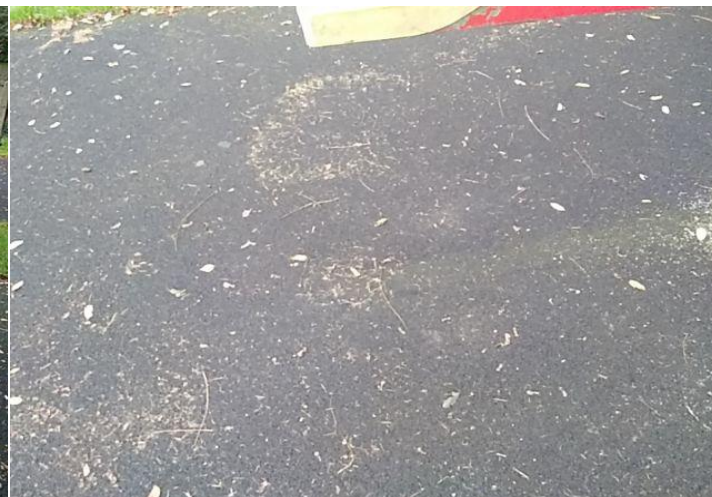
**Finding:** Uneven surface

**Action:** Cause cannot be determined without disturbing the wetpour, monitor for deterioration

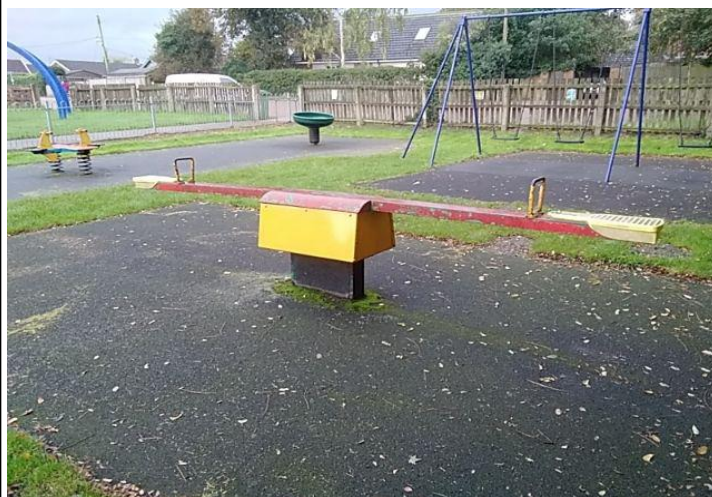
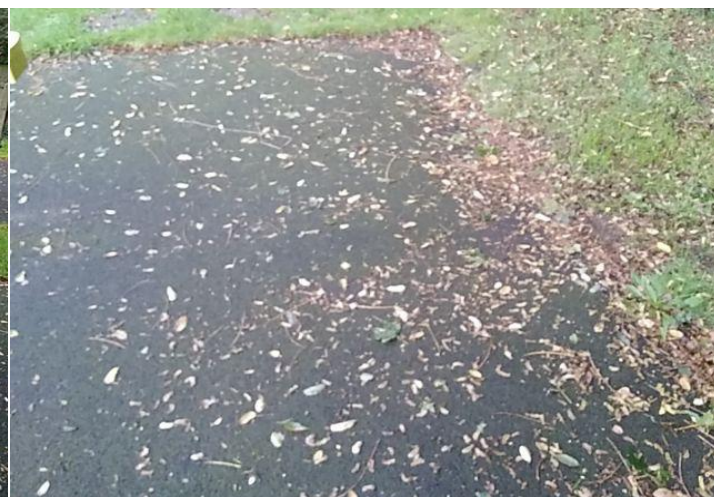
**Finding:** There is some tree debris on the surfacing

**Action:** Remove and maintain

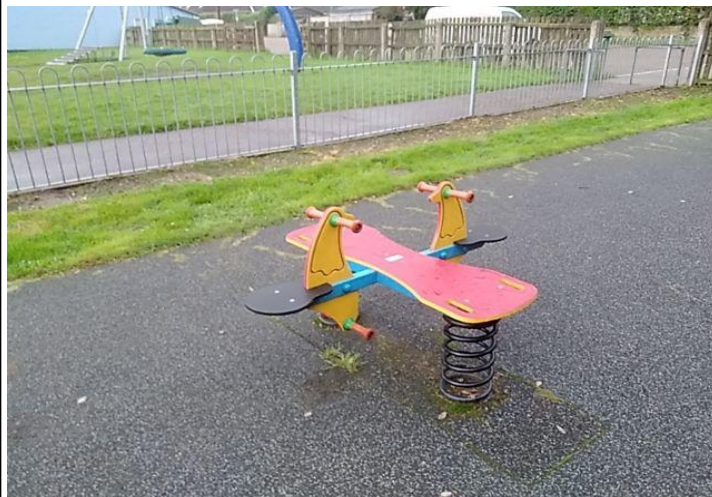
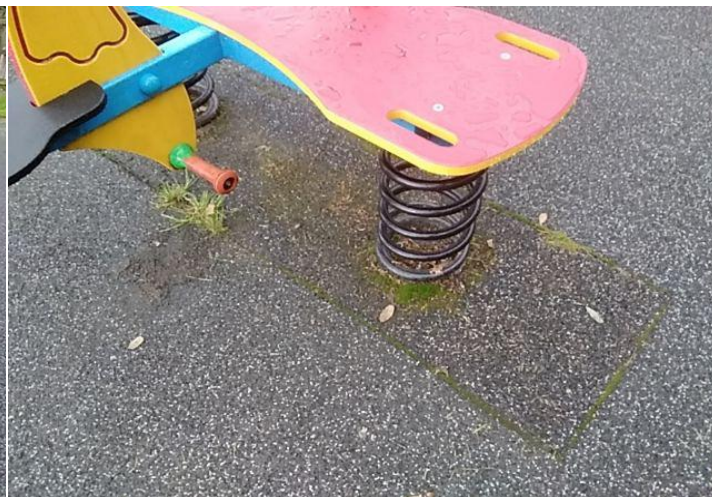
**Finding:** There are weeds/vegetation growth within the surfacing

**Action:** Remove weeds/vegetation growth

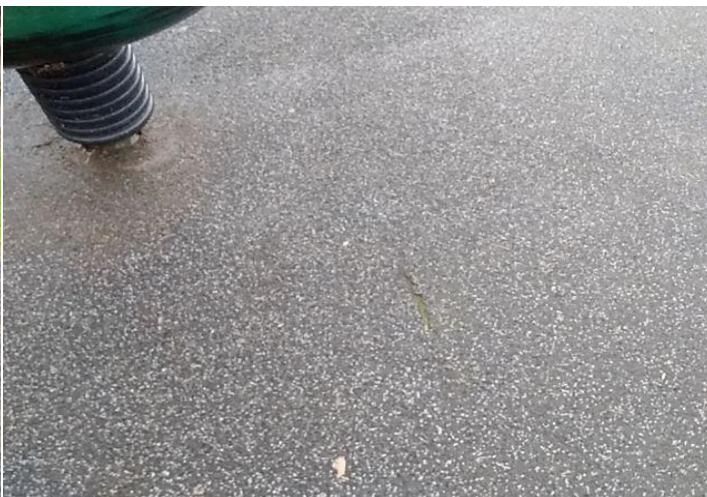
**Finding:** The safety surface around this unit has been damaged

**Action:** Monitor for any further deterioration and repair as required

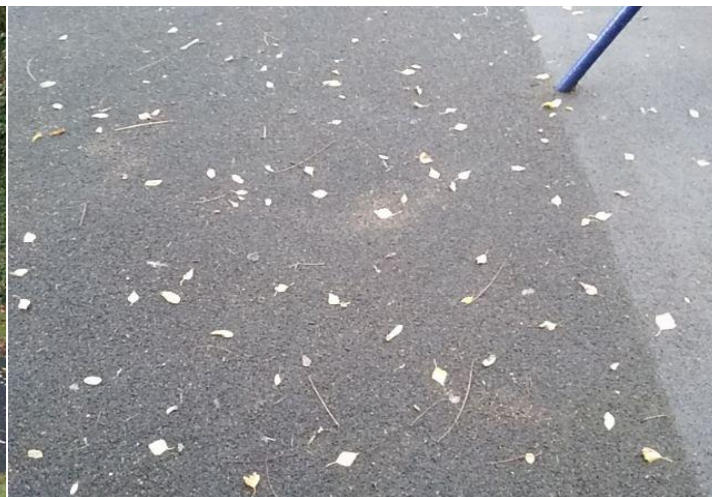
**Finding:** The safety surface around the area is beginning to wear  
**Action:** Monitor for any further deterioration and repair as required

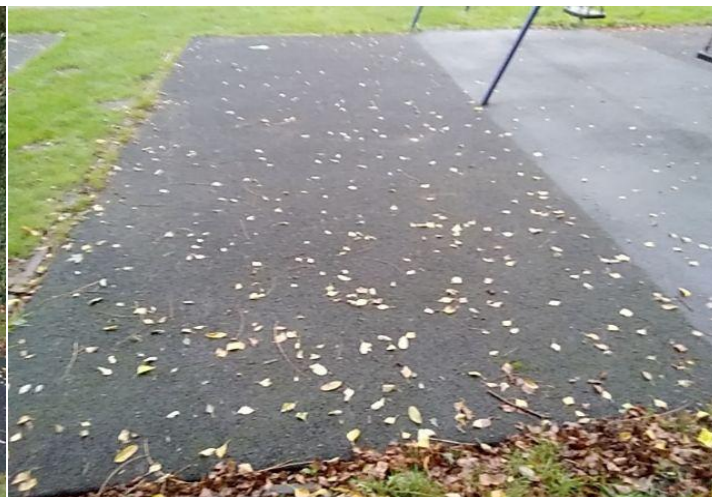
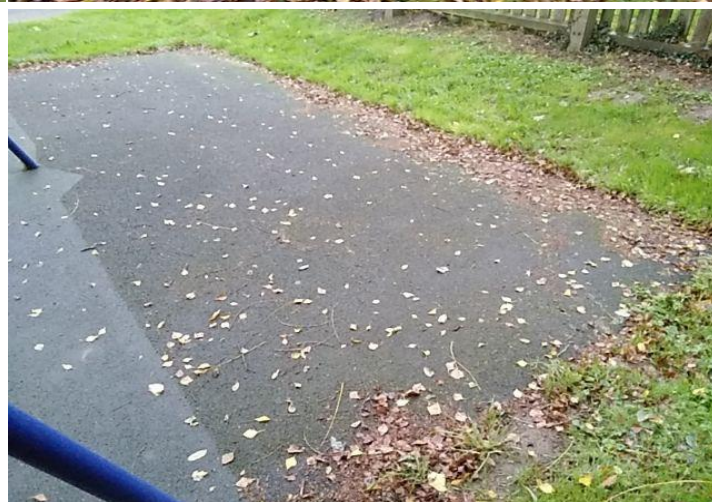
**Finding:** There is some tree debris on the surfacing

**Action:** Remove and maintain

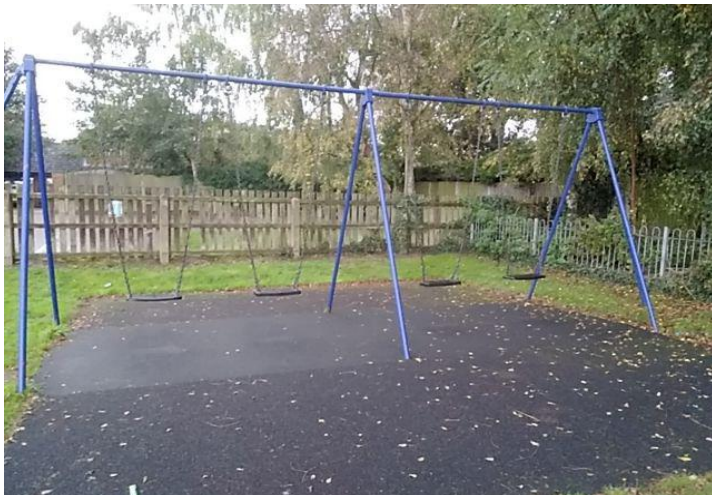
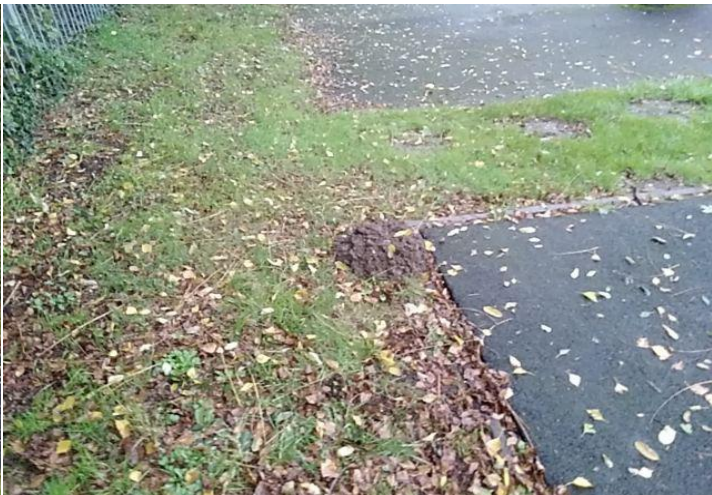
| 8 - Low Risk (Finding 6) | | | |
|---|---|---|---|
| <b>Finding:</b> There are a number of molehills within the area and these may present unforeseen hazards for users | | <b>Action:</b> Remove moles by appropriate means, reinstate surfaces to level and maintain the area | |
