## Tree Hazard Assessment & Tree Work Recommendation Report

Brundall Cemetery  
Allotments  
and  
Church Fen  
Brundall  
Norfolk

December 2024  
Report number: CA/BPC.12.24.1

Report prepared by Conservation Arboriculture  
for Brundall Parish Council

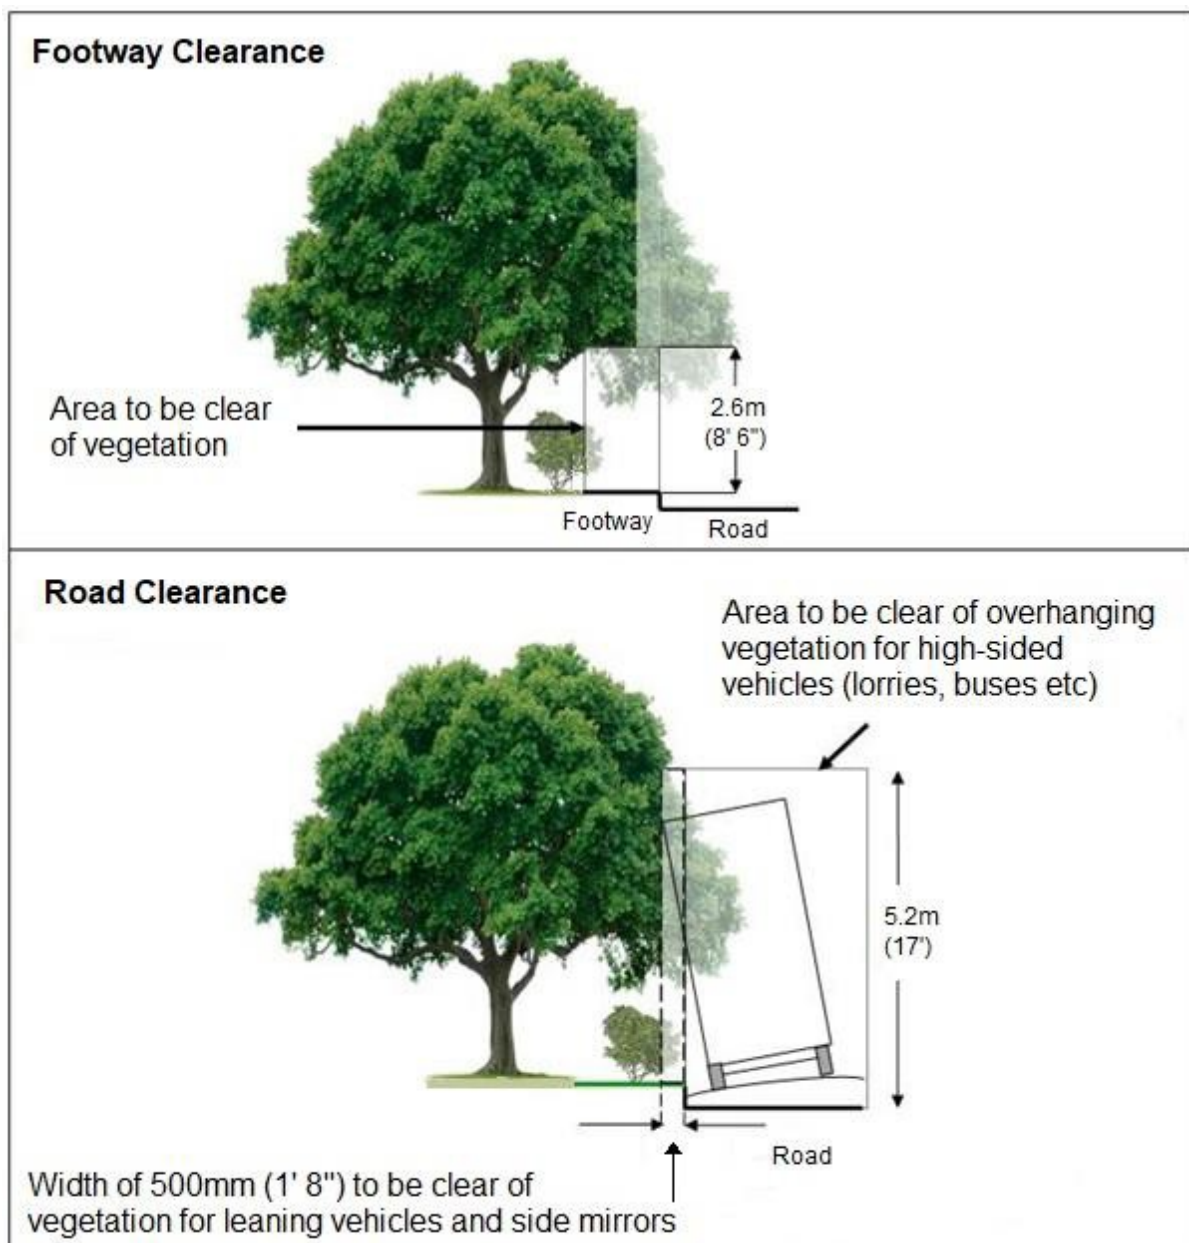
**Required clearance dimensions:** The Highways Act 1980 specifies that the cause of the danger, obstruction or interference is removed. Although no dimensions are specified within the Act, we recommend the following:

**Footway clearance** - minimum headroom of 2.6m (8' 6") ideally back to the highway boundary or otherwise stated.

**Road clearance** - minimum headroom of 5.2m (17') and a minimum sideways clearance of 500mm (1' 8") In both cases, all vegetation should be cut back vertically. See the diagrams below for further clarification.
